AARK Stream Restoration, LLC
NAU Capstone

Channel & Culvert Analysis

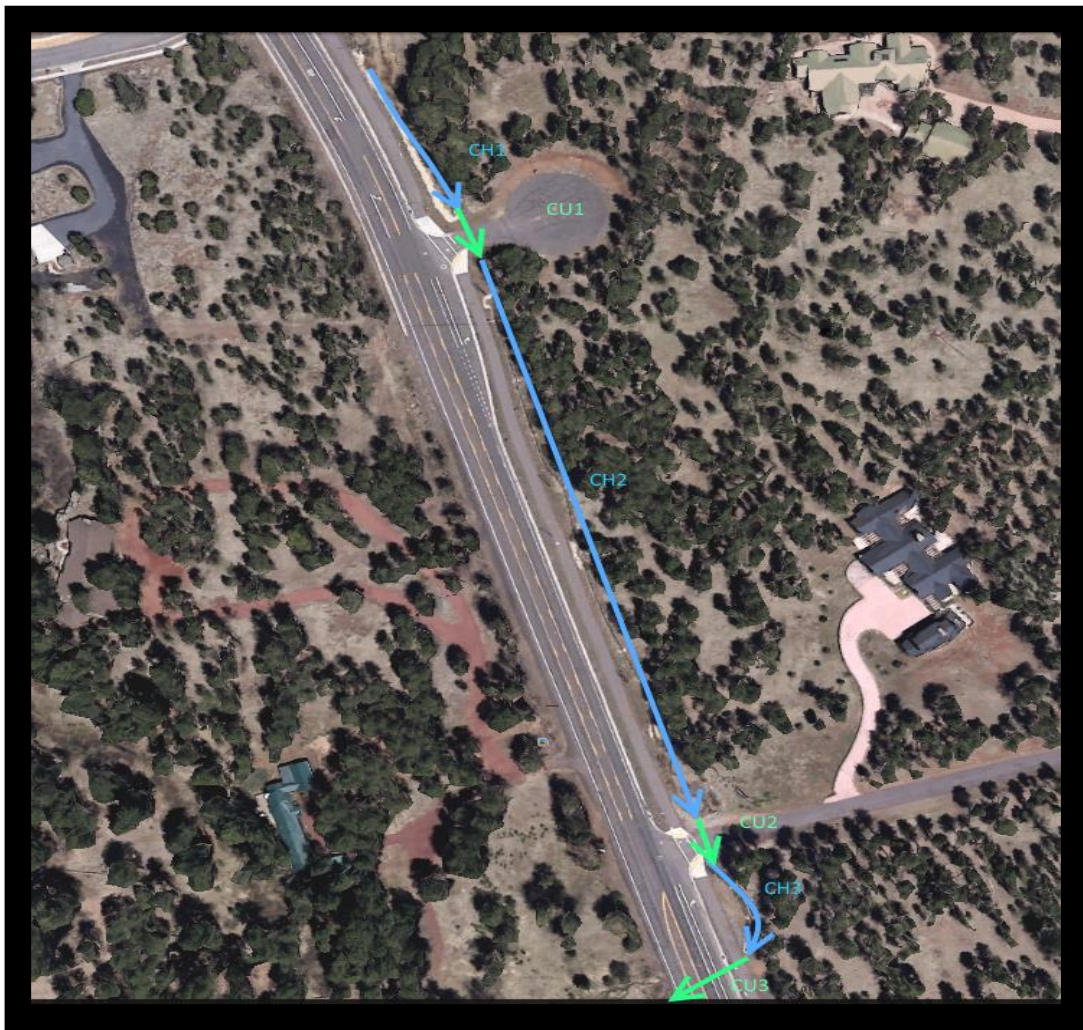
FIGURE 1: ARIAL PHOTO FROM GOOGLE MAPS OF COYOTE SPRINGS ESTATE SHOWING THE CHANNELS AND CULVERTS ON THE REACH
