AARK Stream Restoration, LLC
NAU Capstone

Problematic Areas of Coyote Springs Reach

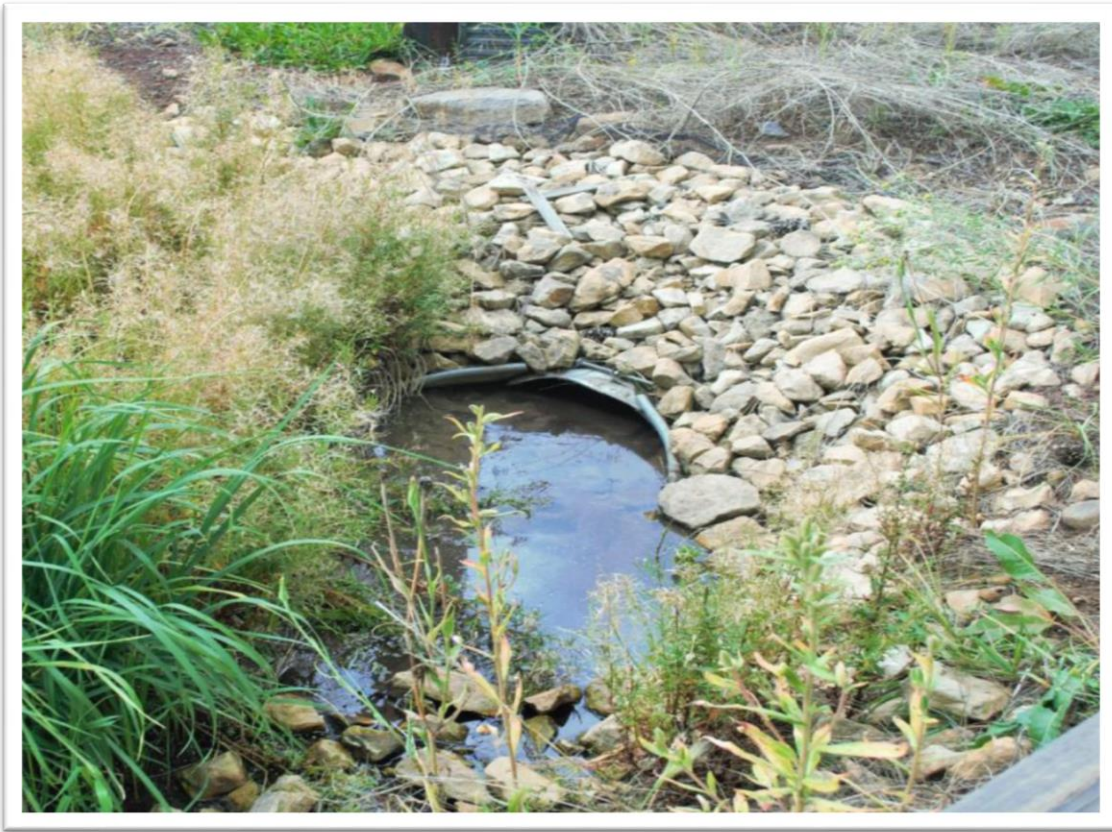
1. Clogged Culverts:

Figure 2: Clogged Culvert in Coyote Springs reach

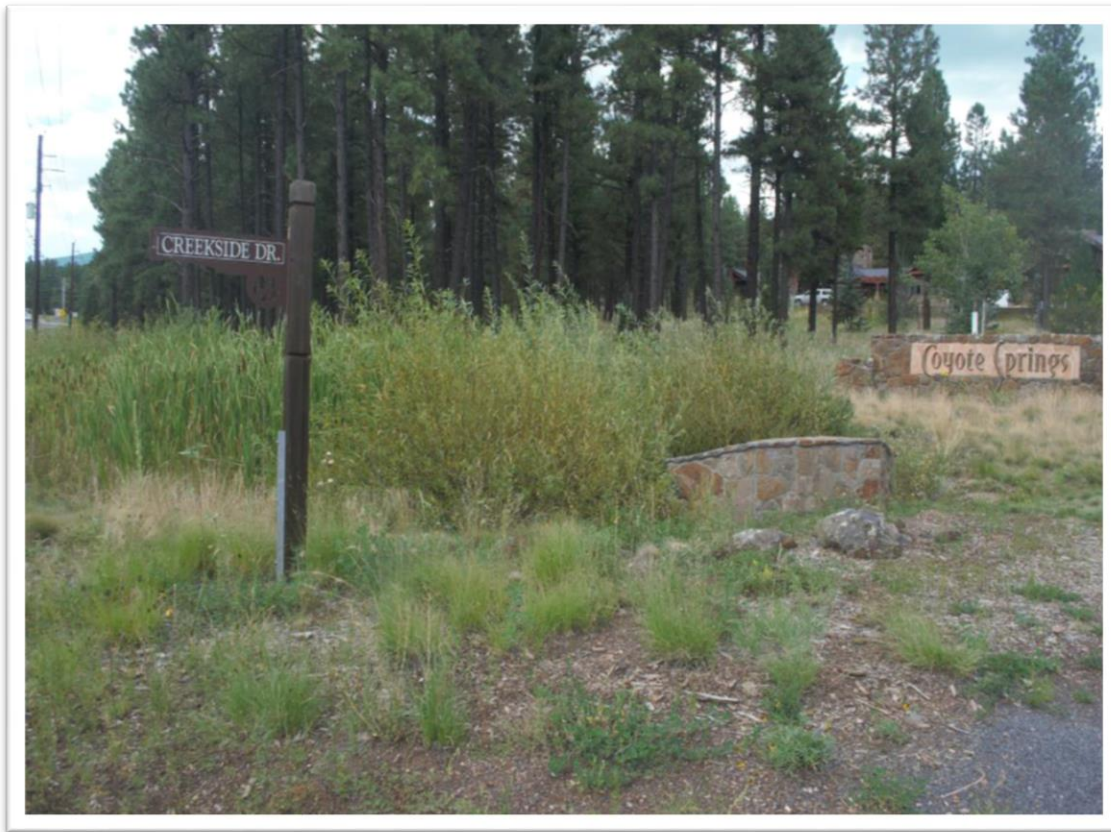
2. Overgrown Pooling Area at Creekside Drive and Highway 180:

Figure 3: Overgrown pooling area

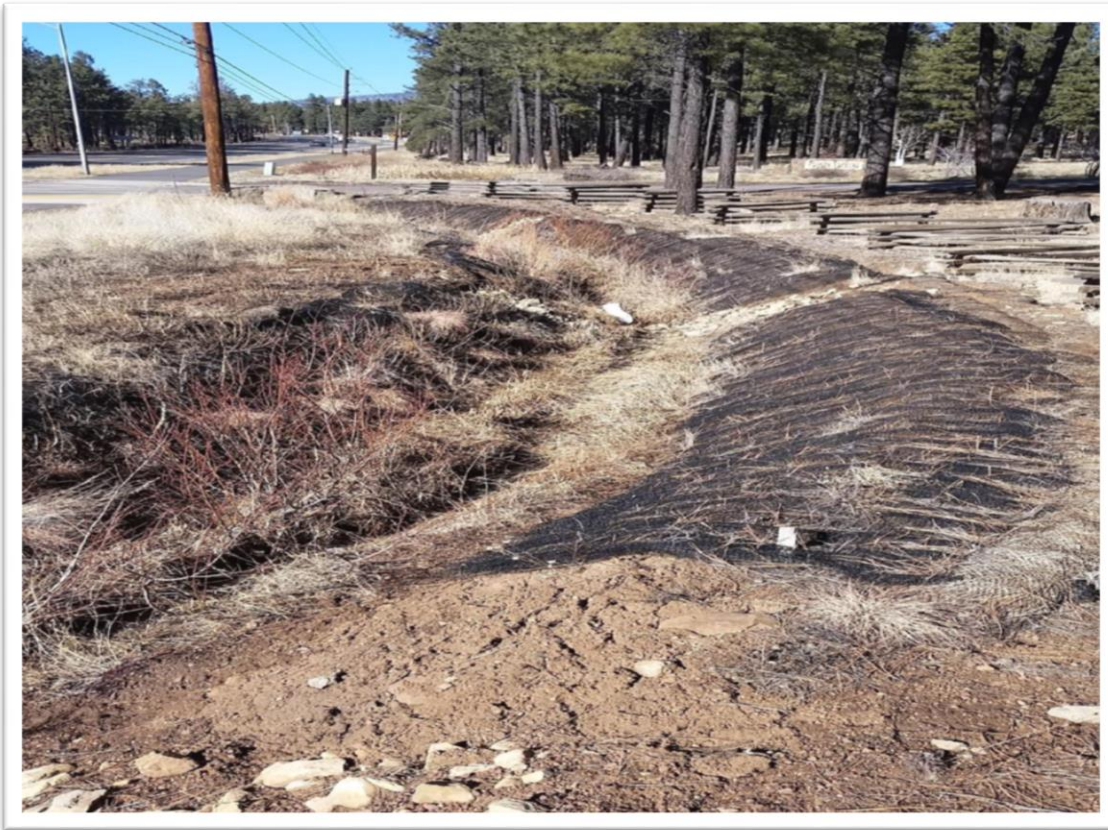
3. Turf Reinforcement Matting on Downstream End of Stream:

Figure 4: Turf reinforcement matting on downstream end of stream
