Rio de Flag Drainage Study
Artemis Designs

December 7, 2021

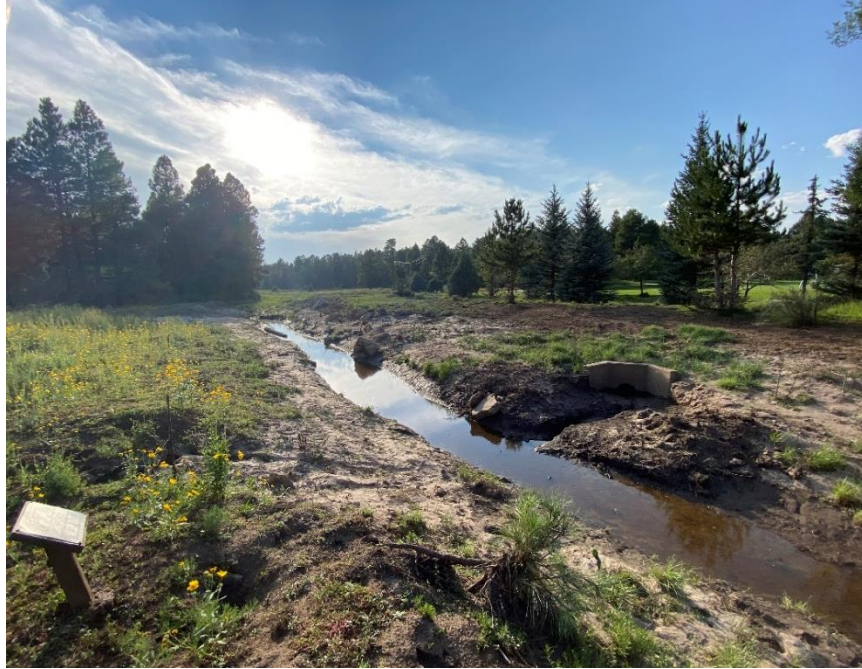
Figure 4: Detention Representation Within the Reach, photo by Jenna McCaffrey

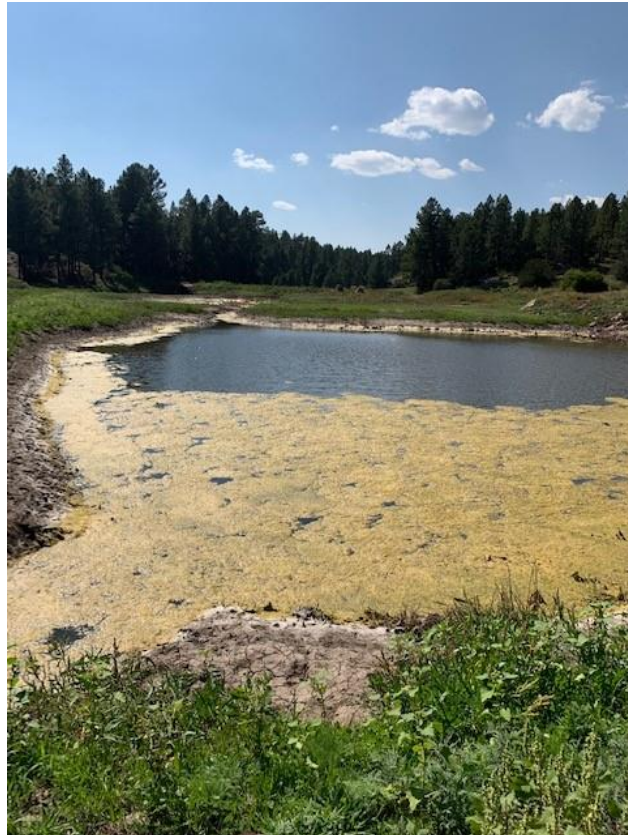
Figure 5: Retention Representation Within the Reach, photo by Destiny Gourley

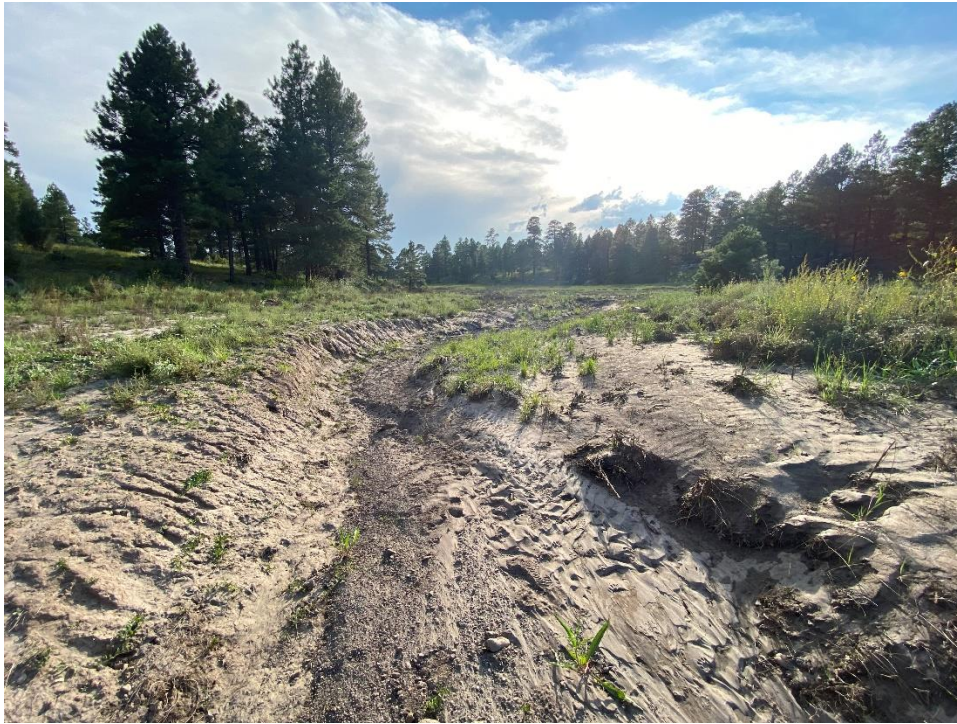
Figure 6: Silting Representation Within the Reach, photo by Jenna McCaffrey

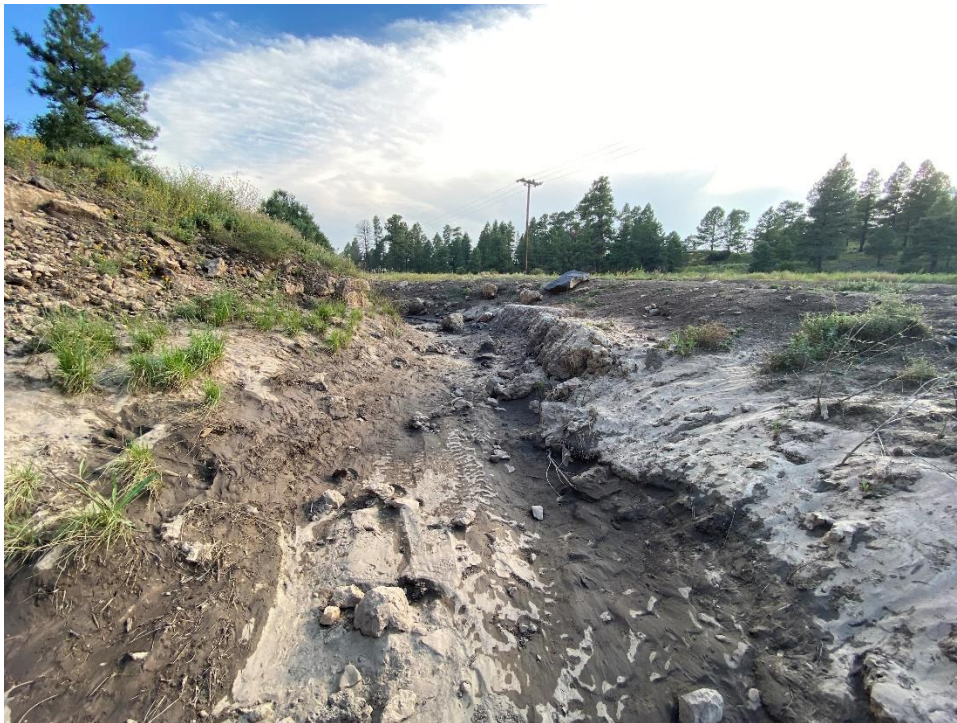
Figure 7: Erosion Representation Within the Reach, photo by Emily Frazer

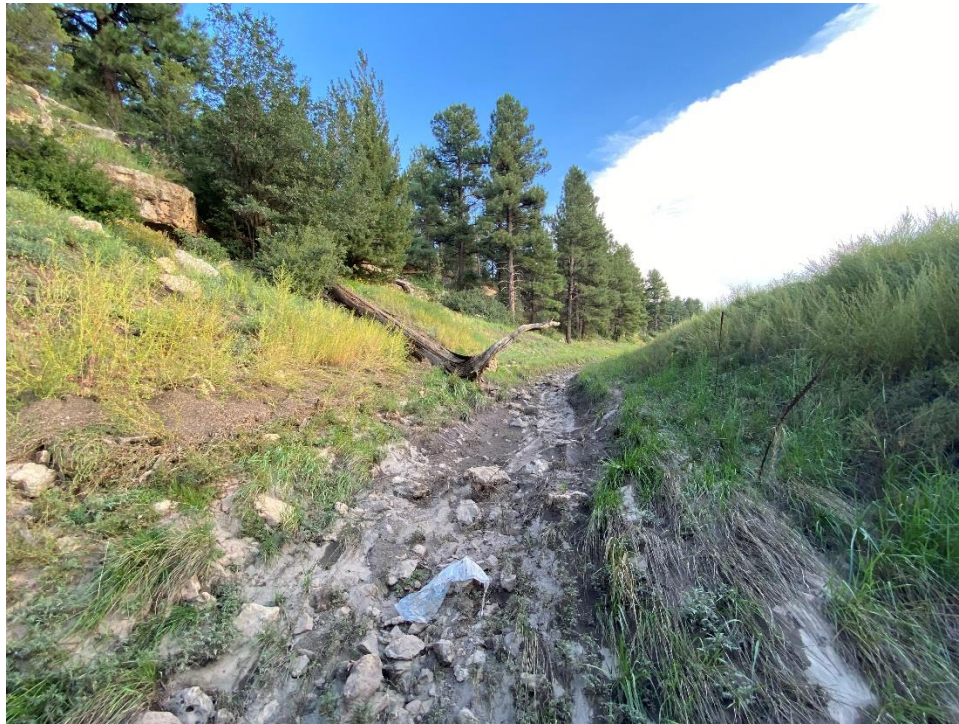
Figure 8: Garbage Pollution Within the Reach, photo by Daniel Segal

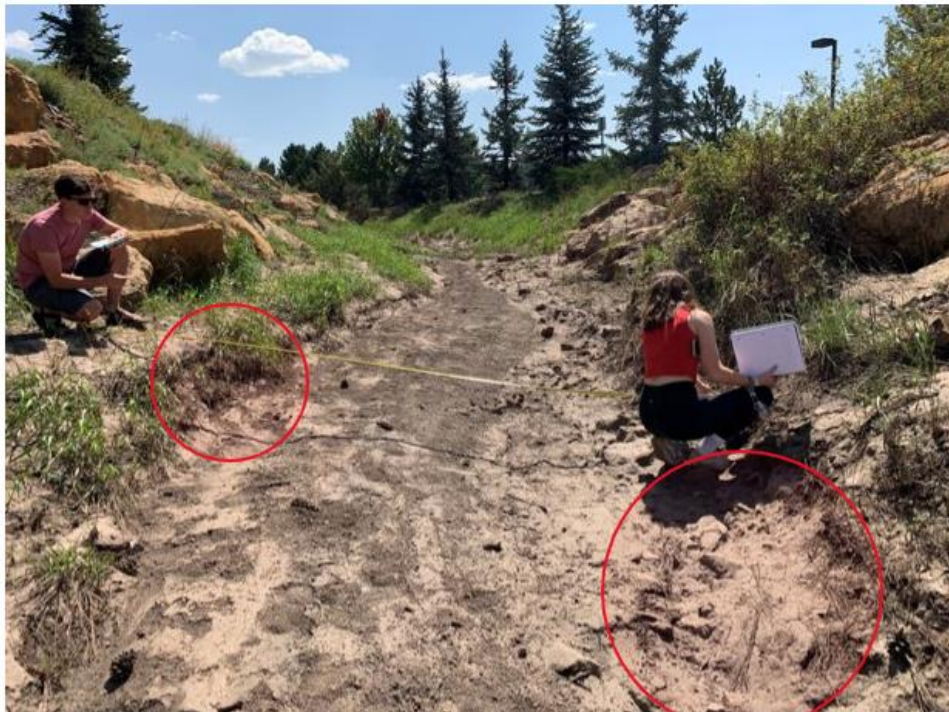
Figure 10: Image of Site 1, photo by Destiny Gourley

Site 1 was determined to have signs of erosion as seen circled in red in figure 10.

The cross-section analysis for Site 1 can be found in Appendix I, showing the cutting of the thalweg (circled in red to the right) and incision of the bank (circled red, left) due to excessive erosion.

Erosion affects sites 1, 3, 5, and 8. For sites 1, 3, and 5, it is recommended that alternative materials be used to armor the banks with riprap. This will help to slow the water velocity and therefore prevent erosion from continuing to occur in the future. Site 8 is different than the other three sites that suffer from erosion issues. Site 8 currently has two different channels that have formed. This leads to standing water in the area in addition to the other issues. So, it is recommended that for site 8 the second channel be filled, the main channel be excavated to help with flow, and the banks be armored with riprap after this is completed.

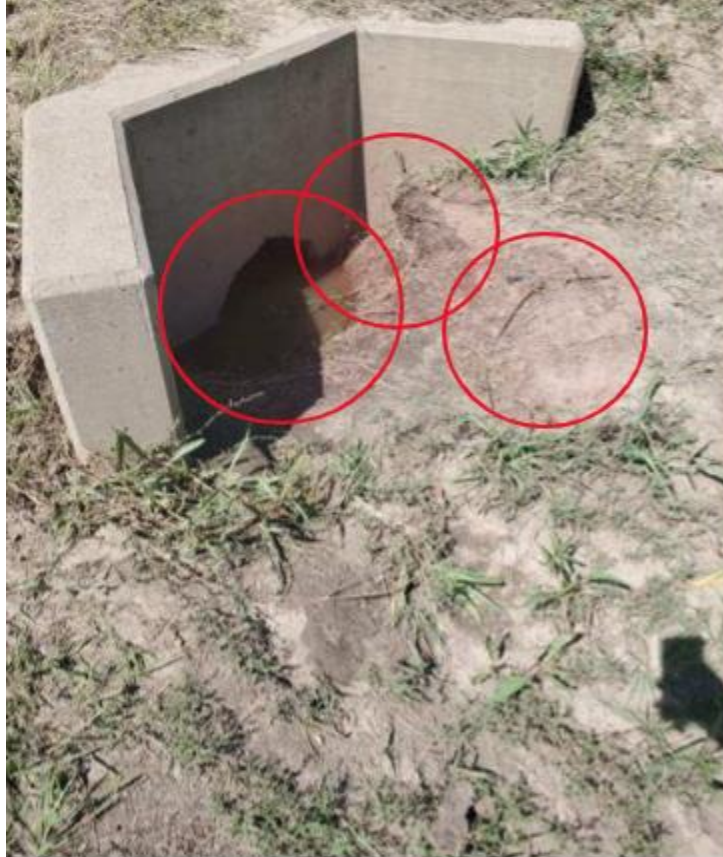
Figure 11: Image of Site 2, photo by Daniel Segal

Figure 11 shows Site 2 which contained pooling water, a sign of detention (as seen circled in red) followed by signs of siltation. Detention and silting are concerning for they inhibit water conveyance.

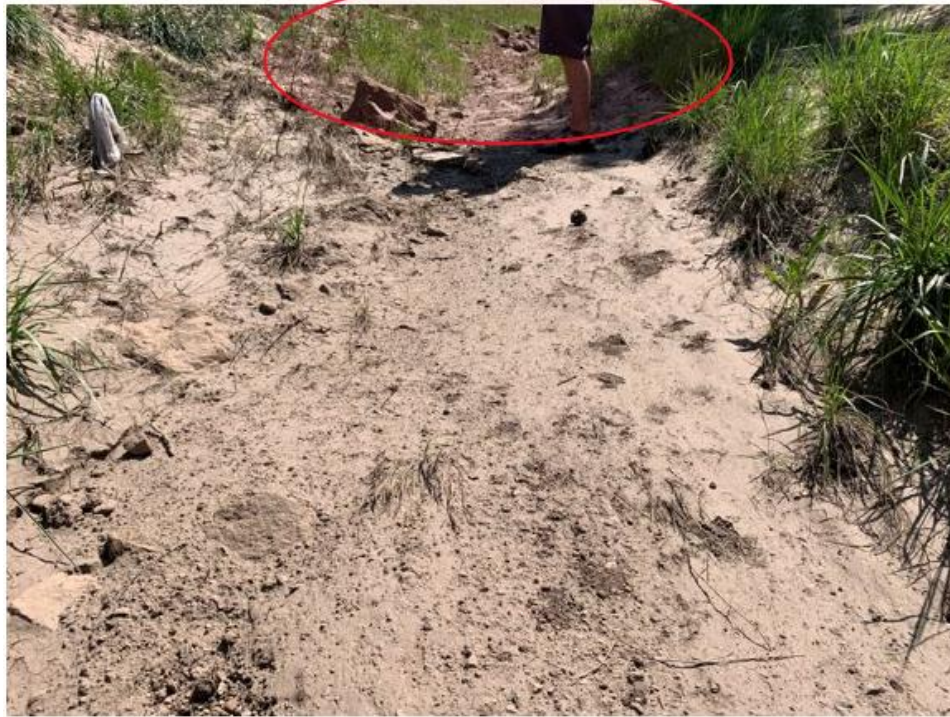
Figure 12: Image of Site 3, photo by Emily Frazer

Site 3 shows signs of erosion. The velocity in this area is higher than it should be, which can lead to erosion occurring. Figure 12 shows site 3, and the red circle shows where there are signs of erosion.

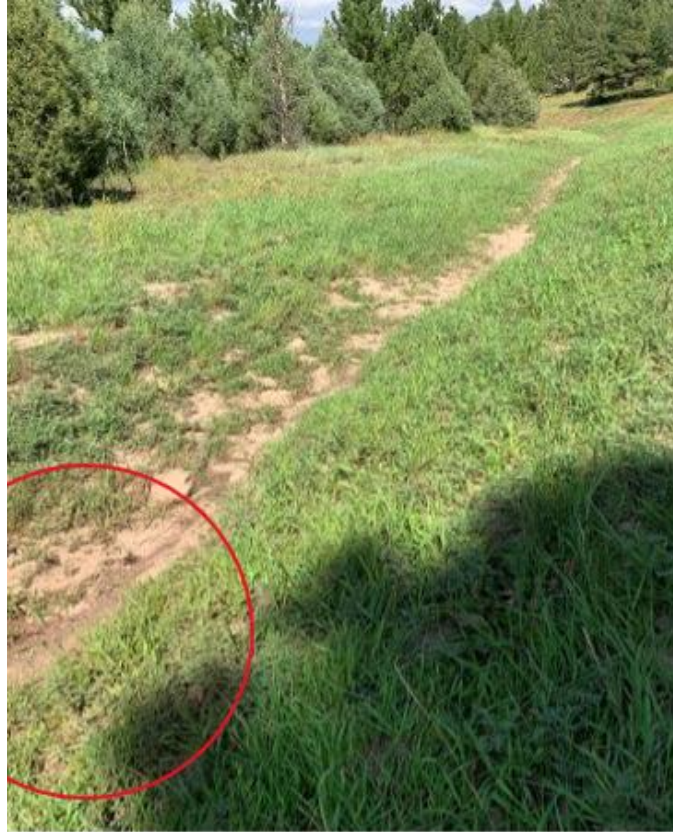
Figure 13: Image of Site 4, photo by Destiny Gourley

Site 4 shows signs of detention and silting. The red circle in Figure 13 shows where there were signs of detention in this section of the channel. The slope in this area is extremely small, which could easily lead to detention within the channel.

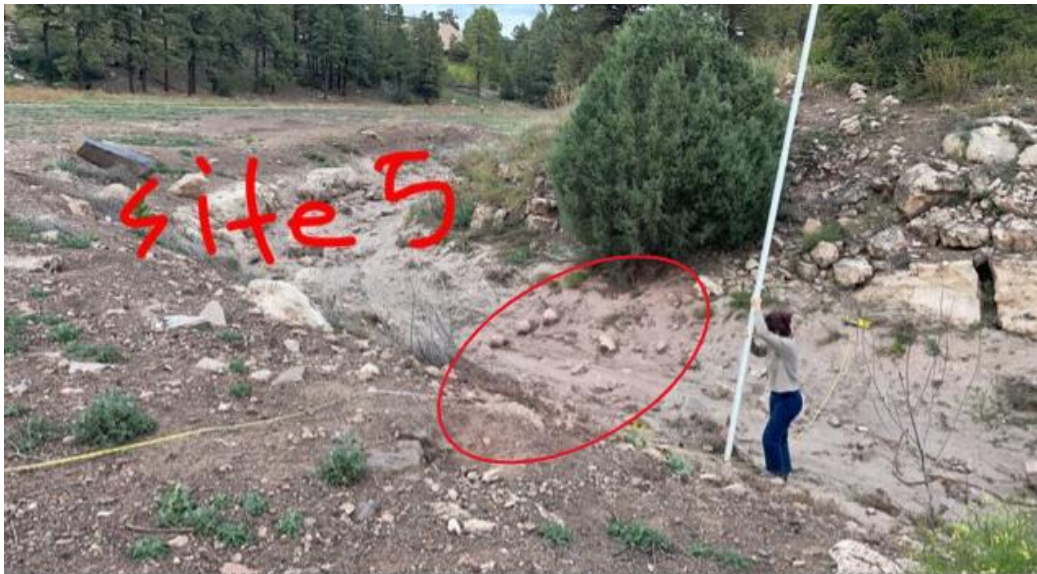
Figure 14: Image of Site 5, photo by Jenna McCaffrey

Figure 14 shows Site 5 with evidence of erosion circled in red.

Site 5 showed evidence of high velocity discharge with a lack of vegetation in and around the channel, large boulders deposited, and no evidence of standing water. The results of the hydraulic analysis of this site can be found in Appendix I.

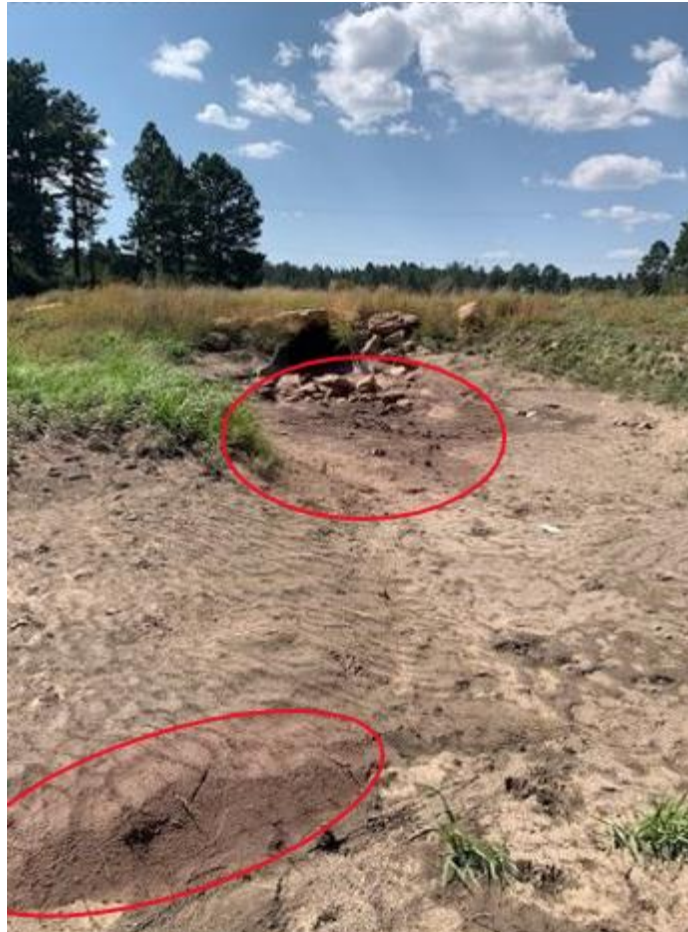
Figure 15: Image of Site 6, photo by Emily Frazer

Figure 15 shows Site 6, including the outlet of one of the two culverts connecting the Rio de Flag to Spruce Wash.

Site 6 is the confluence with Spruce Wash, there are two culverts that convey the discharge. This site is subject to excessive sedimentation due to the museum fire scar that is part of the spruce wash watershed. The geometry of the site is constantly in flux due to this silting and the very shallow slope at this section of the channel. The image shows one culvert (circled red, above) and a newly formed sandbar due to silting (circled red, lower left).

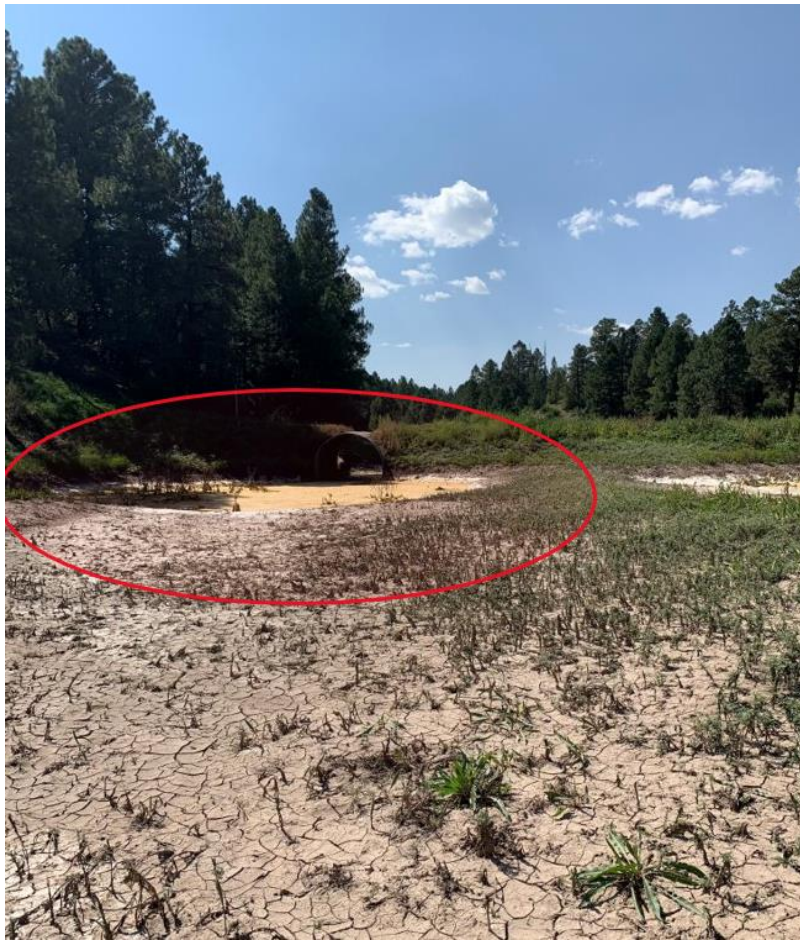
Figure 16: Image of Site 7, photo by Destiny Gourley

Site 7 showed obvious signs of retention within the channel. In the photograph below, the retention is highlighted in the red circle.

The cross section of this site can be found in Appendix I. The overall bankfull width of this section of the channel is nearly 50 feet while the slope is only around 0.05% which is very small. Due to the large bankfull width and the small slope, this was assumed to be the reason for retention within this site.

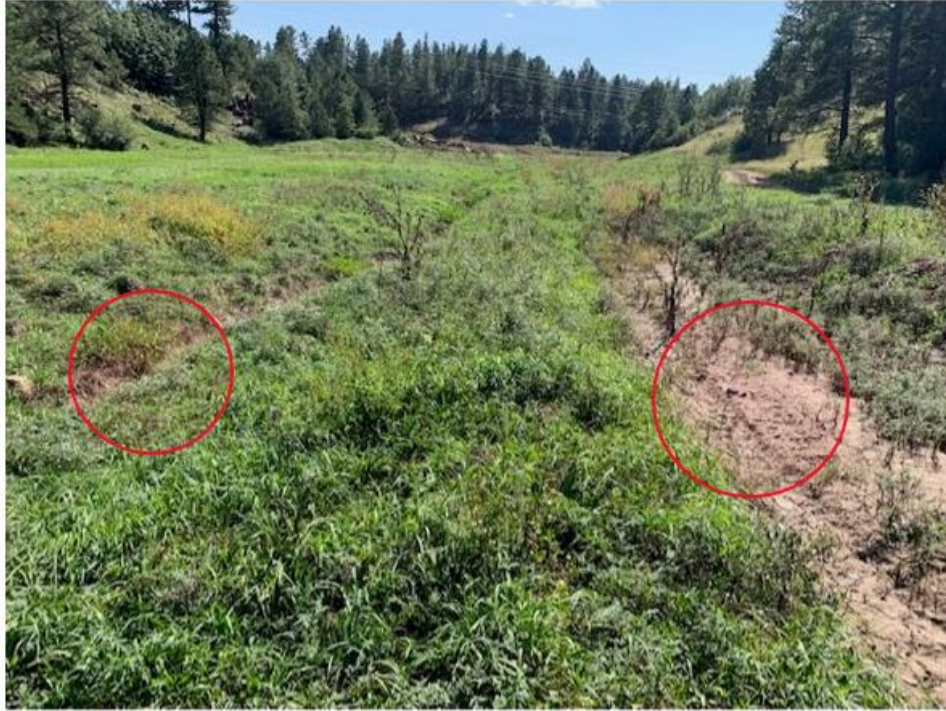
Figure 17: Image of Site 8, Photo by Jenna McCaffrey

Site 8 was classified as a major area of concern because the channel at this site has separated into two different channels. This was assumed to have occurred from ATV riders creating their own trail without thinking of the negative impacts that may occur from creating this new channel. Figure 17 shows both channels circled in red.

The cross section of this site can be found in Appendix I. The cross section shows how there are two defined channels in this area, each including their own banks and thalwegs. It was important to improve this area so that there can be more control over the stormflow when conditions exist. This could be accomplished by combining the two channels into one for better stream conveyance.

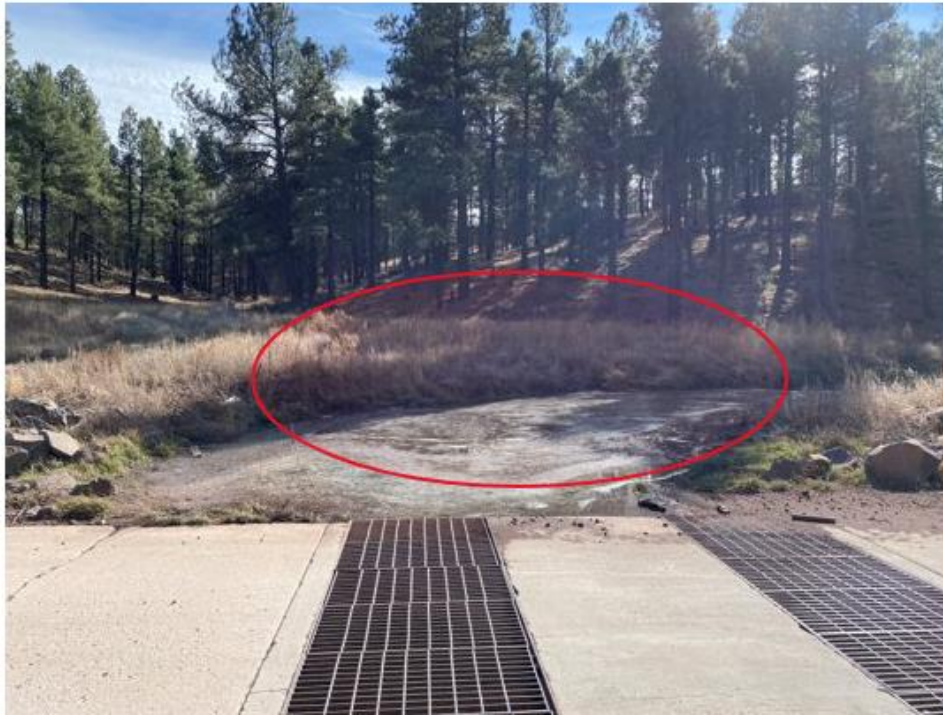
Figure 18: Image of Site 9, Photo by Emily Frazer

The following figure shows Site 9 where detention and silting were prevalent. It can be seen there are high water levels which often lead to overflow onto Herold Ranch Rd.

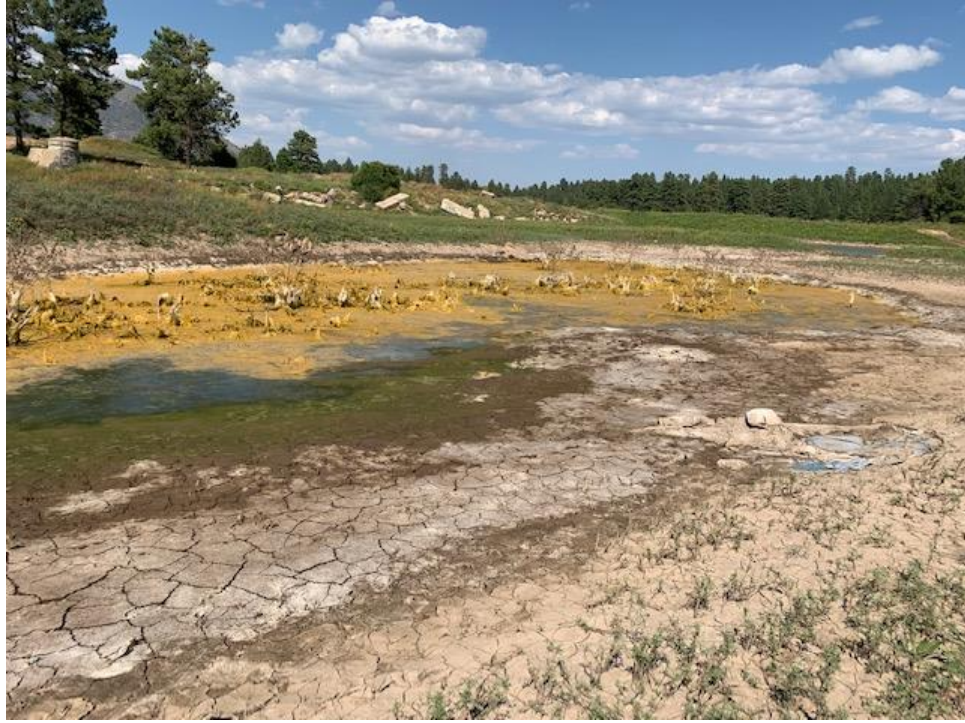
Photo Log 1: Rio de Flag channel station 23+42, looking downstream (north). This section shows retention and erosion.

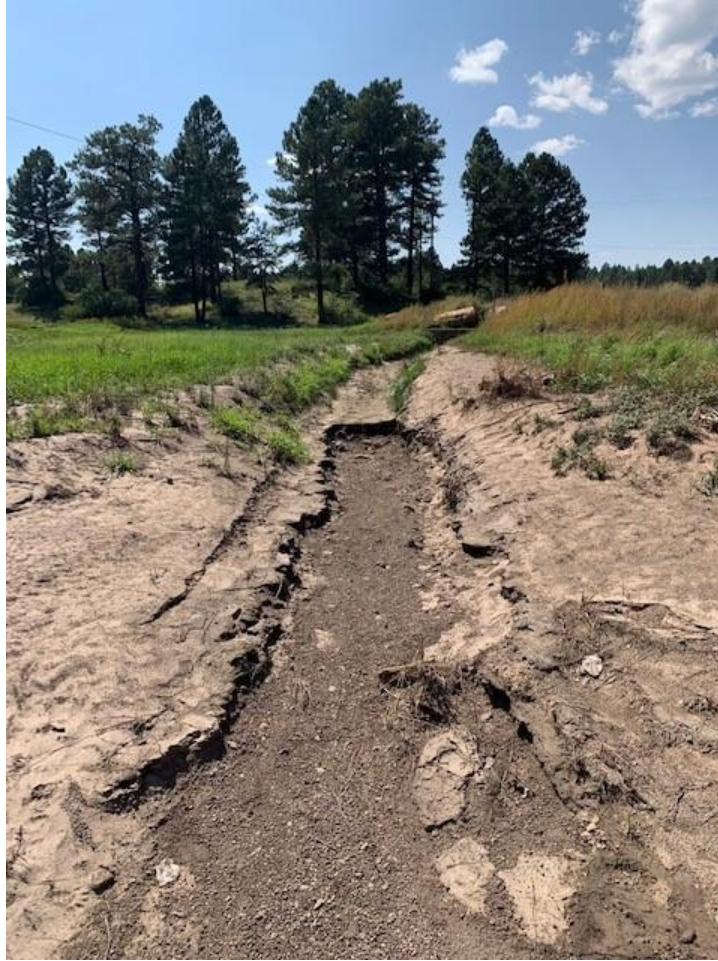
Photo Log 2: Rio de Flag channel station 37+10, looking upstream (south). This shows silting and erosion

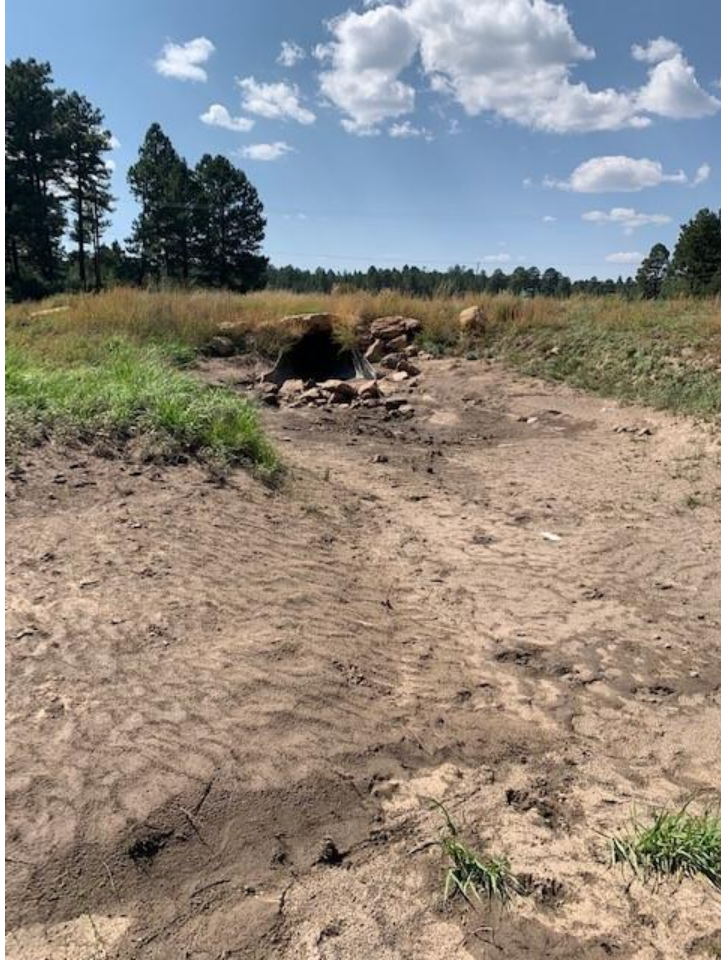
Photo Log 3: Rio de Flag channel station 44+06, looking downstream (north). This section of the channel shows silting and erosion.

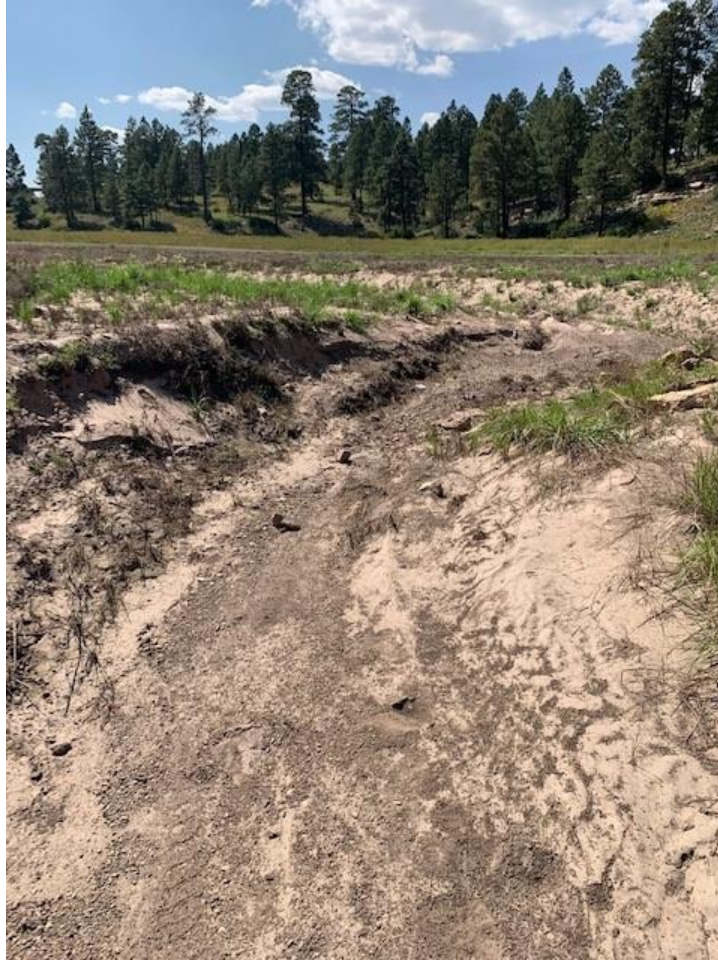
Photo Log 4: Rio de Flag channel station 54+77, looking upstream (south). This section of the channel shows silting, erosion, and signs of detention.

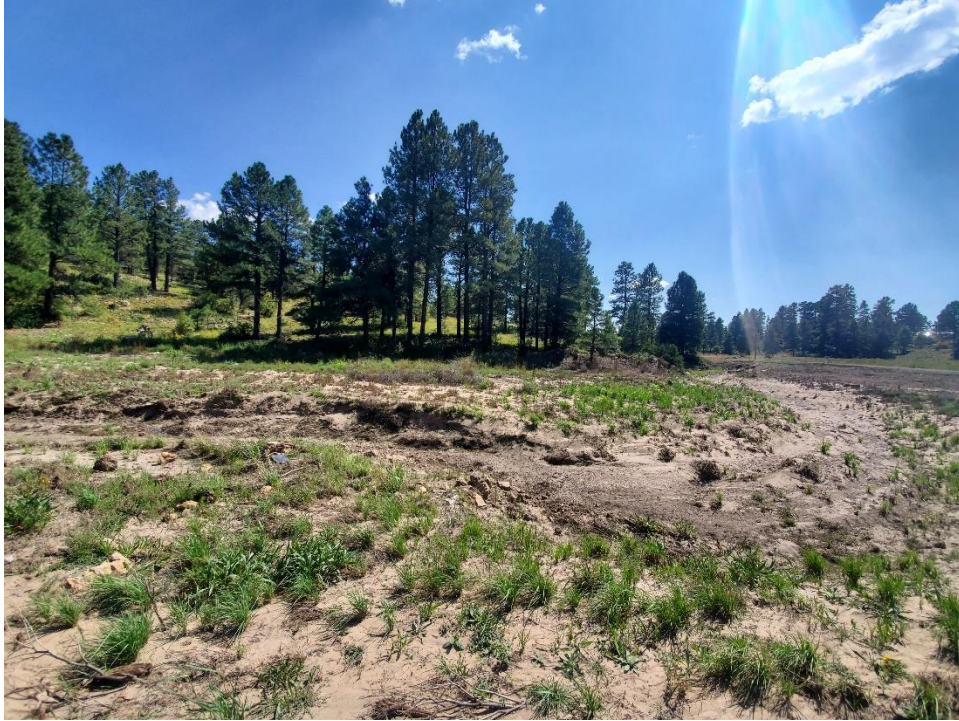
Photo Log 5: Rio de Flag channel station 55+14, looking upstream (south). This section shows silting and erosion.

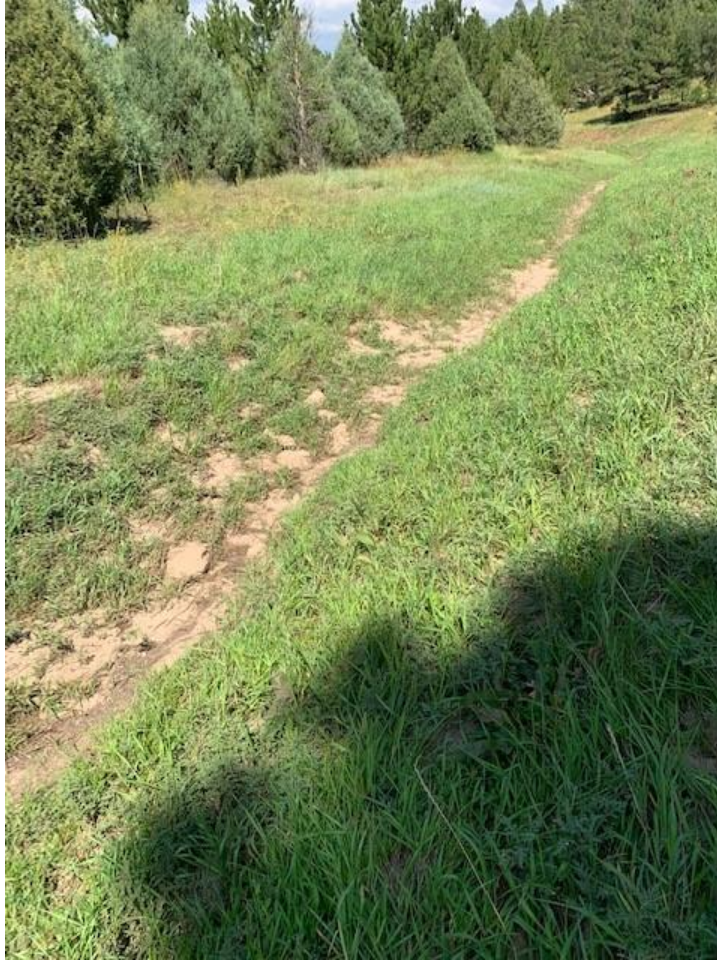
Photo Log 6: Rio de Flag channel station 70+09, looking downstream (north). This section of the channel shows silting, it is apparent that detention or retention would occur in this area had a flow been present.

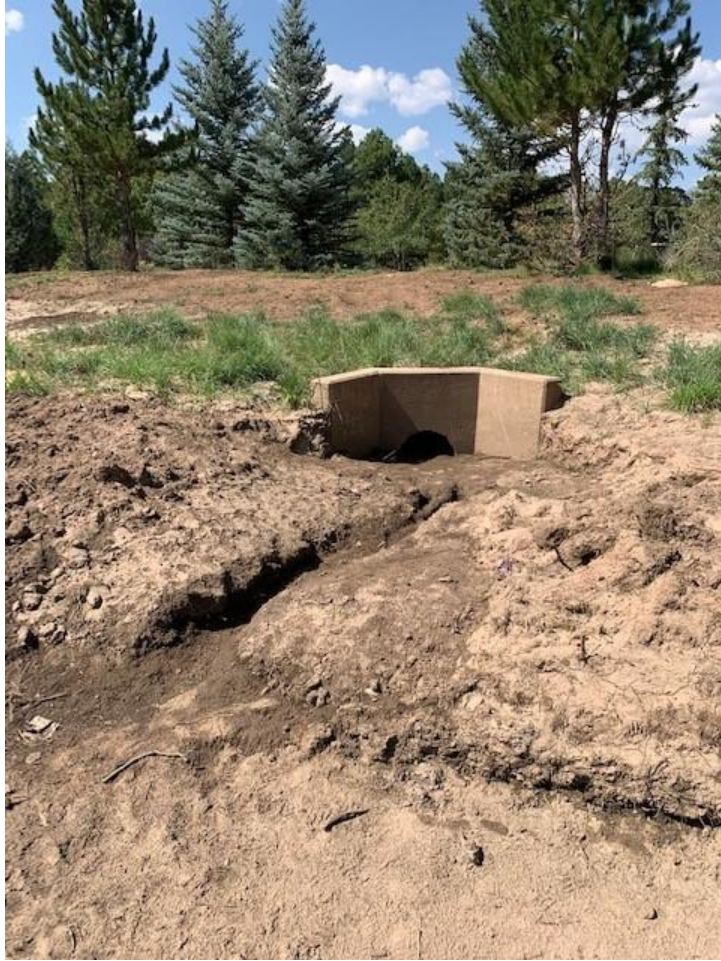
Photo Log 7: Rio de Flag channel station 71+84, looking downstream (north). Silting and erosion are present.

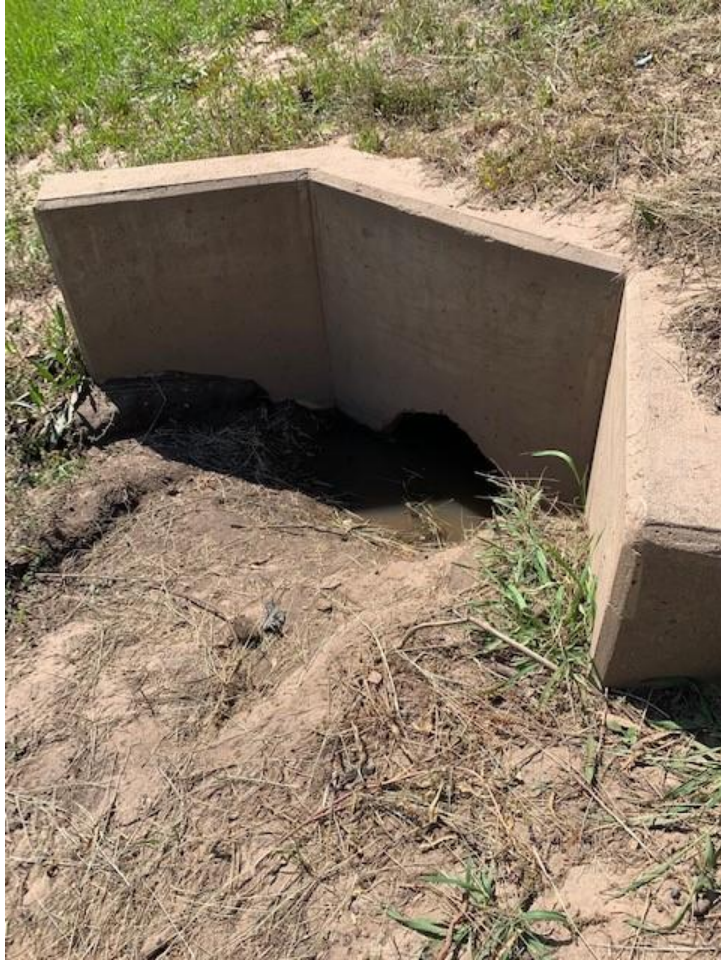
Photo Log 8: Rio de Flag channel station 76+97, looking downstream (north). This image shows silting and erosion.

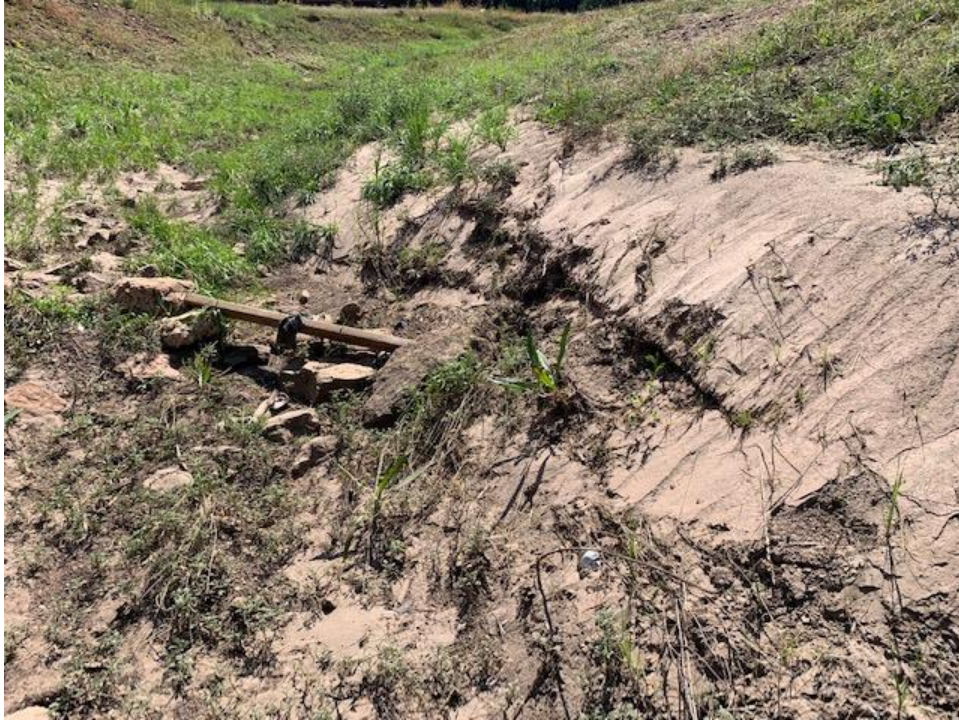
Photo Log 9: Rio de Flag channel station 78+15, looking upstream (south). This image shows silting and erosion.

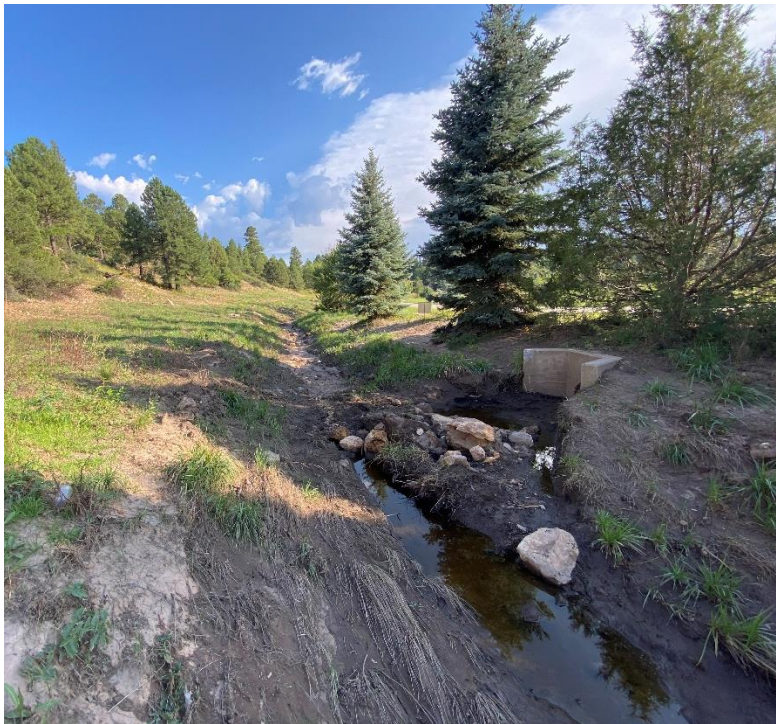
Photo Log 10: Rio de Flag channel station 78+87, looking upstream (south). Detention, erosion, and silting is shown.

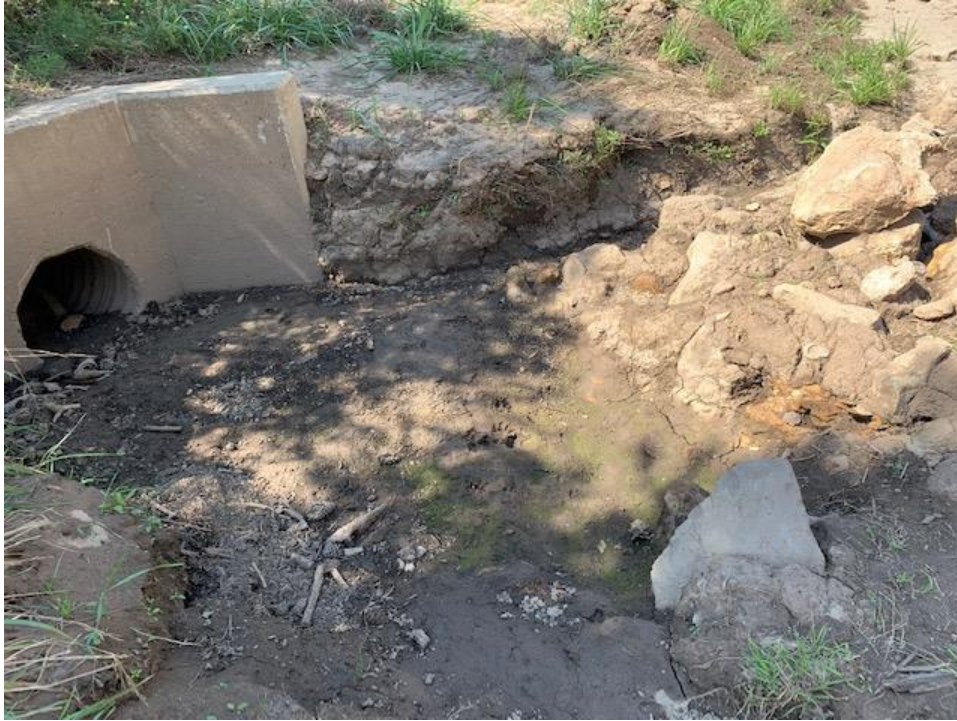
Photo Log 11: Rio de Flag channel station 79+35, looking downstream (north). This section is showing erosion, silting, and can be assumed detention would occur in the area if a flow was present.

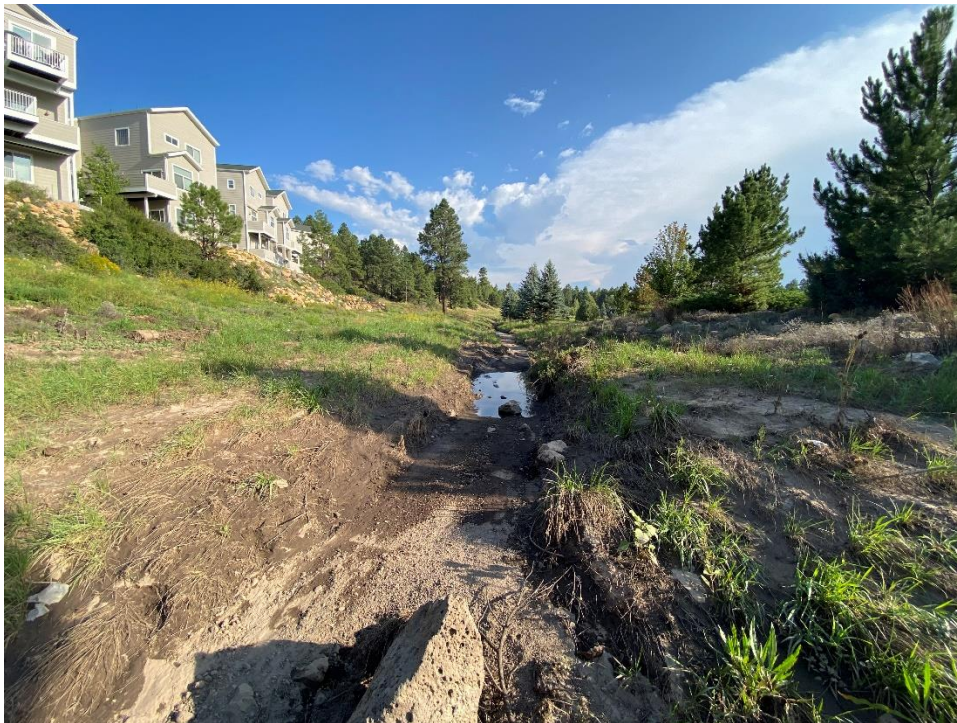
Photo Log 12: Rio de Flag channel station 80+78, looking upstream (south), this section of the channel is showing erosion, silting, and detention.

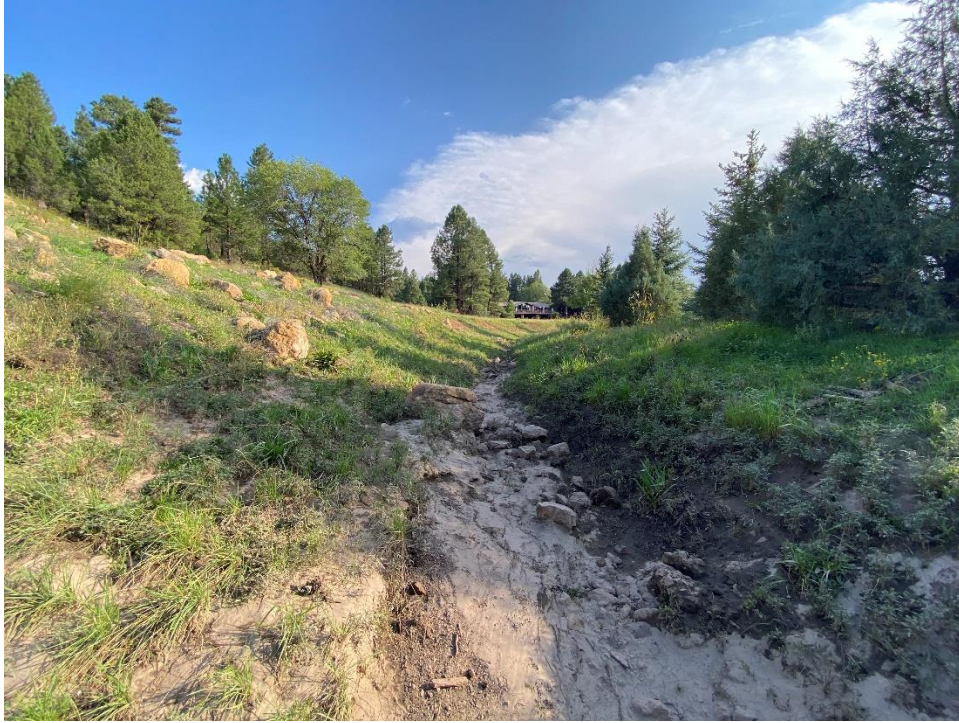
Photo Log 13: Rio de Flag channel station 82+60, looking upstream (south). This section shows silting and erosion.
