Rio de Flag Drainage Study

BY: ARTEMIS DESIGNS

DATE: December 3, 2021

CENE 486 CAPSTONE PRESENTATION

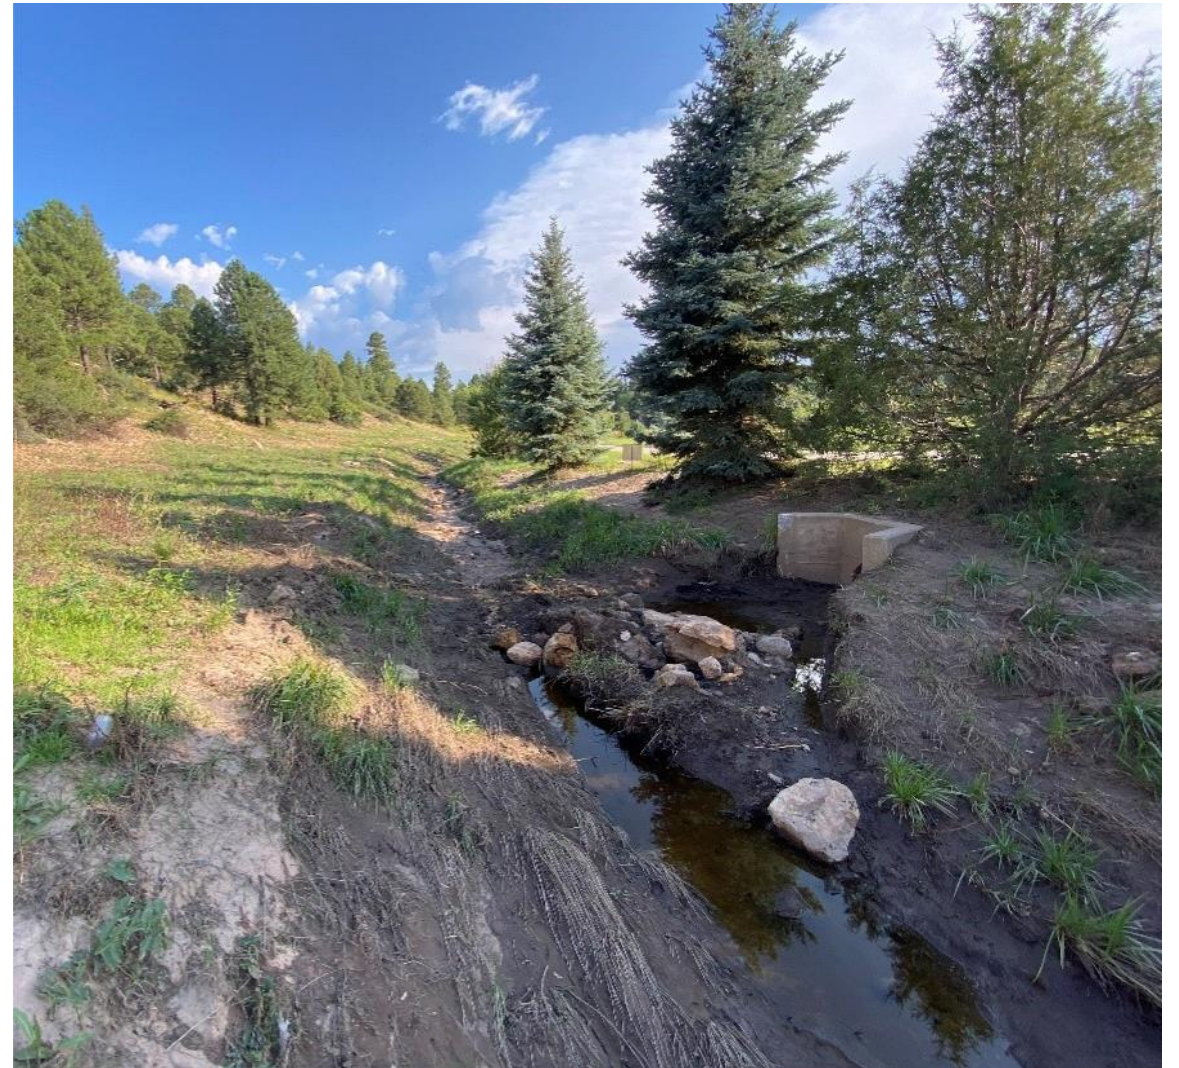
Figure 1: Channel Station 78+87, downstream near
Foxglenn Park (photo taken by Jenna McCaffrey)

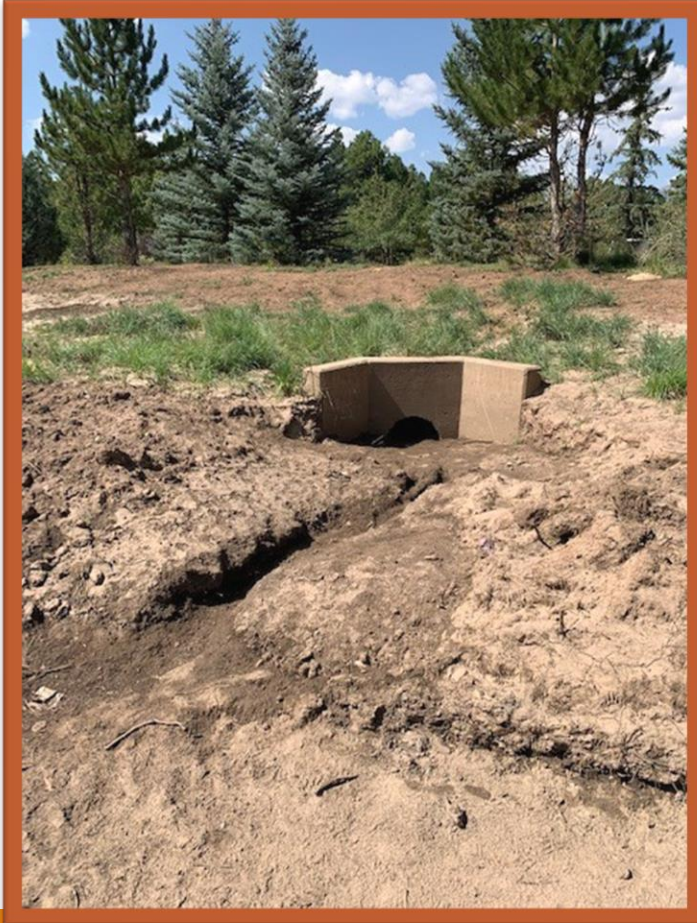
Figure 4: Rio de Flag channel station 71+84, looking west. Silting is present. Photo taken by Emily Frazer.

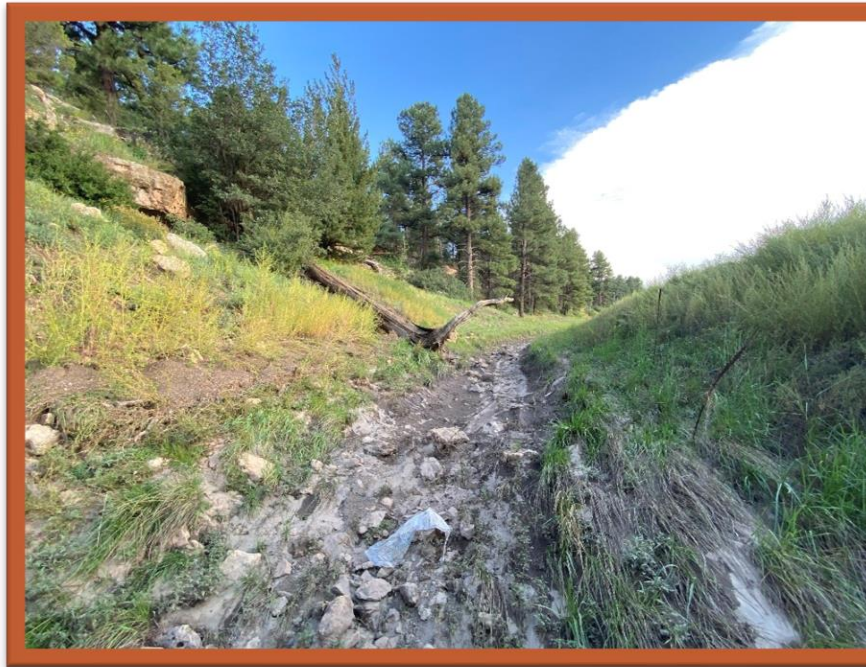
Figure 5: Rio de Flag channel station 60+13, upstream (south). This section shows garbage pollution within the reach. Photo taken by Jenna McCaffrey.

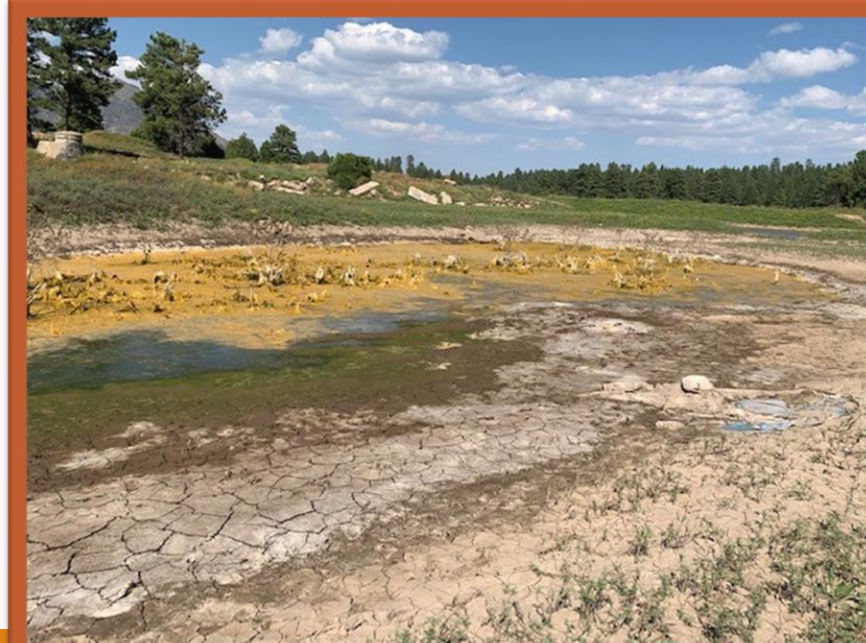
Figure 6: Rio de Flag channel station 23+42, looking west. This section shows retention. Photo taken by Destiny Gourley.

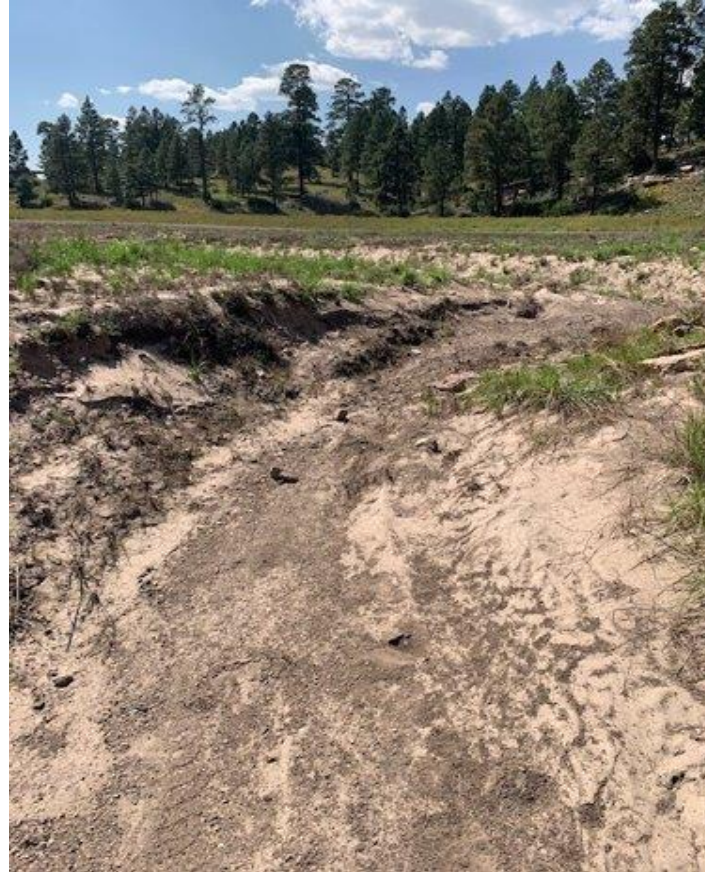
Figure 27: Rio de Flag channel station 54+77. This section of the channel shows erosion. Photo taken by Emily Frazer.

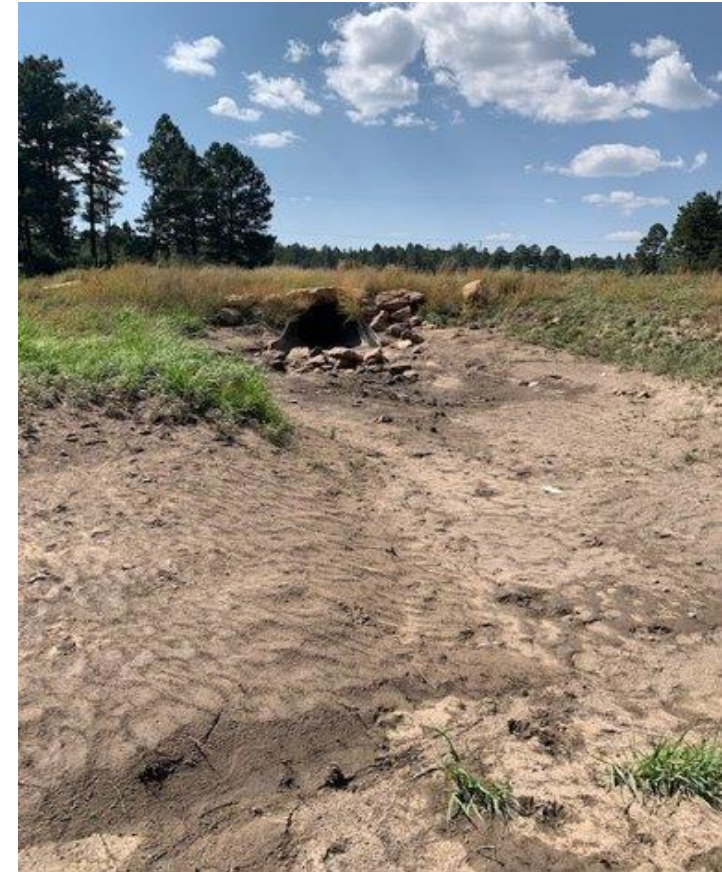
Figure 28: Rio de Flag channel station 44+06. This section of the channel shows detention and silting. Photo taken by Destiny Gourley.

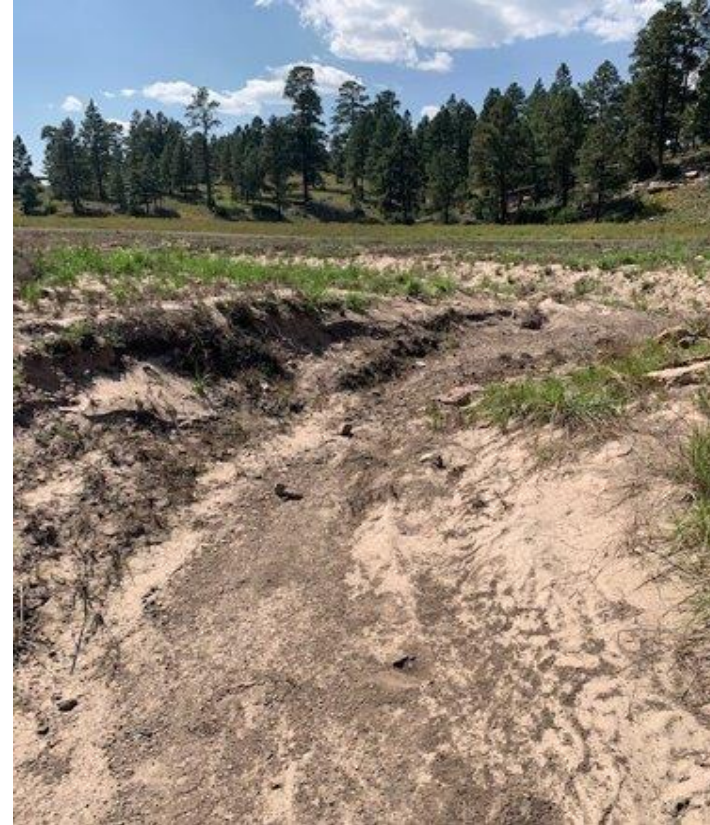
*Figure 32: Erosion within the reach.
Photo taken by Emily Frazer.*

- ❖ Affects
 - ❖ Site 1, 3, 5, & 8*
- ❖ Solutions
 - ❖ Alternative Materials
 - ❖ Armor the banks with Riprap
 - ❖ *Include excavation to ensure proper flow

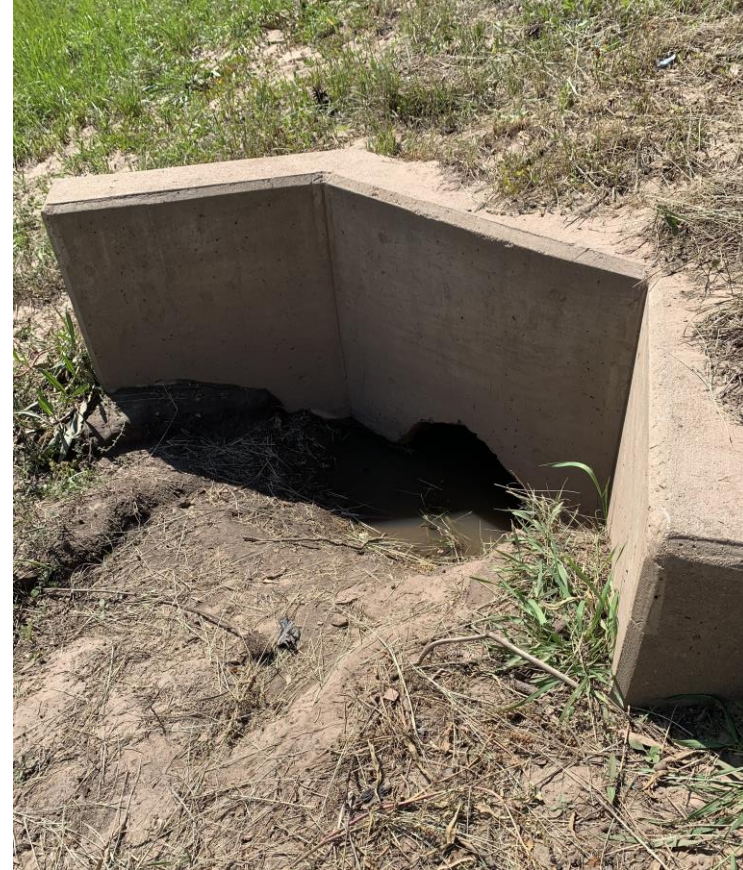
Figure 33: Detention & Silting at Culvert. Photo taken by Destiny Gourley.

- ❖ Affects
 - ❖ Site 2 and 4
- ❖ Solutions
 - ❖ Excavate
 - ❖ Around Culvert
 - ❖ Alternative Materials
 - ❖ Armor the Inlet Riprap
 - ❖ Prevents Silting Downstream

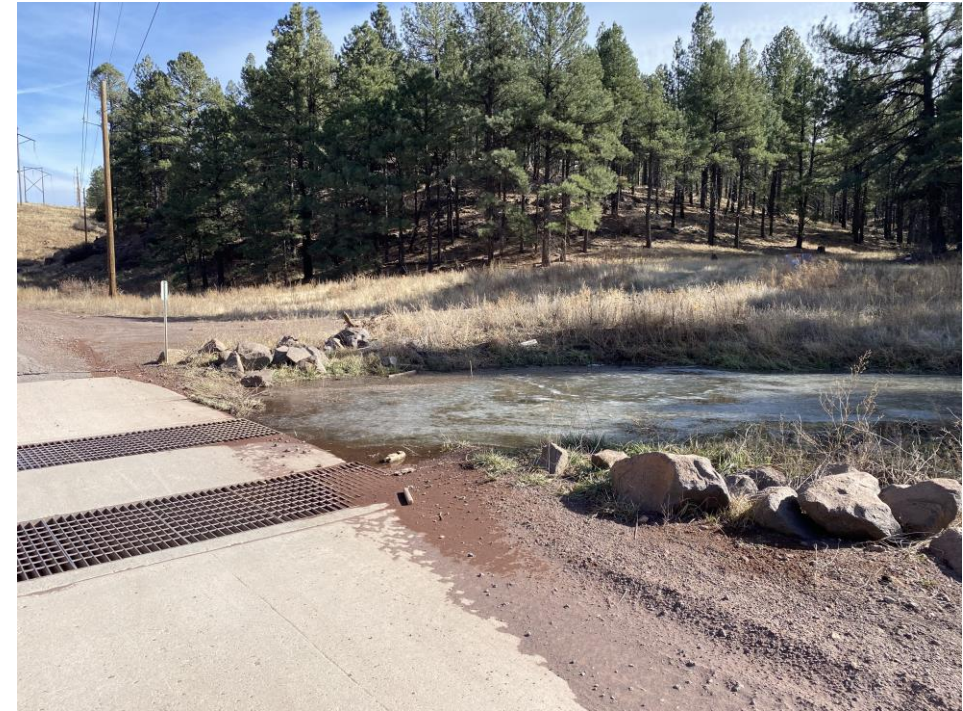
Figure 34: Detention & Silting. Photo taken by Jenna McCaffrey.

- ❖ Excavate

- ❖ Alternative Materials

- ❖ Armor the banks with Riprap

- ❖ Weir

- ❖ Excavate to make wider & more trapezoidal
 - ❖ Maintenance excavation to prevent further silting downstream

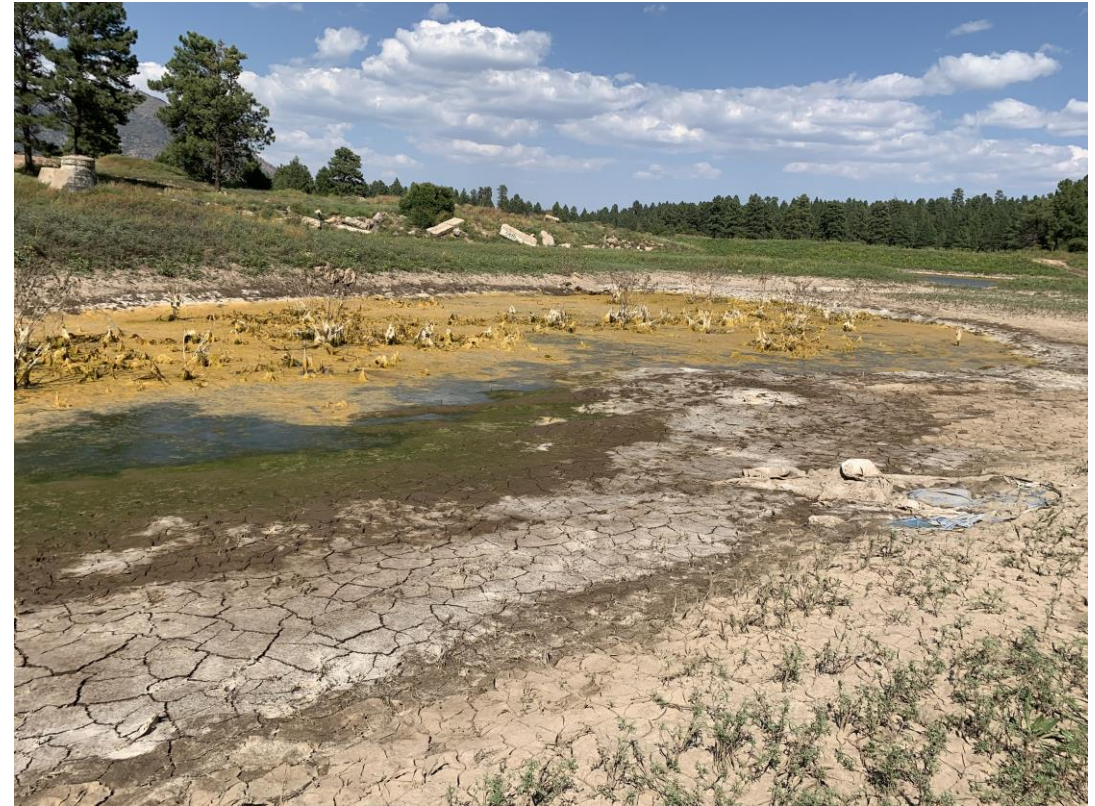
Figure 35: Retention Pond. Photo taken by Destiny Gourley.

- ❖ Affects
 - ❖ Site 7
- ❖ Solutions
 - ❖ Excavate
 - ❖ Fill
 - ❖ Reroute channel to avoid retention ponds
 - ❖ Further Engineering Study Required

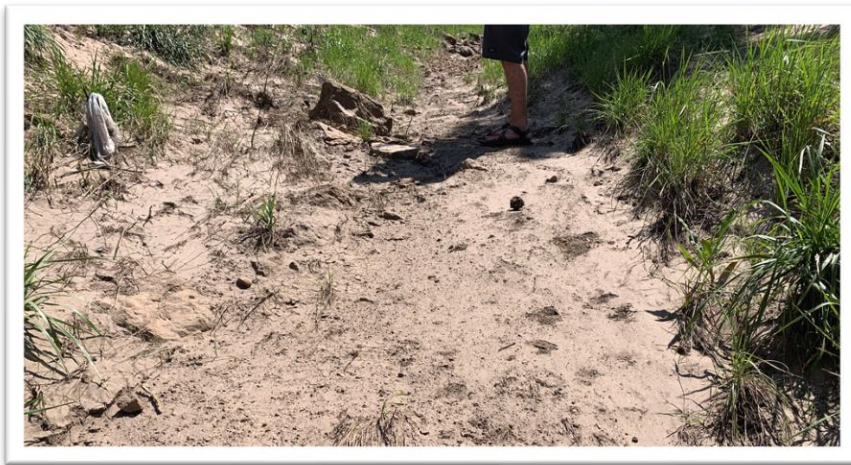
*Figure 36: Garbage in Reach 1.
Photo taken by Destiny Gourley.*

- ❖ Culvert Grate
- ❖ Install signage
- ❖ Plant hedges and trees

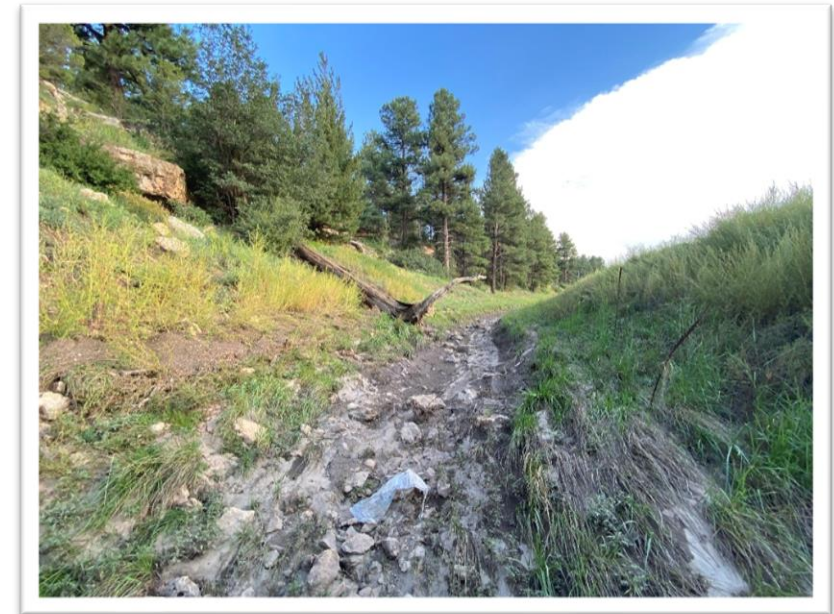
*Figure 37: Garbage in Reach 2.
Photo taken by Jenna McCaffrey.*
