Cholla T809 Condition Assessment Report

Provided by students of Northern Arizona University
with the support of Arizona Public Service

5/2/2013

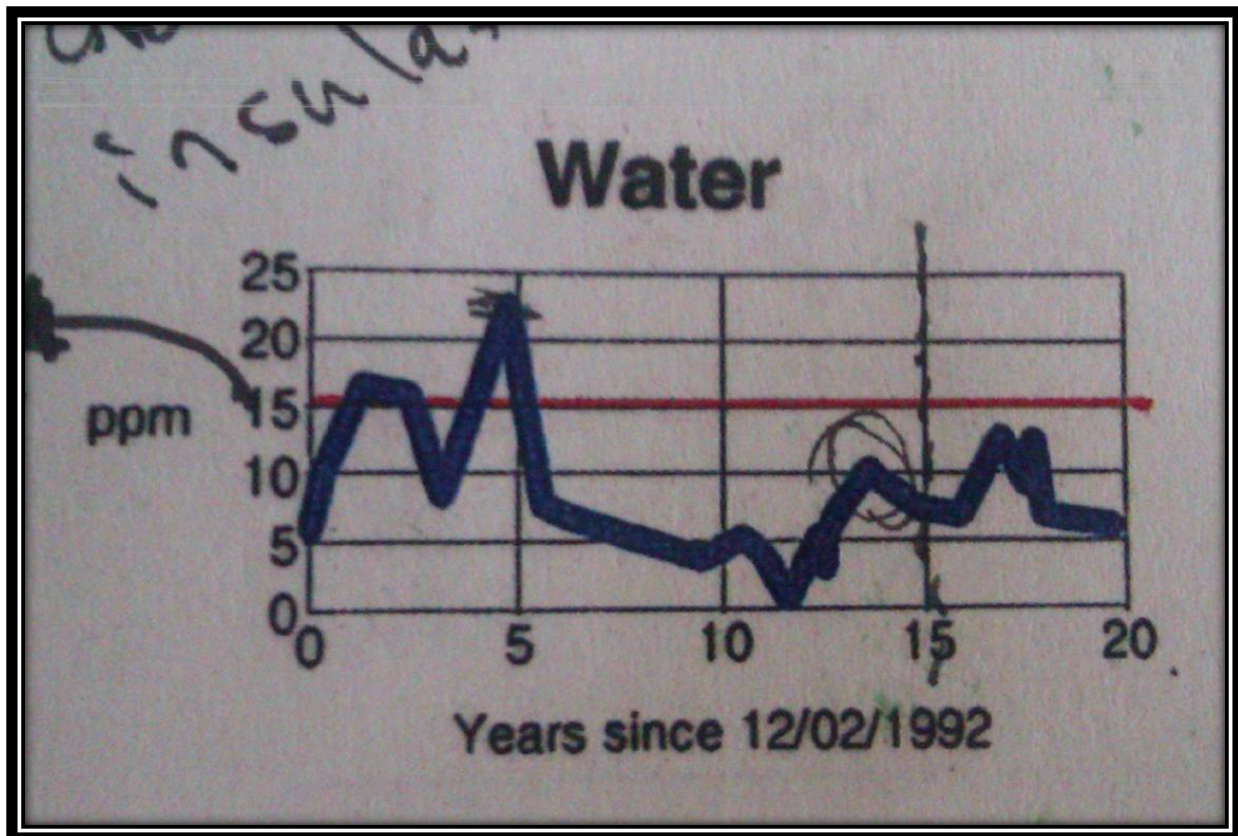
Figure 5
Dissolved Gas Analysis Data Received from APS

Relatively early on in the transformer’s life, there were spikes in the water content within the transformer. In Figure 5, shows steep spikes as well as sharp drops in water content inside the transformer. These step drops could be from result of APS fixing the transformer from year to year due to the sudden increases in water content. As the timeline continues to October 2006, the water content levels in the transformer start to stabilize at 10 ppm but those early fluctuations could have caused damage to other parts of the transformer. The water content in the oil goes over 15 ppm in the water content test three times and has past 20 ppm once sense 1991(close to half the transformer’s total life). The Bureau of Reclamation has recommended that transformers over 230kV should never exceed 12 ppm so this water level in the oil of the transformer could be a sign of problems in the transformer. These levels of moisture in a transformer could have happened due to small oil leaks which will allow moisture in the transformer as well as the degradation of the solid insulation.

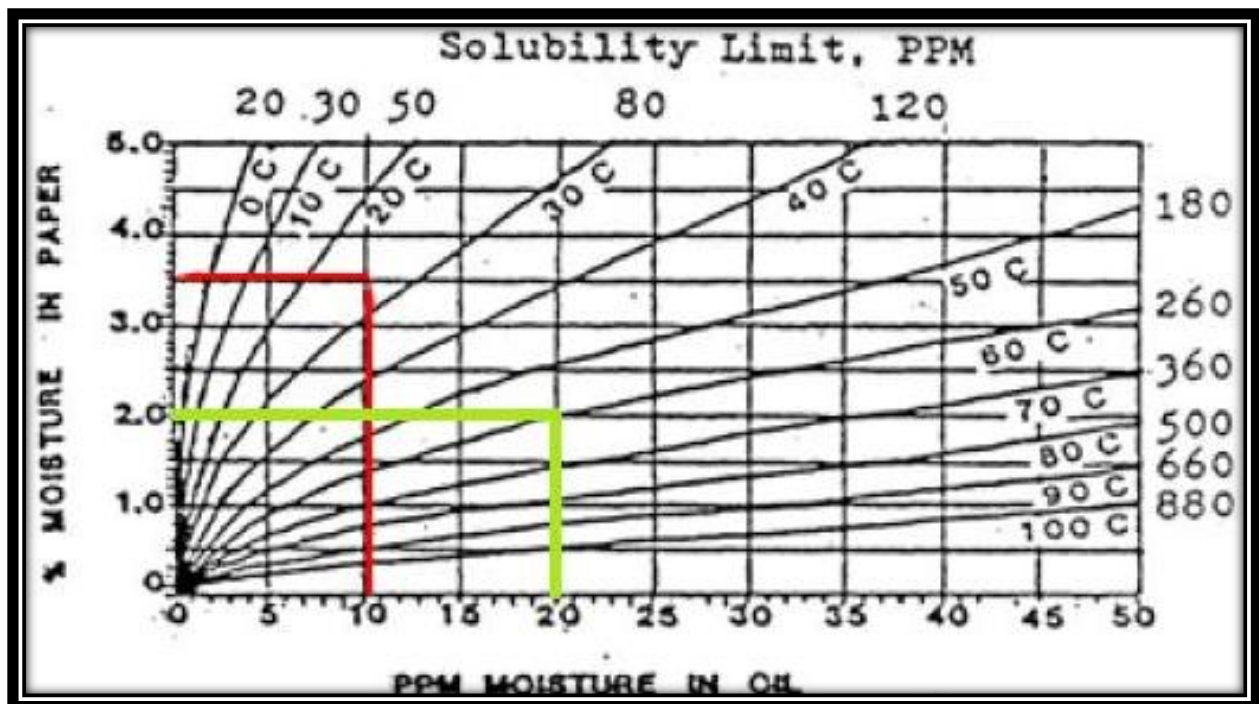
Figure 6
Moisture Equilibrium Curves

These signs of high water content could have a negative effect on the solid insulating material within the transformer. The graph in Figure 6 gives us a relationship between moisture in oil and the moisture in the paper insulation material; as the temperature in the oil decreases and moisture in the insulating oil increase then the moisture in the paper insulation will increase. The green line in the graph shows the characteristics of the transformer we are currently analyzing at one of its most critical water content points. It should be noted that moisture in oil in not necessarily an indicator of moisture in paper. The moisture content can change quickly during warm up and cool down of a transformer.

The IEEE Guide for Oil Filled Power Transformers gives us a guide on how to interpret the percent moisture in the paper we gathered from the graph above. Our transformer has a 2% moisture in paper which falls between the “dry paper” and “wet paper” condition given in Table 8.

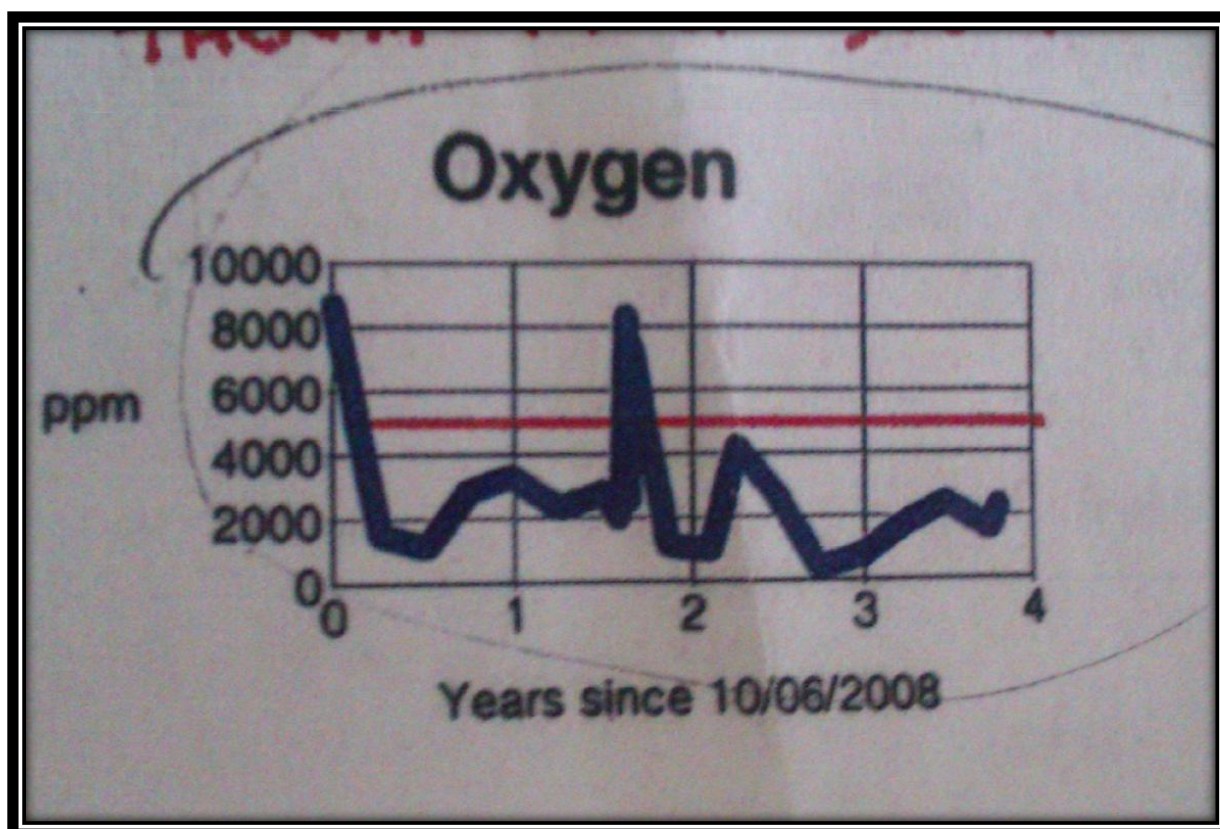
Figure 7
Dissolved Gas Analysis Data Received from APS

It is critical for life extension to keep transformers as dry and as free of oxygen as possible. Cellulose degrades much faster than oil because it contains oxygen within its molecular structure. The degradation process generates water, carbon dioxide and furfurals, and is accelerated by external sources of oxygen, high temperature and high levels of oil acidity. The dissolved gas analysis data we received from APS in Figure 7 shows that there was a spike of oxygen close to two years ago. This spike of oxygen does not help the life of the transformer but stands as an incident that would reduce the life of the transformer. The rise in oxygen could signal more water that was added to the paper insulation and signal further reduction of the insulating properties of the paper.

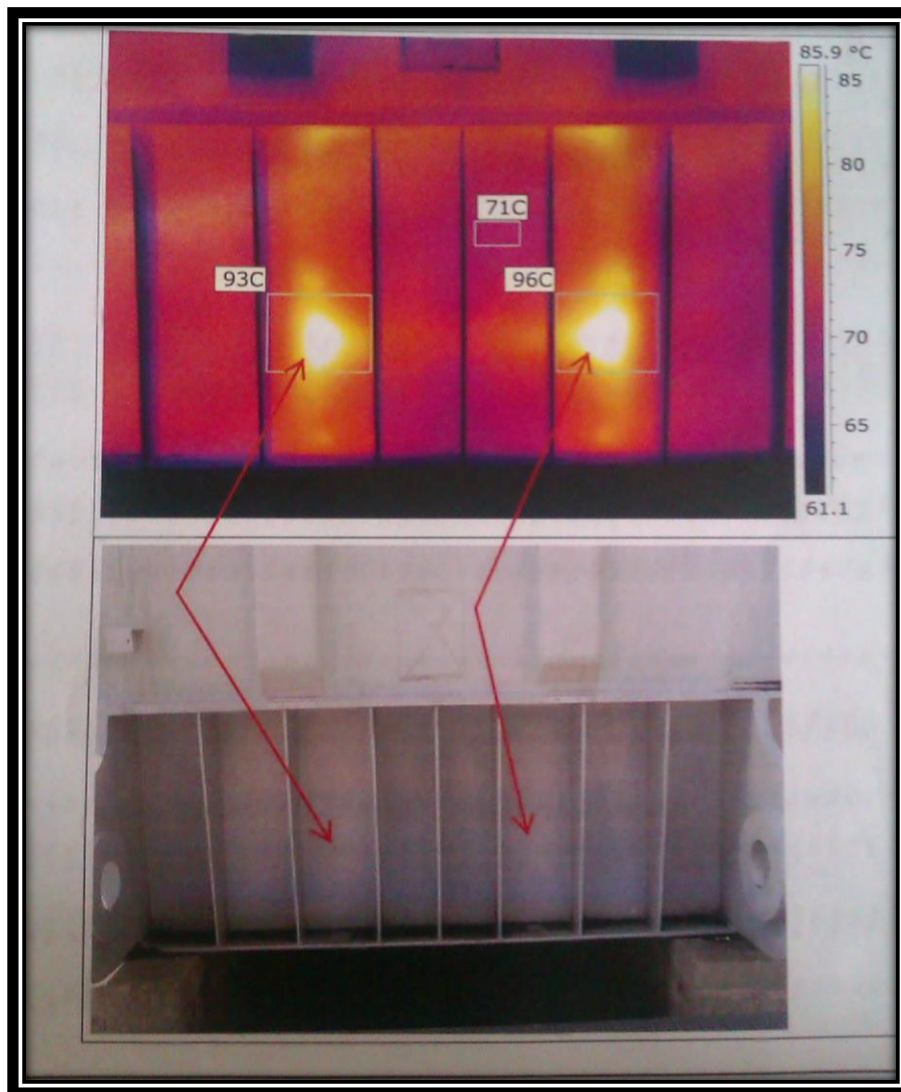
Figure 8
Thermal Picture Comparison of the Unit 2 Transformer

Recently, thermal images were taken of the transformer we are assessing which indicated that there were areas of extreme heat compared to the rest of the transformer, in Figure 8. Reasons why there was a high water content in the transformer could be from degradation in the solid insulation material between the coils of the transformer. Natural wear on the solid insulation could pose health problem with the transformer because this drops the insulating material's strength. Drops in the solid insulating material strength can cause arcing between the coils inside of the transformer and cause local hot spots in certain areas of the transformer. Common among many of the transformer failures is a short turn. The shorted turn develops as a result of breakdown of the solid insulation which causes winding temperature to shoot up. The transformer shows signs of a short turn which would suggest that it's at the end of its life.
