Parabolic Trough Tracking System

Saad Almonnieay, Robert Blaskey, Daniel Chief, Christopher Mesko, Jairo Rivera, and Jacob Seitzer

December 3, 2014

NORTHERN
ARIZONA
UNIVERSITY

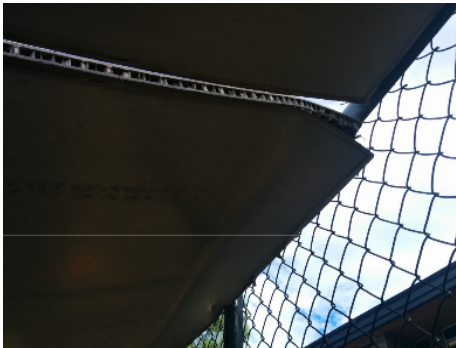
Crack in the Panel

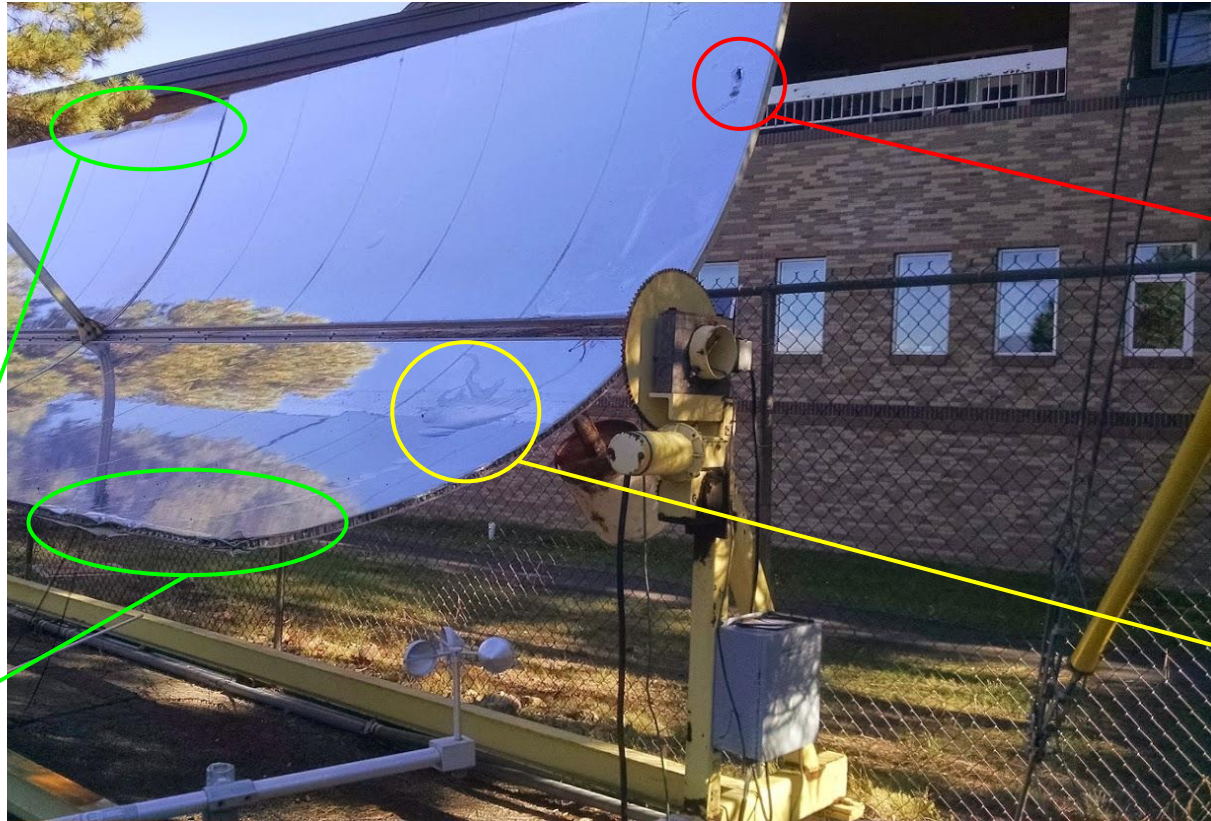
Parabolic Trough Initial Condition
Picture

Holes on Surface

Water Damage

Frayed Edges

- Cheap
 - Reflective
 - Flexible
 - Can be used to cover holes in parabolic surface and water damaged spots
 - Can also be used to cover trim on reflective surface, optimizing solar reflection
-
- 2 mil 25ft X 4ft = 100 ft²
 - Cost: \$20.02

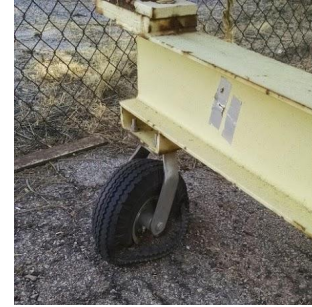
Damaged Tire Picture

- 4 Marathon wheels and tires assembled
- 4 ply
- 300 lbs capacity per tire and wheel
- 10.5 inches height
- 3/4 in bearings

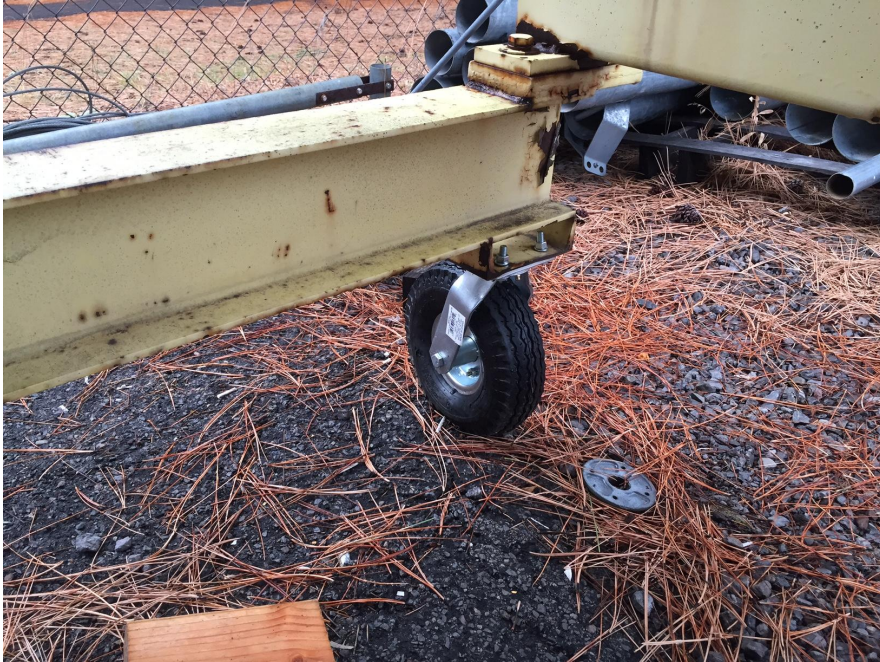
Replaced Caster/Tire
Picture

- 3 wheels installed in good shape with spacers
- One wheel caster broke in the process of installing wheel
- Solution: Order a wheel/caster assembly and have a spare tire
- Subtotal: \$123.99

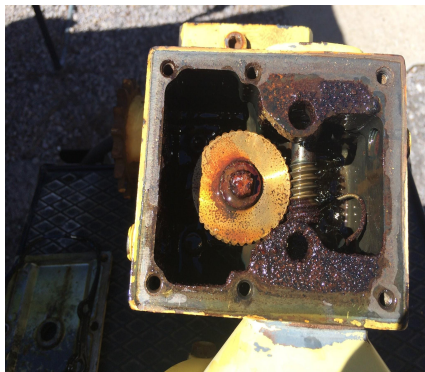
Gear Box Picture#1

Before

- The gearbox was taken to Coconino Auto suppliers in Flagstaff, AZ, and cleaned professionally from the rust and oil.
- The cost was \$35
- New gasket cost: \$8
- Gear oil- 75W 90: \$8.50

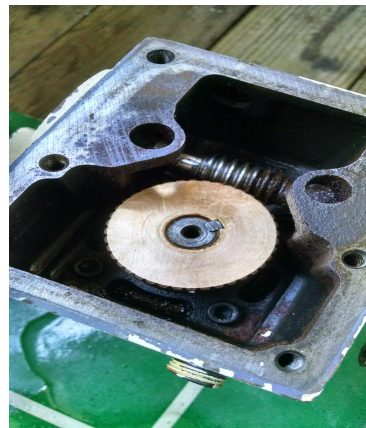
Gear Box Picture#4

After
