Parabolic Trough-Tracking System

Team 14

Trough Repair and Replacement Parts

*Submitted towards partial fulfillment of the requirements for
Mechanical Engineering Design I – Fall 2014*

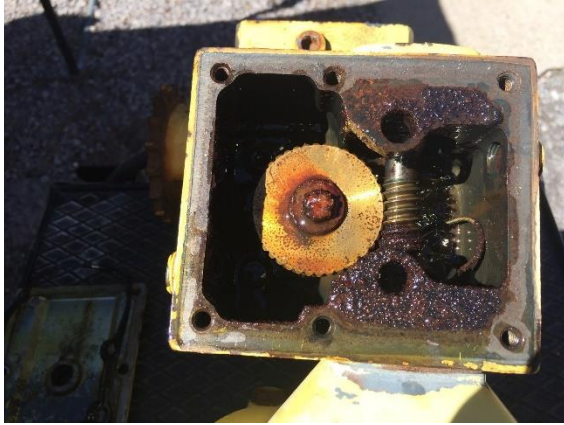
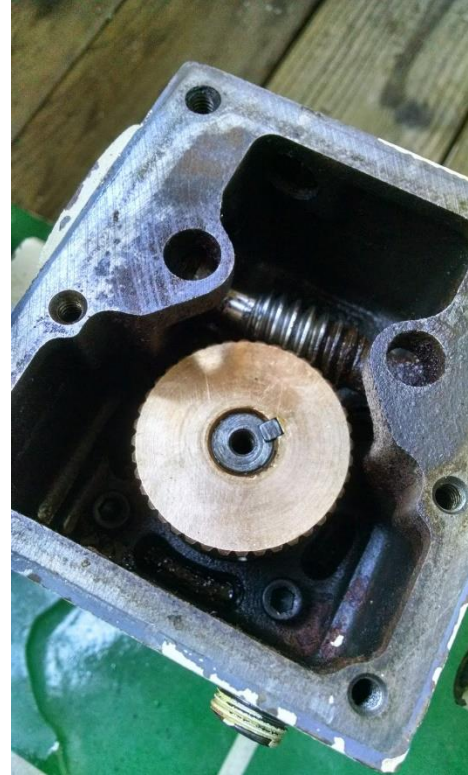
The gear box is a double speed reducer gear box that has worm gears to rotate shafts for a 17 tooth sprocket output. The gear box was inspected by motion industries and K&M Tools and Machinery that determined that the gear box was still operable. The original gear box had a lot of rust and dirty oil in it, so it was necessary to give the gear box a deep cleaning, preferably by a professional. In order to get it cleaned, we made sure all the oil was drained, and everything was taken apart previously to delivering it. The gear box was professionally cleaned at Coconino Auto Company for \$35.00. The top section of the gear box in figure 5 displays a before and after picture of excessive rust within this section. The oil and most of the rust was removed from the gears and the box. However, there is still a little rust on the worm gear. This is not an issue because the rusted part of the worm gear does not make contact with the gear attached to the horizontal shaft, making it irrelevant to the function of the shaft.

Figure 5- Top Gearbox before (left) and after (right) cleaning

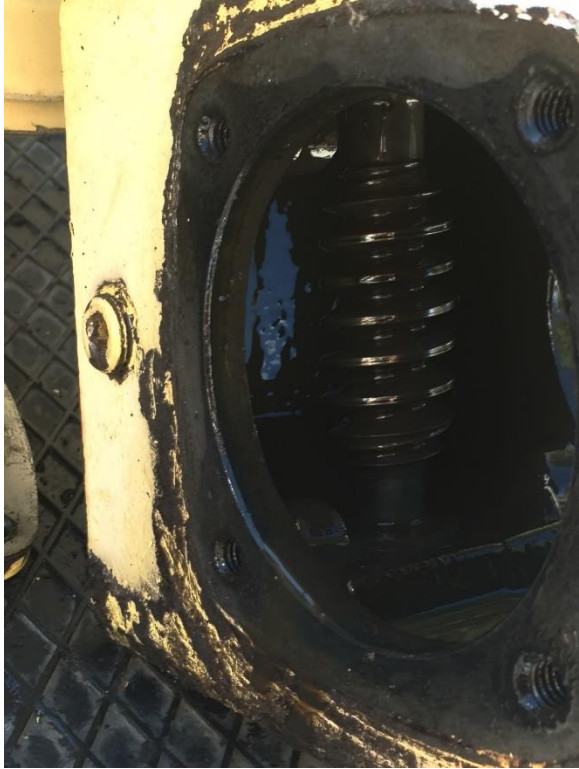
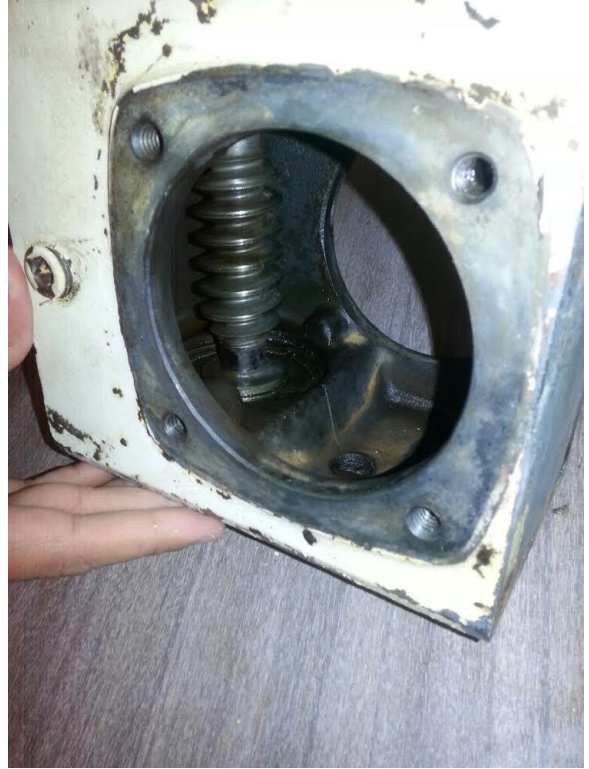
The other section of the gear box did not require as much cleaning. Due to oil being present in this section, the gears were preserved, so there was minimal rust. However all of the excessive oil was removed from the worm gear, and gears leading to the sprocket. Figure 6 shows the before and after picture of the box itself. The shaft leading to the output sprocket was separated from the rest of the gear box. In figure 7 it shows the before and after picture of the sprocket assembly. Similarly, there was minimal rust on the assembly. There was an excessive amount of dirt and dried oil on the outside of the gear box. After cleaning, there is a big difference between the before and after gearbox, as shown in figures 5-7. The next tasks are to get a new gasket for the upper section of the gearbox. This gasket needs to be custom made. We will purchase a section of gasket material, \$8.00 and cut the proper dimensions in order to fit it into the sectional plate.

Figure 6- Lower gearbox before (left) and after (right) cleaning

The only other steps, in order to make the gear box operable, is to place 75W-90 oil in the box for \$8.50. This oil will sustain the gear box for temperatures down to 0°F. Oil type 75W-110 would also work for the gear box. Once this is done, the gear box can be assembled together again. The only other critical step is to place the correct motor on the 3/8 inch vertical shaft into the gear box.

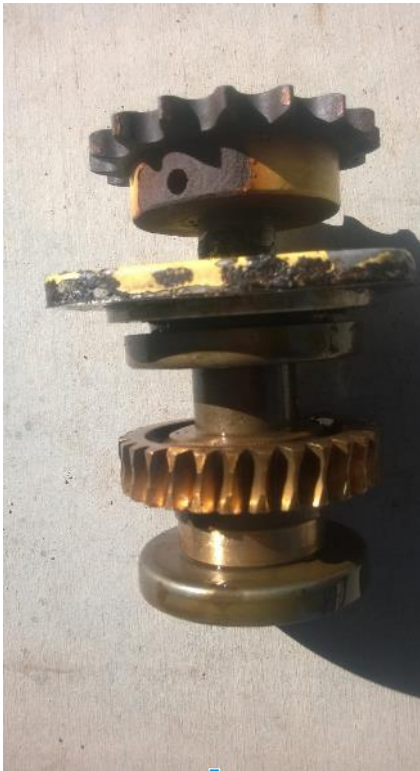
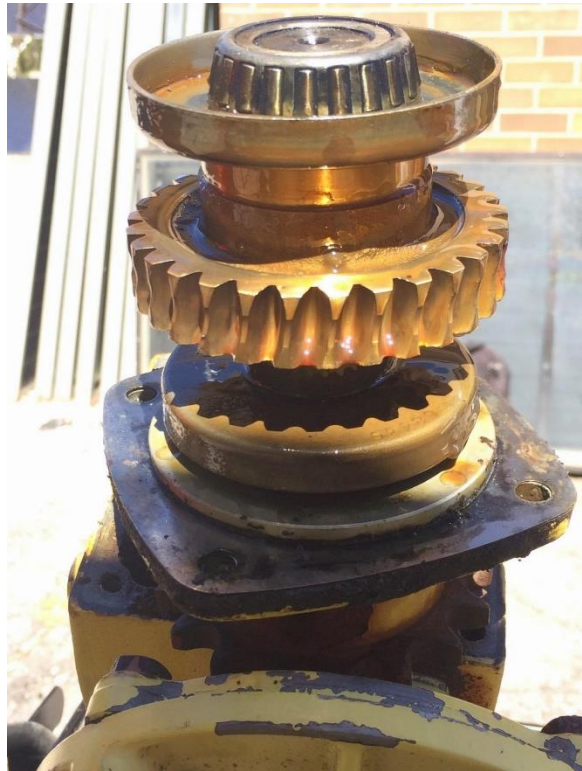
Figure 7- Sprocket assembly before (left) and after (right) cleaning
