# Parabolic Trough

## Tracking system

Document

*Submitted towards partial fulfillment of the requirements for  
Mechanical Engineering Design I – Fall 2014*

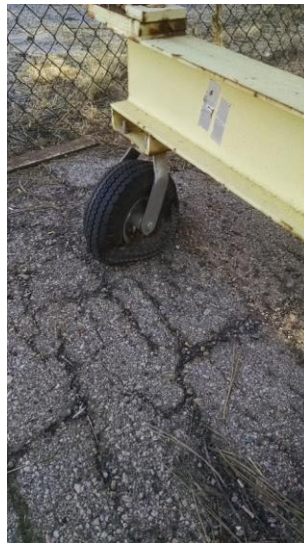
In its current state, the parabolic trough is stationary due to the condition of the tires and wheels. Eventually the trough will need to be removed from the solar-shack in order to have a suitable working and testing environment, so these issues must be fixed. Each tire is deflated, as seen in Figure 1, and the conditions of the wheels are unknown, but most likely they are unable to be reused. As a result, new tires/wheels were ordered.

**Figure 1-Current State of Wheels**

Based on the tires that are currently on there, it was found that they are Marathon 20011, 4.10/3.50-4, 4 ply, with a 10.5" Diameter. The load capacity for these tires is 300 lbs, which indicates that the trough must weigh less than 1200 lbs. The cost of each wheel and tire is about \$14.50, giving a total of \$60.00 before shipping.

From the information gathered on the current wheel/tire assembly, new parts have been ordered to replace them. Each wheel will have to be removed and replaced one at a time using a hydraulic-jack for each corner because the height and weight of the trough. The new wheels/tires are currently being shipped and will be arriving soon. Once the parts have arrived, installation of the new wheels/tires will begin so the trough can be moved to a more suitable working and testing environment.

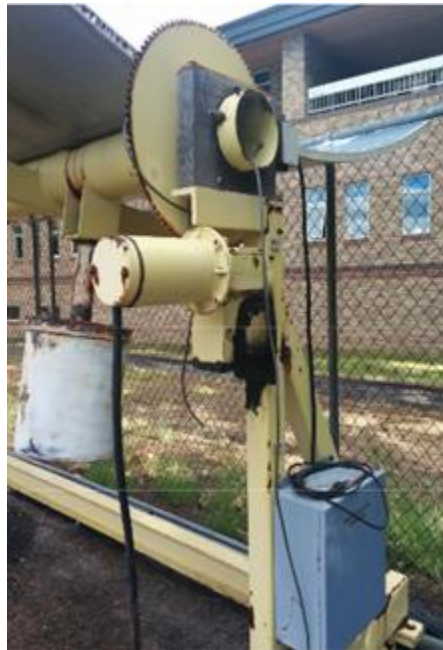
When researching chains, the specifications needed were the length, pitch, and roller width. We measured the length using a tape measure around the large sprocket, seen in Figure 2, and small sprocket (not pictured). The measured distance our team found was 75 inches or 6.25 ft. From McMaster-Carr, the chain lengths are rounded up to the nearest foot. Therefore, the chain length we need is 7 feet. Also, we measured the pitch and roller width needed with a tape measure.

**Figure 2: Big Sprocket with missing chain**

The values we came up with are  $\frac{5}{8}$  in pitch and  $\frac{3}{8}$  in roller width. With these values, we came back to McMaster-Carr's website and found the ideal chain for our scenario. The chain we purchased is a standard steel ANSI 50 roller chain and links, with a pitch of  $\frac{5}{8}$  in and roller width of  $\frac{3}{8}$  in. This chain has a working load limit at 561 lbs and costs \$5.98 per foot leaving us with a total \$41.86 before shipping.

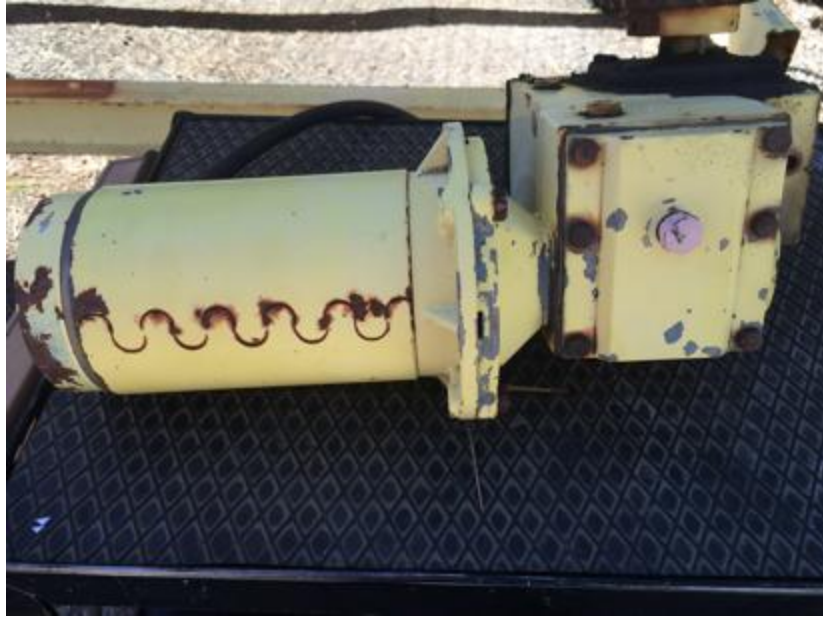
The upper level gearbox is connected to the motor which can be seen in Figure 3. The motor shaft and the worm gear is secured together by a rectangular key. After disassembling the cover plate we found that the lubricating oil turned black, the original color of the lubricating oil was golden. There was minimal amount of oil left in the upper level gearbox, since the system has not been operated or maintenance over 15 years. Most of the lubricating oil drained down to the lower level of the gearbox. The interior surface and the worm gear holding the horizontal shaft show some rust.

**Figure 3: Motor connected to the upper level gearbox**

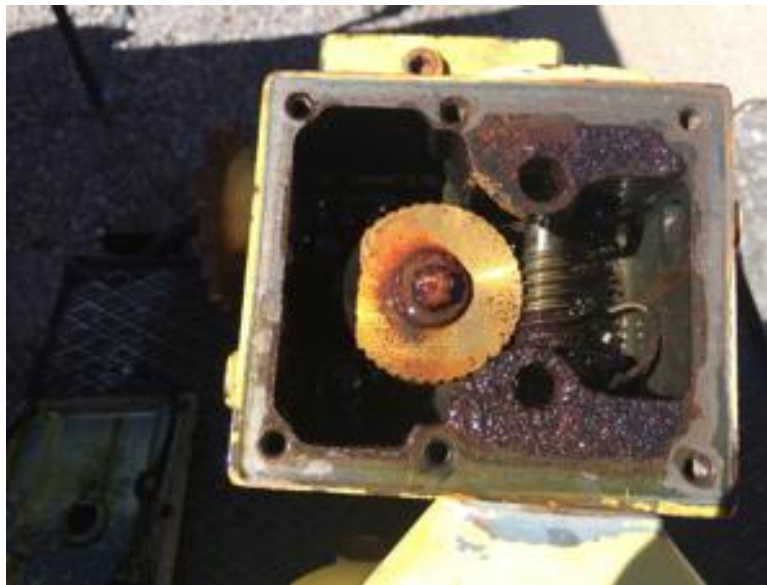
Figure 4 shows the helical gear secured by a bolt and a washer has some rust and will be replaced. The helical gear has minimal rust but can be cleaned by a wire brush. However, the shaft was able to rotate, but we still to decide if it can work efficiently in the near future.

**Figure 4: Upper gearbox with the cover off**

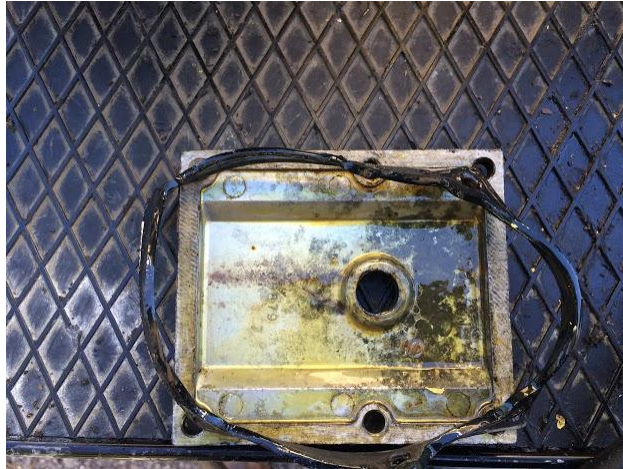
The rubber gasket has stretched and deteriorated from the weather of Flagstaff. The gasket will need to be replaced before the system is put back online. The defective gasket was the cause of the rusted parts in the upper level gearbox which are pictured in figure 5. Moisture and condensation found its way through the gasket and the addition of minimal lubrication oil, the results was rust. There is a possibility that the cover plate will need to be replaced, but until it has been cleaned and tested, the team will make its decision. The six bolts securing the cover plate will be replaced. The pink, once red in color, filler cap is made of plastic and will be a group decision if it needs to be replaced. The drain plug located on the upper level gearbox is in good working condition.

**Figure 5: Upper gearbox cover**

The cover plate and gasket on the top gearbox needs to be replaced. The cover plate may be reusable, but the gasket is in poor condition. The biggest obstacle has been the motor. There was no documentation left behind for the parabolic trough and no serial numbers left on the motor itself. In order to find a specific motor, the gear ratio, torque, power, and angular velocity needed to be found. The power required to track the trough can be assumed to be between one and two hp. Once the group can finalize a sustainable torque then we can order a specific motor for the entire assembly. The next step is find a motor and control box. The current control box is set to operate the trough manually. The team is seeking out a more update control box that can be ordered along with the motor. The control box needed is to have capability to program the trough to track. Once these parts are ordered or installed, we can concentrate on repairing the parabolic surface.

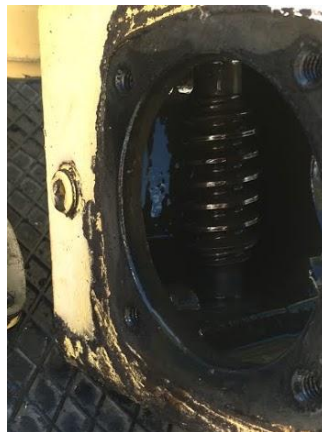
After disassembling the side cover mounted to the gearbox to observe the interior of it. We found that it contains a vertical worm gear connected to the vertical shaft that rotates a helical gear in the same shaft located at the upper gearbox. The worm gear is connected perpendicularly to another helical gear located in the horizontal shaft that rotates the outer small sprocket. The vertical gear coming down has a roller ball bearing attached to it. As seen in figure 6 the bearing sits between the upper level gearbox and the lower level gearbox to reduce friction and secure the vertical shaft. The roller ball bearing and the vertical shaft are in good condition. This is due to the lubricating oil protecting the parts from condensation and moisture.

**Figure 6: Vertical worm gear connecting the upper level to the lower level gearbox.**

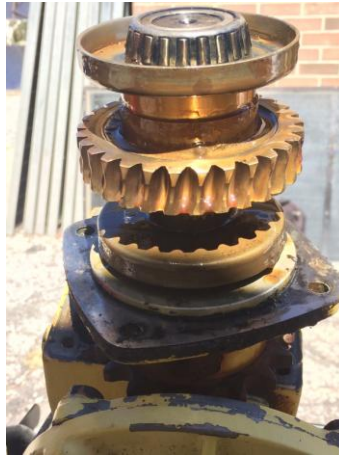
The sprocket and shaft assembly from the lower gearbox is in good condition. The assembly was also protected by the lubricating oil. The shaft assembly is made up of taper bearing, helical gear, spacers, shaft and a sprocket at the end, figure 7.

**Figure 7: Sprocket and shaft assembly**

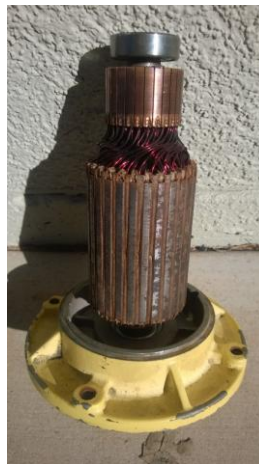
The motor, figure 8, used in this tracking system did not come with any documentation, so our information we have on it is based off observations after disassembly, and what the experts at US Bearings and Drives have told us. The motor is a DC motor because of the brushes that go over the vertical shaft. From the experts at US Bearings and Drives, we got an estimated horsepower of 1-2 HP and an estimated cost for the motor itself of \$200-300. From opening the gearbox and testing the gear ratio, we came up with 292 revolutions of the motor will turn the small sprocket one full revolution. The next step would be to solve for the required torque of the motor which will be possible when we calculate the weight of the parabolic trough.

**Figure 8: Uncovered Motor**

The current motor is not in working condition, and will have to be replaced. We can replace the motor once we solve for the specifications of torque, power, and rpm of the motor.
