# Memorandum

**Re:** Team Understanding of “Oak Creek” Capstone Project

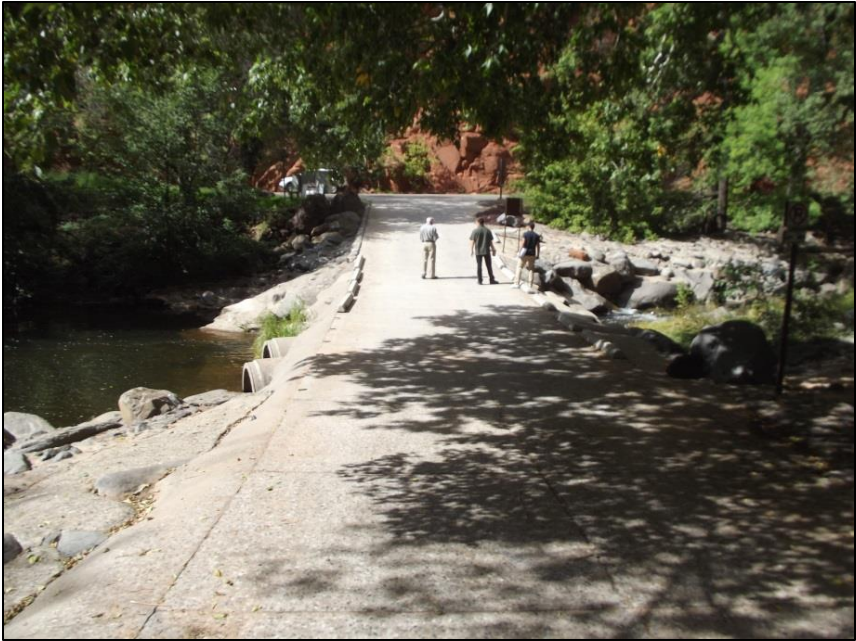
**7.1 Appendix A**

During a large flood in 1993, the low water crossing used by the residents of the Mission Rancho/ Rancho Shangri-La subdivision to cross Oak Creek was washed out. The flood reached a historical peak of 23,200 cfs at the downstream gaging station in Sedona on February 19, 1993. After the floodwaters abated, a temporary crossing was devised using fill dirt compacted over a few small culverts. This allowed residents to drive to their residence until a more permanent solution could be constructed. The existing structure was built near the end of the 1993 and is the sole means of vehicular transportation to and from the subdivision (see Appendix A).

The crossing can be seen in its entirety. This is looking towards 89-A.

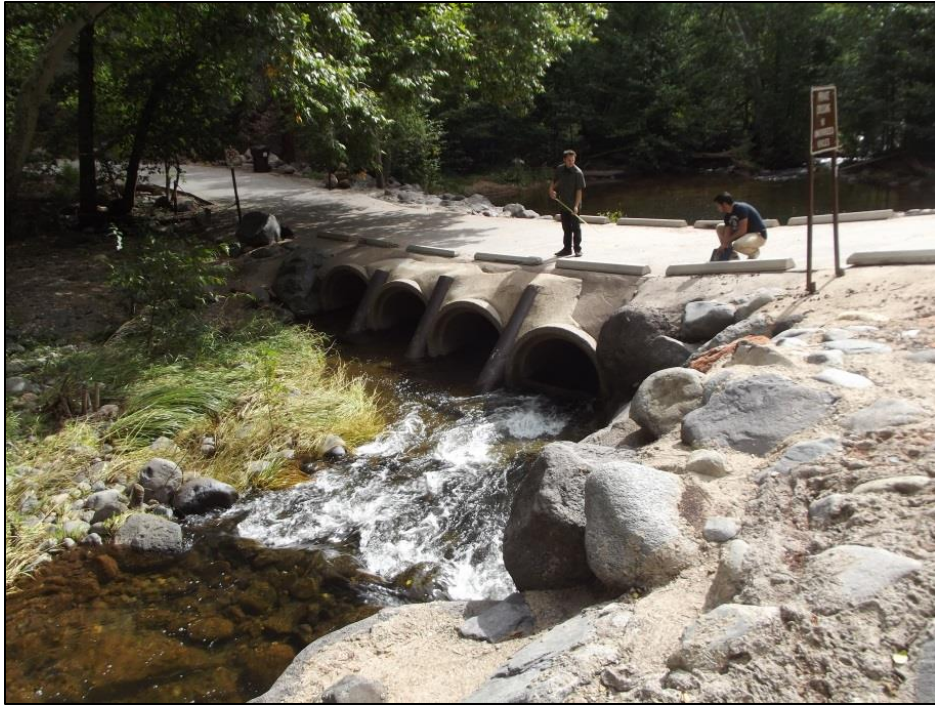
## 7.2 Appendix B

The existing crossing is approximately 40 feet long and 14 ½ feet wide. During flows below that of overtopping, the creek flows through four 48" concrete culverts (see Appendix B). The elevation of the roadway is approximately four feet above the water line at base flow. The existing crossing has a weight limit of 30 tons.

The four circular culverts are shown in the picture above. The culvert on the far right receives much more water due to the river coming in from the right side of the crossing.

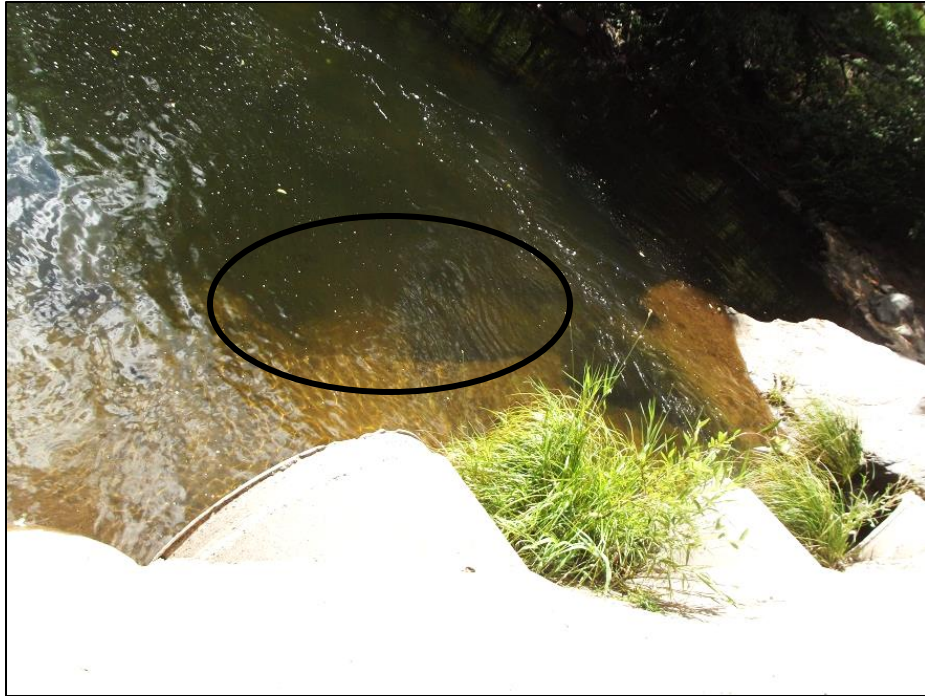
### **7.3 Appendix C**

The residents of the subdivision are concerned with erosion that is taking place and are concerned that this erosion could lead to the failure of the crossing during a large flood. Of most concern is the erosion that is occurring under the downstream apron and the western downstream retaining wall (see Appendix C). Erosion extends up to three feet under the downstream apron and up to seven feet under the downstream retaining wall used to support the roadway across the creek.

The apron can be seen to the left of the culverts and is circled. This is the downstream end of the culverts.
