DAMsel In Distress Engineering 2112 S Huffer Ln Flagstaff, AZ 86011 (520) 981-9515

WEST CATARACT CREEK DAM FINAL DESIGN REPORT

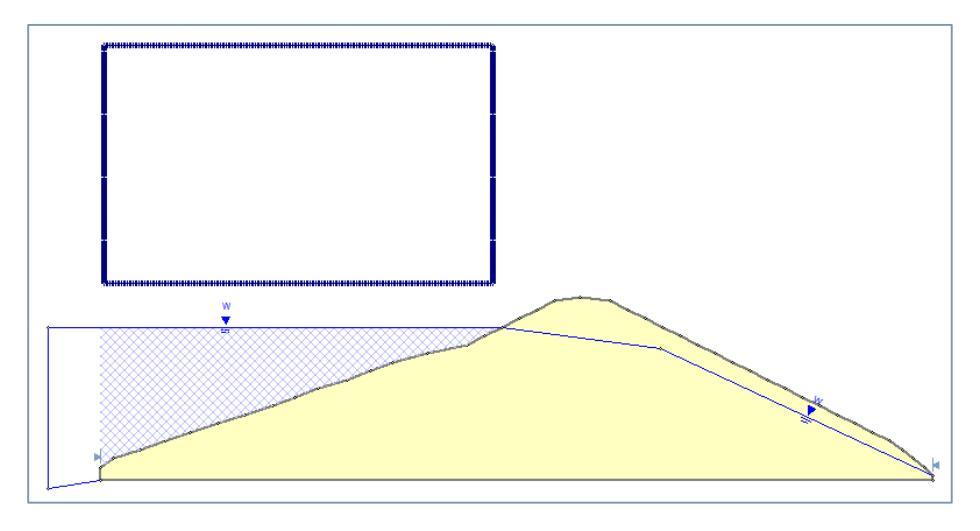
Figure 4 - Slide Input (RocScience)

tables relevant. The cross section for West Cataract Creek Dam was created by scaling off a contour map of the dam from the as-built drawings. This cross section was put into the software along with the reservoir at full capacity as shown in Figure 4, below.

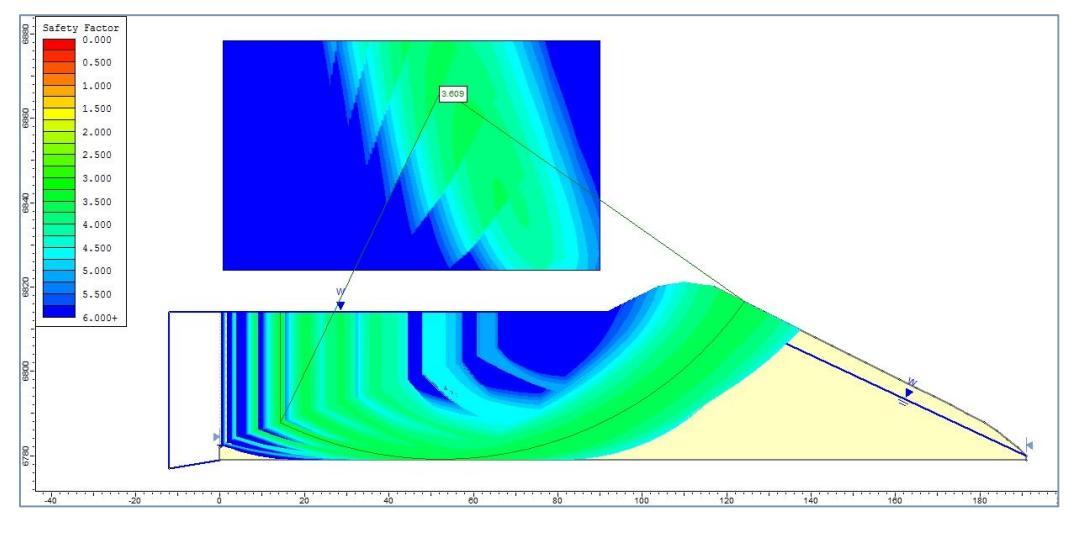
Figure 5 - Slide Ouput - Front Slope (RocScience)

The factors of safety of the worst case slip surfaces throughout the dam from the front and from the back were 3.6 and 1.6, respectively. Both of these values are above the required factor of safety of 1.5, resulting in a stable dam. This method of analysis can only show an estimate of the slope stability since the soil properties were assumed, however, conservative values were used to increase the confidence in the results.

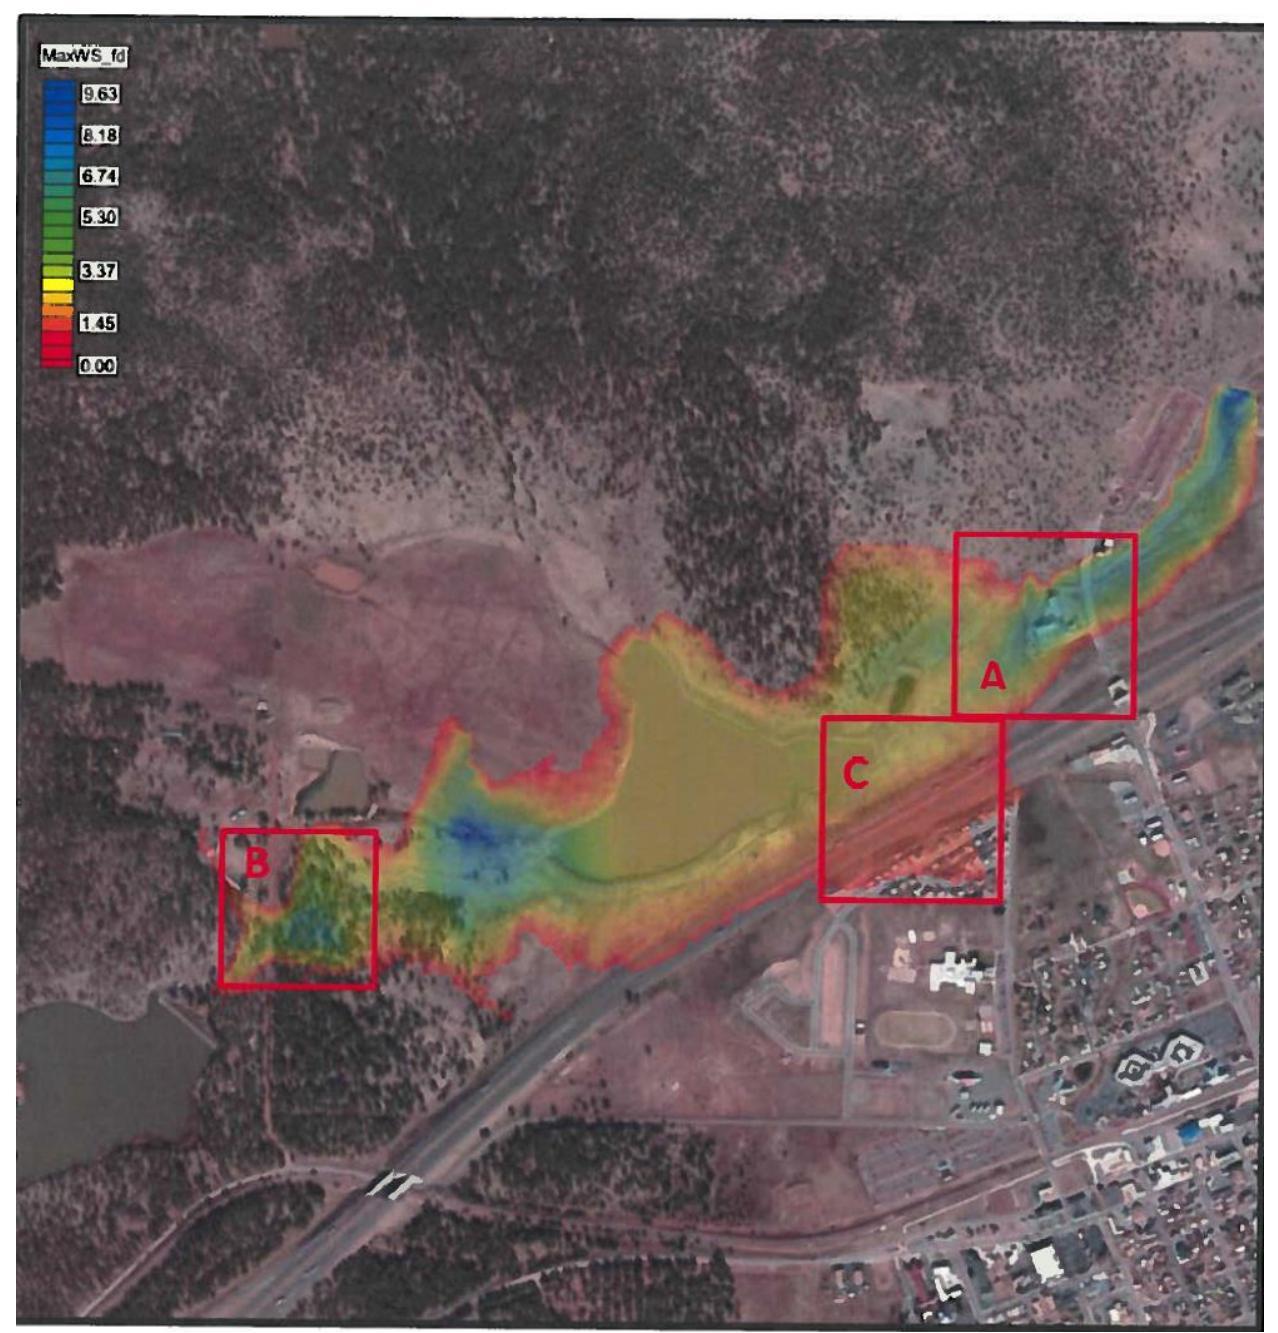
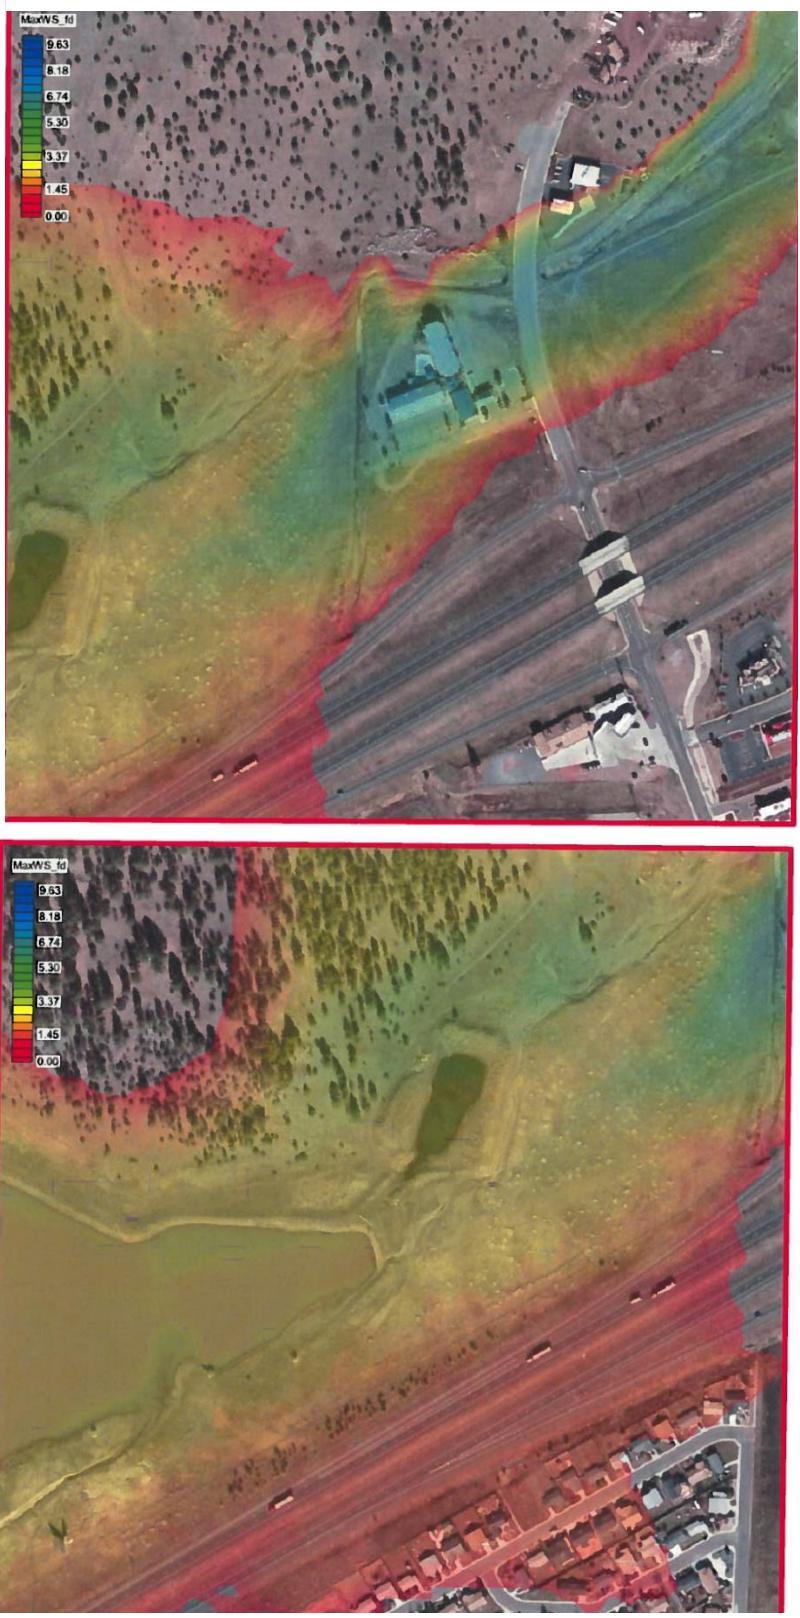
Downstream Effects of a Sunny Day Failure as determined by ADWR

Affected hotel and gas station north of I-40

Depth of water over I-40 as well as affected Williams homes.

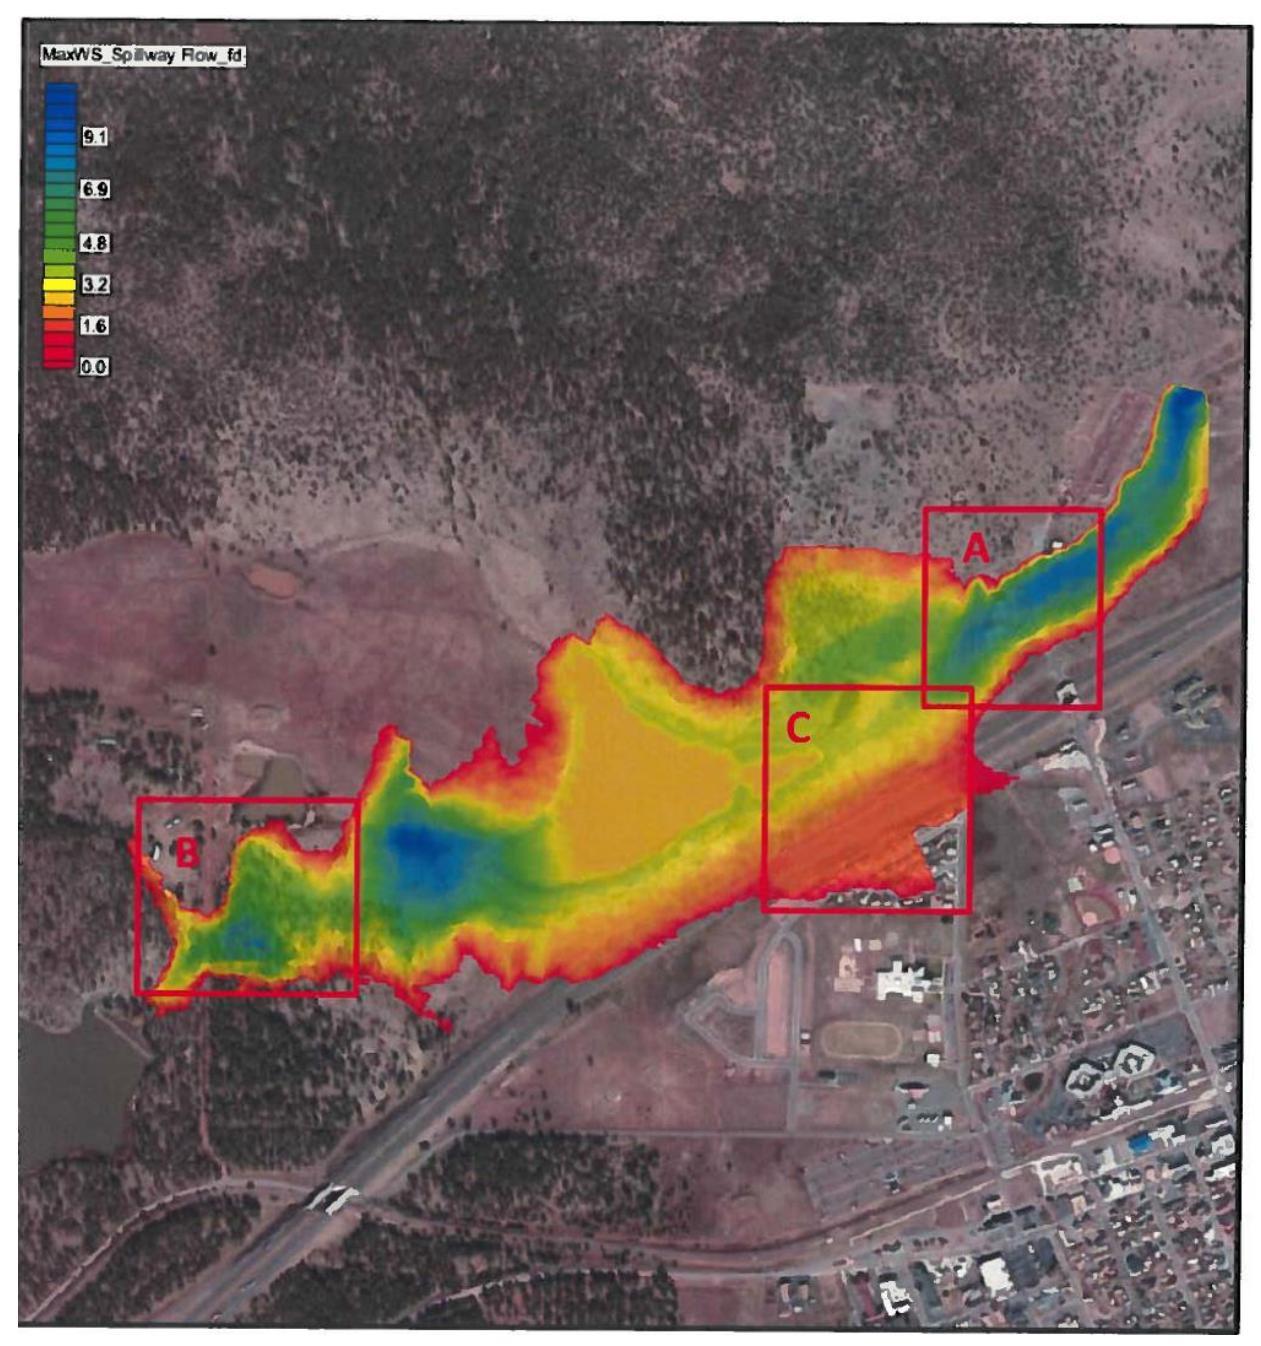
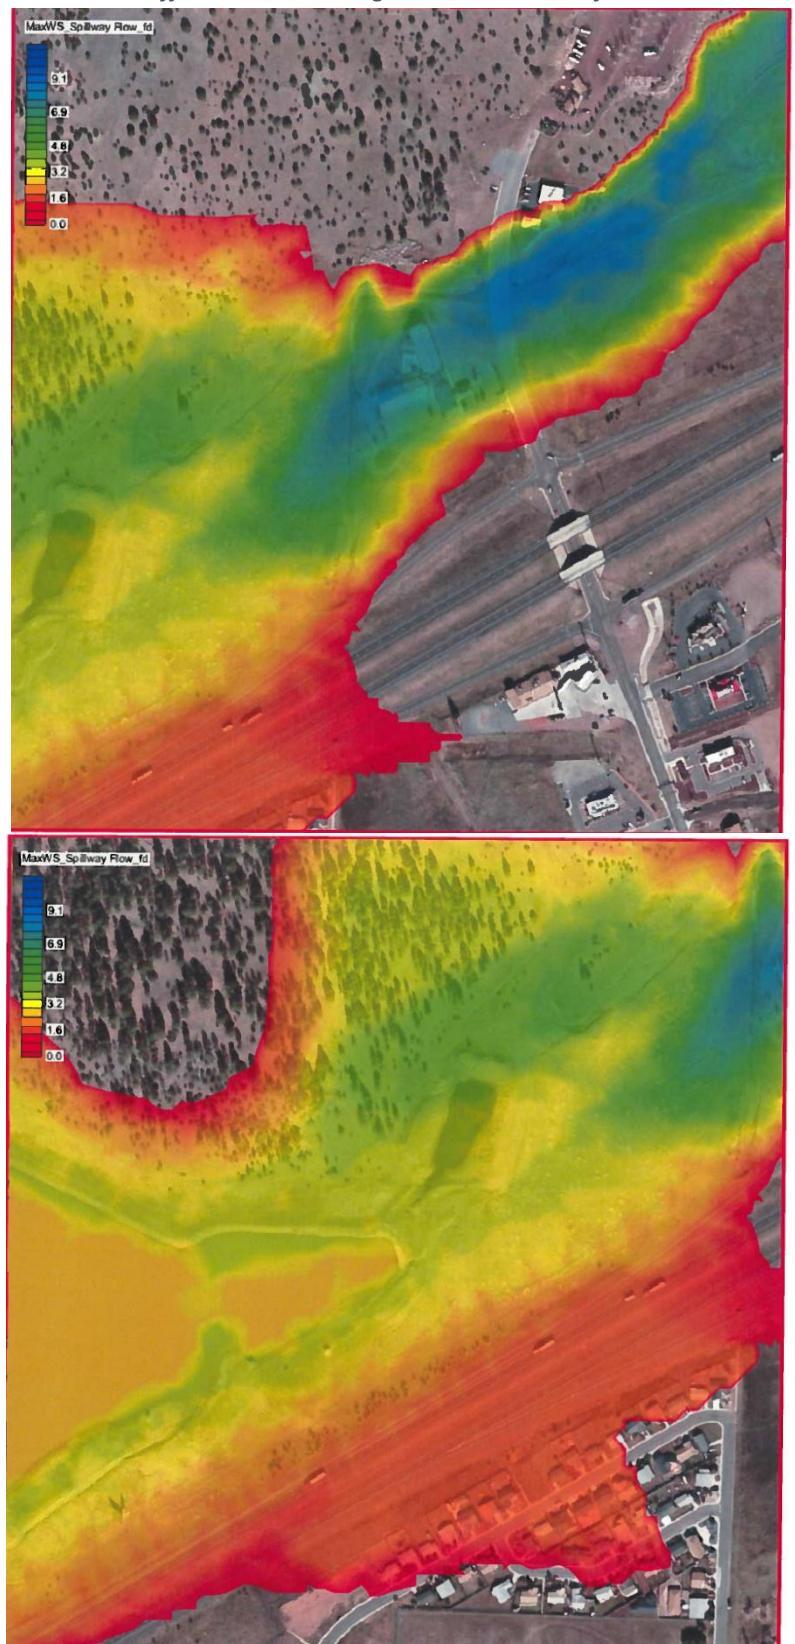
Downstream Effects of a Rainy Day Failure as determined by ADWR

Affected hotel and gas station north of I-40

Depth of water over I-40 as well as affected Williams homes.
