Saginaw Hill Erosion Control

Design Report

Spring 2016 NORTHERN ARIZONA UNIVERSITY CENE 486 Capstone

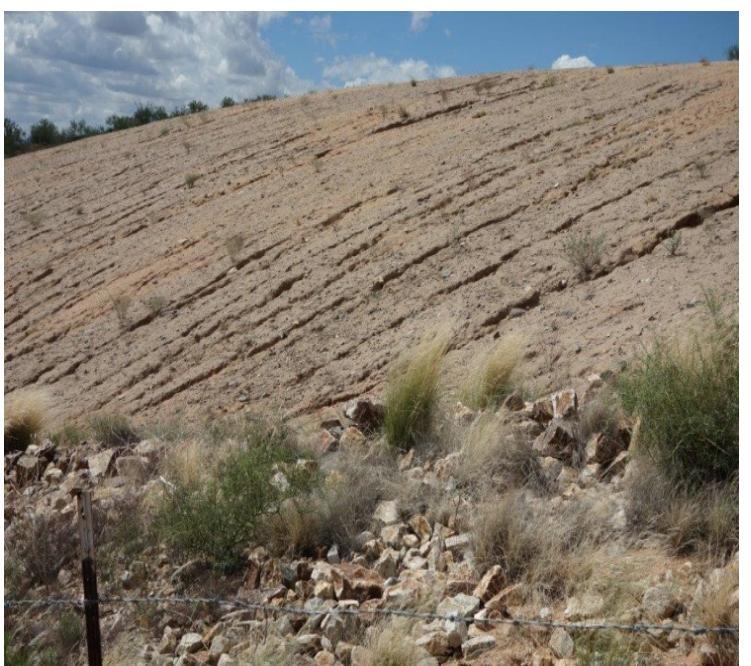
and diversion channels appeared to be damaged by erosion. There was sedimentation in the diversion channels and the repository cap's vegetation layer was missing entirely. Figure 1.5 shows the current condition of the cap. The exposed marker layer and wire-netting geotextile fabric can be seen above in Figure 1.6.

Figure 1.5: Vegetation is sparse and erosion is evident on the repository cap [5].

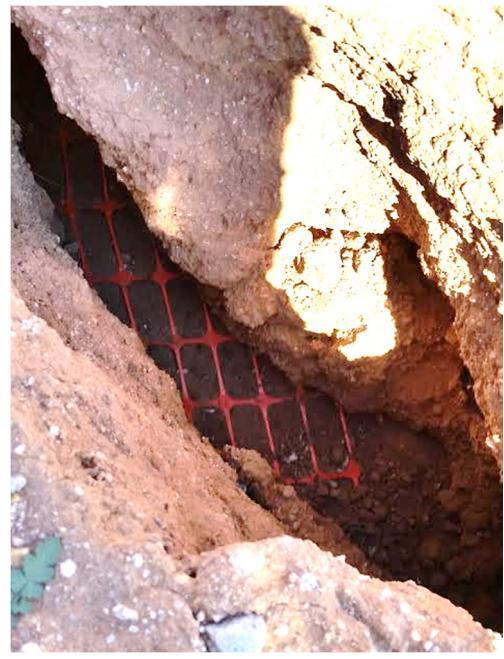
Figure 1.6: Exposed marker layer and mesh wirenetting

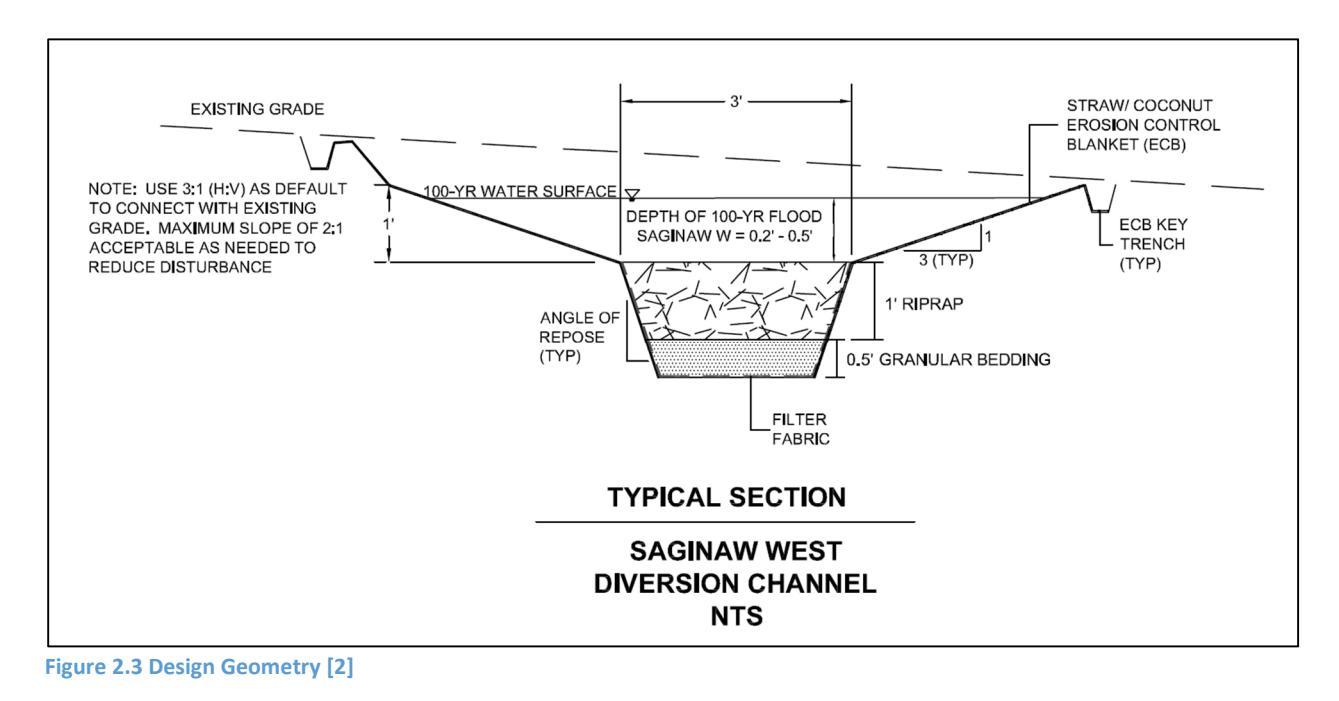
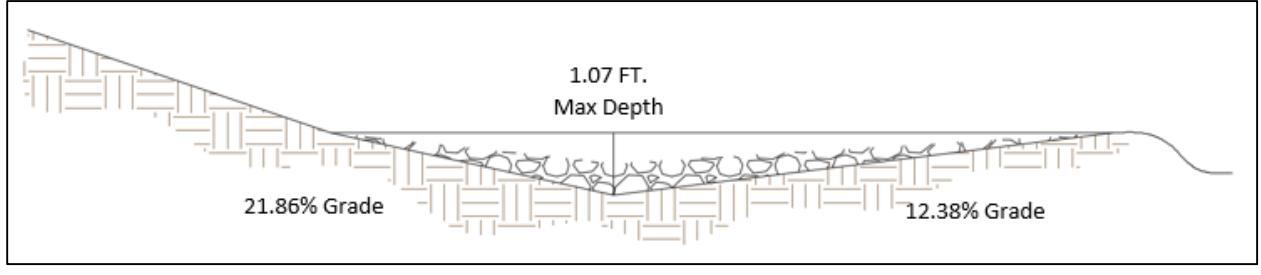
Figure 2.4 Observed Geometry

from a 100-year storm, but the site visit revealed that the geometry and slope of the constructed channel differed from the original design. The original design versus the constructed design can be seen in Figures 2.3 and 2.4, respectively.

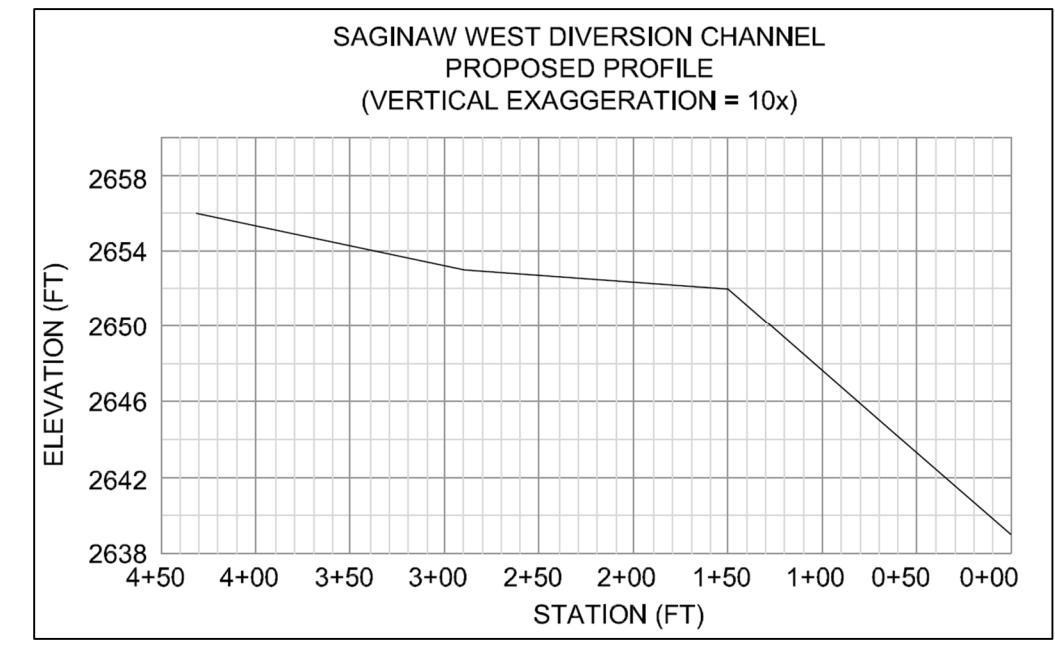
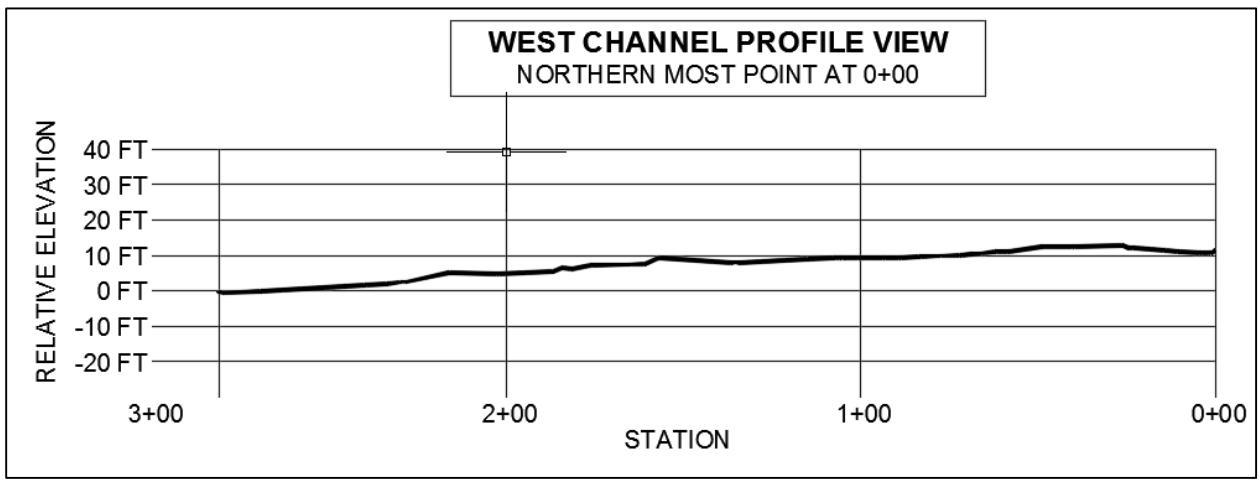
Figure 2.5 Design Profile

The slopes of the designed channel and the constructed channel also differed. In the original design, the highest elevation of the channel is on the northern side of the cap and slopes down towards the south. However, the constructed channel is the opposite of this, with the highest point towards the south and sloping downhill northwards. A comparison between the proposed drainage

channel profile and the constructed (observed on site visit) drainage channel profile can be seen in Figures 2.5 and 2.6 below. The stationing of the channel can be seen in Appendix F.

Because of these discrepancies, the team performed a hydraulic analysis to ensure the constructed channel is able to adequately convey runoff from the hill. Using Bentley Flowmaster, it was determined that the design channel has a maximum discharge of 41.7 cfs and the constructed channel has a maximum discharge of 44.9 cfs. The constructed channel is therefore adequate for conveying runoff during a 100-year storm. The software output for this analysis can be seen in Appendix G.

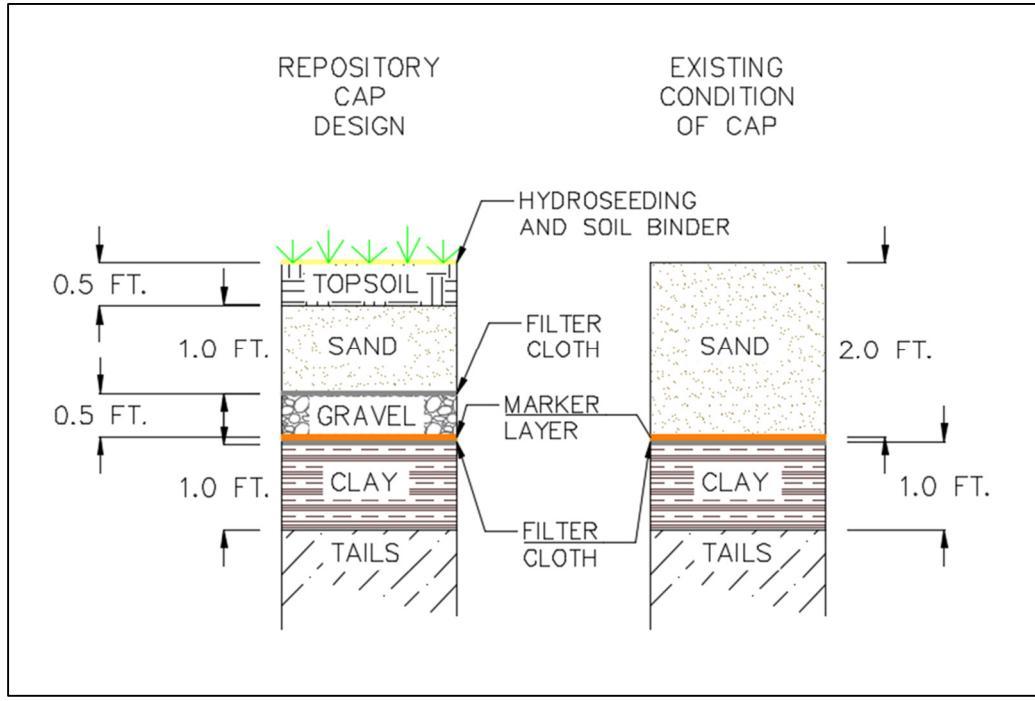
Based on the analysis discussed above, the source of erosion is most likely due to the composition of the top layer of the cap. MARS Consultants analysis found that the top two feet of the cap is composed primarily of sand, with no topsoil or drainage layers as specified in the original design. See Figure 2.7. The sand performs adequately as an infiltration layer, but without a gravel layer there is nothing to convey the infiltrated water off of the cap. Additionally, sandy soil is a poor growth medium, so the absence of a topsoil layer is likely why the initial hydroseeding failed.

Figure 2.7: Repository cap design vs. existing condition of cap.
