Parabolic Trough-Tracking System

Team 14

Project Proposal

Department of Mechanical Engineering
Northern Arizona University
Flagstaff, AZ 86011

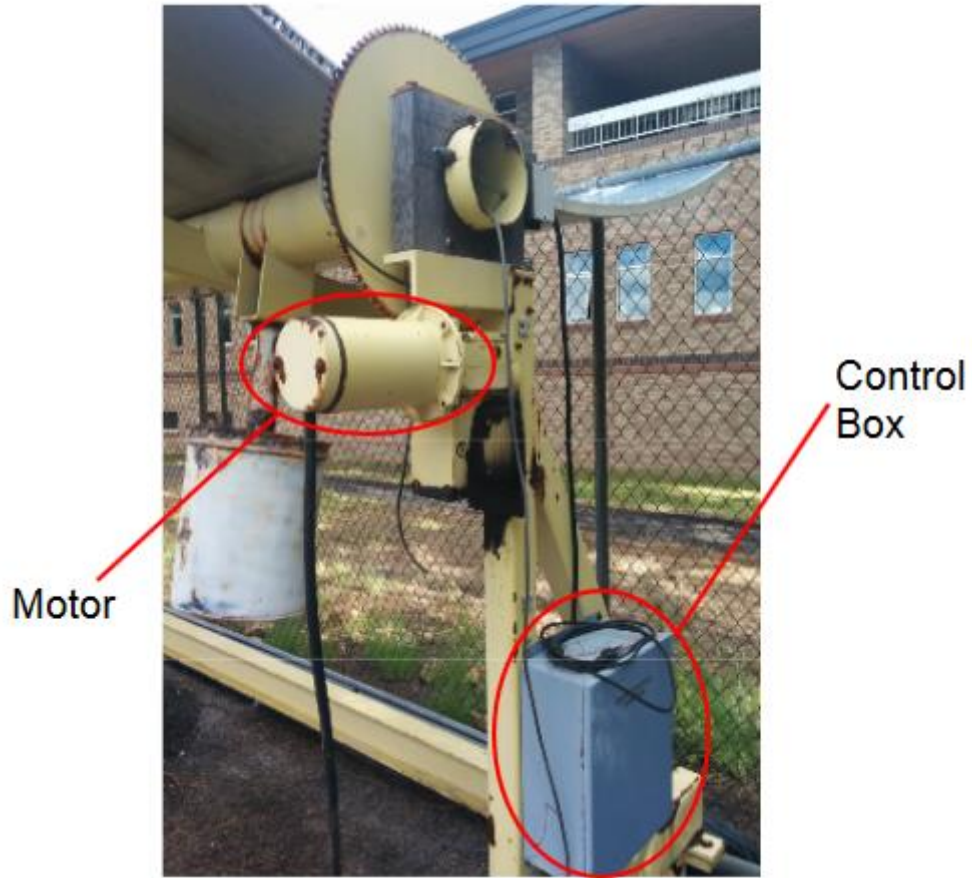
Figure 2- Motor and control box

The tracking system is in need of a new motor to turn the parabolic trough upon its horizontal axis and a control box is also needed to control the motor. A programmable control box is preferred in order to obtain the maximum amount on solar flux throughout the day without having to manually control it. Due to environmental constraints, the parabolic trough must also be mobile so it may not have any obstructions from sunlight. The current inoperable motor and control box is displayed in Figure 2.

Another difficult task was finding a control box that would be compatible with the motor. The given control box is worn, rusted, and inoperable due to lack of maintenance and weather getting inside the box.

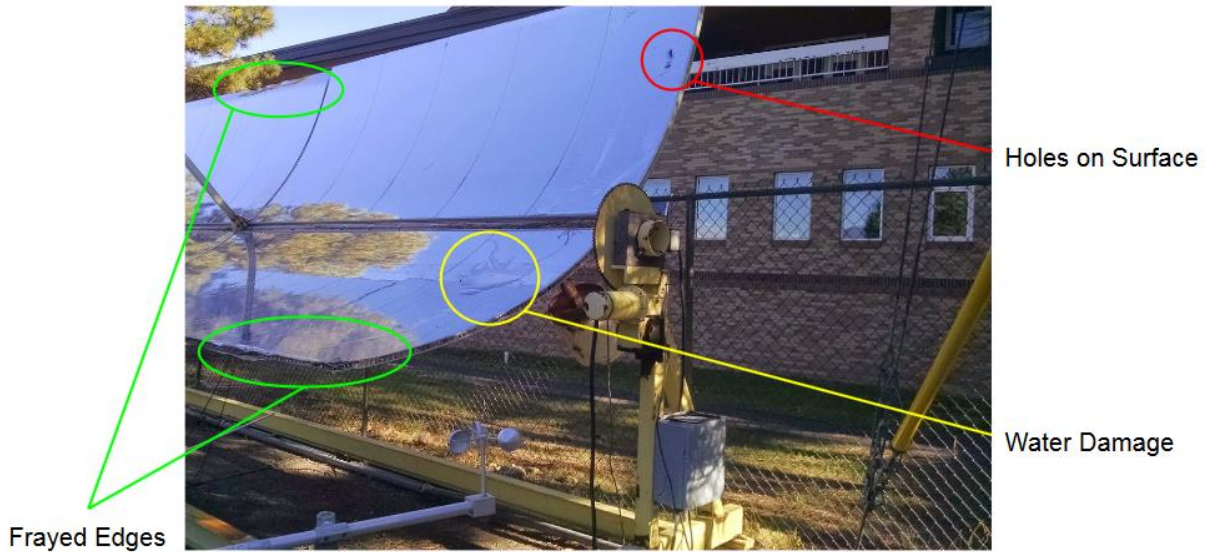
Figure 3-Parabolic Trough Damages

Figure 3 shows physical damage on the parabolic trough which includes frayed edges, water damage, and holes on reflective surface. The damages on the parabolic trough must also be repaired in order to ensure all areas of the trough are effective and no further damage is accumulated.

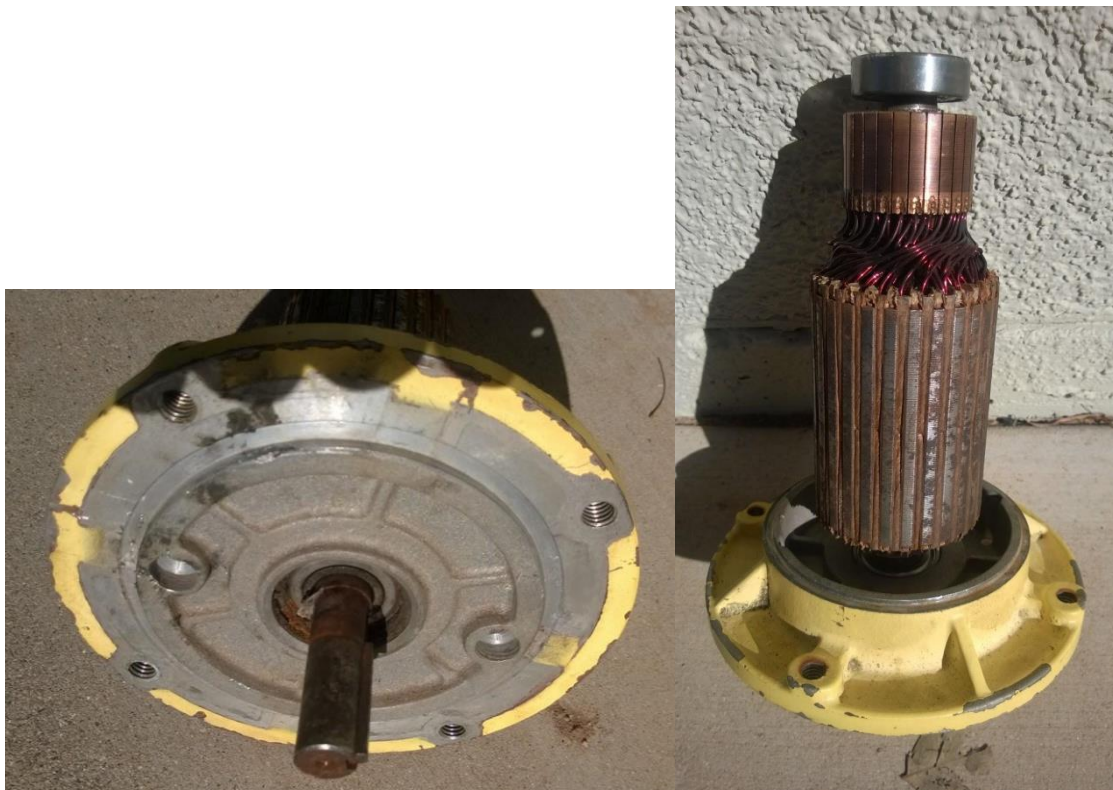
Figure 4 - Motor shaft and face (left) and side view of entire motor (right)

One of the most difficult tasks has been finding a replacement for the current motor. Figure 4 below shows some wear and tear on the motor with excessive rust. There was no tag or paperwork left behind describing what kind of motor it is, what company it is from, or any specifications. This made it difficult to find the correct motor that would match the output needed to sustain the load of the trough.

Since the motor seemed to match the gear box, we searched the gear box and found the company Boston Gear labeled on it. Thus, we contacted Boston Gear and spoke to a specialist on their gears and motors. Based on the description, the specialist said it sounded like a $\frac{1}{6}$ hp motor with a 56C face. He recommended a particular model, but we were not sure that amount

of power would sustain the trough load. Also, since this motor was at least 15 years old there was not an exact motor match, in particular the dimensions. The client recommended that we find a 1 hp motor that would match the current gear box. General specifications of most motors include 90 volts and 170-1800 rpm. The motor found, displayed in Figure 5, has all the correct specifications of what the trough needs. These specifications are a power of 1 hp, output of 90 volts, 1750 rpm, shaft size of $\frac{5}{8}$ inch diameter, and a 56C face. The motor found is from Baldor company, model CDP3445, at \$743.30. This would be a suitable motor for what the trough needs.

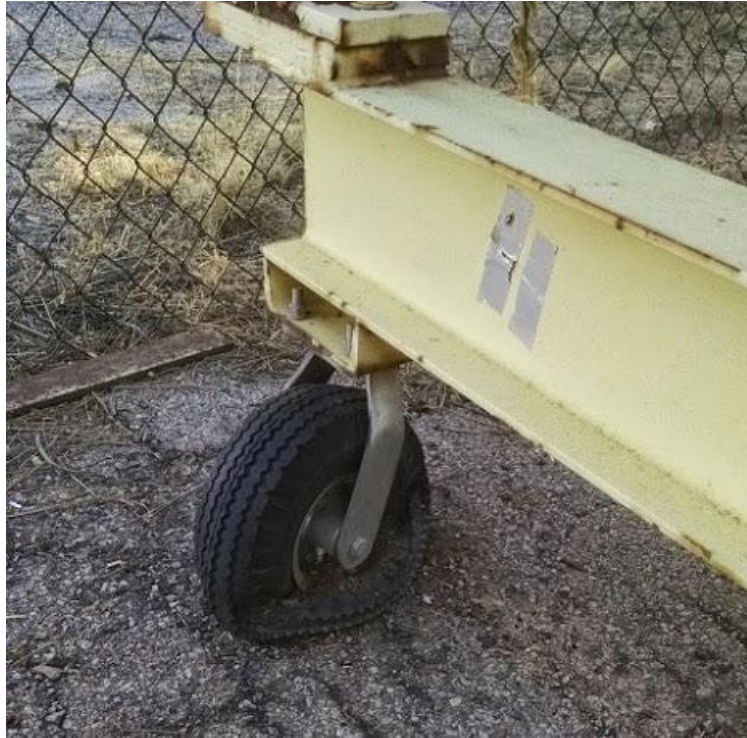
Figure 7- Damaged tires

At the beginning of the semester, the parabolic trough's four tires, one of four in Figure 7 were all damaged and needed to be replaced.

The tires were replaced with Marathon 4.10/3.50-4 tires, which cost \$14.50 per tire plus shipping. After the tire was purchased, the team started the process of installing the new tires on the trough.

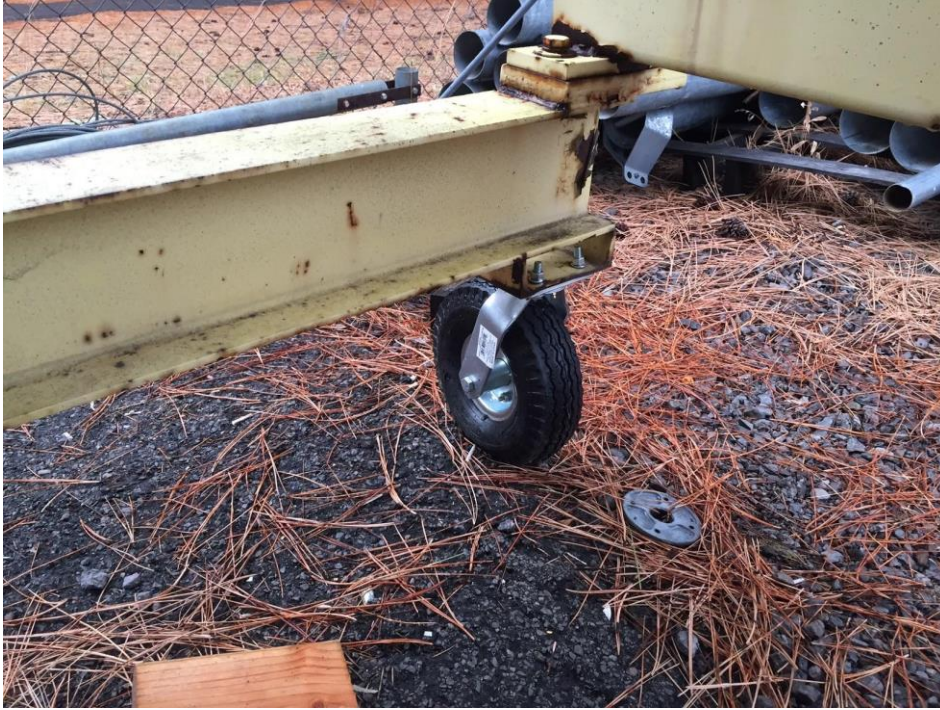
Figure 8- Replaced Caster with the tire

During installation of the new tires, one of the four casters broke, which then generated three solutions to this problem. The first option was to replace all the casters with new casters that are only sold with tires and not separately. The total cost was \$65.99 for each combination of caster and tire with a subtotal of \$263.96 if the Marathon tires were returned. The second option was to weld the broken caster using the NAU machine shop. Although this option would have no cost, if the caster was welded, the durability of the caster would be unknown and may fail again with the load of the parabolic trough. The third option was to replace only one caster that would come in combination with a new tire and keep one of the purchased Marathon tires as a spare at a cost of \$65.99. One caster and tire combination was purchased as it was the best solution at a reasonable cost. The purchased caster and tire combination is displayed in Figure 8.

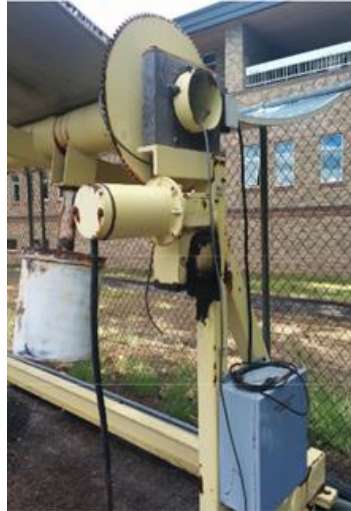
Figure 9- Big Sprocket with missing chain

When researching chains, the specifications needed were the length, pitch, and roller width. We measured the length using a tape measure around the large sprocket, seen in Figure 9, and small sprocket (not pictured). The measured distance found was 75 inches or 6.25 ft. From McMaster-Carr, the chain lengths are rounded up to the nearest foot. Therefore, the chain length we need was 7 feet. Also measured was the pitch and roller width needed with a tape measure. The values measured are $\frac{5}{8}$ in pitch and $\frac{3}{8}$ in roller width. With these values, an ideal chain was found on McMaster-Carr's website. The chain purchased is a standard steel ANSI 50 roller chain and links, with a pitch of $\frac{5}{8}$ in and roller width of $\frac{3}{8}$ in. This chain has a working load limit at 561 lbs and costs \$5.98 per foot that had a total of \$41.86 before shipping.

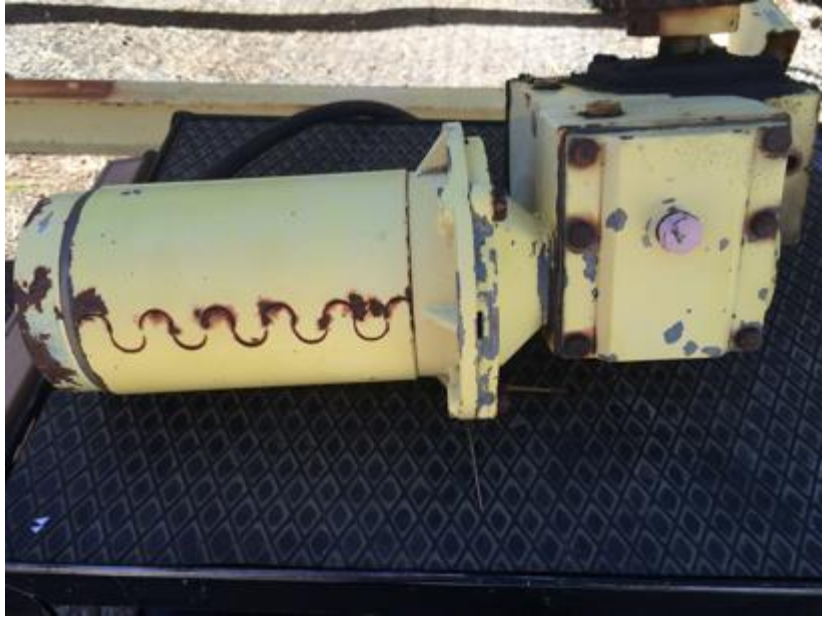
Figure 10- Motor connected to the upper level gearbox

The upper level gearbox is connected to the motor which can be seen in Figure 10. The motor shaft and the worm gear are secured together by a rectangular key. After disassembling the cover plate lubricating oil was found that turned from a golden color to black. Since the system has not been operated or maintenance over 15 years, there was minimal amount of oil left in the upper level gearbox, . Most of the lubricating oil drained down to the lower level of the gearbox. The interior surface and the worm gear holding the horizontal shaft showed some rust.

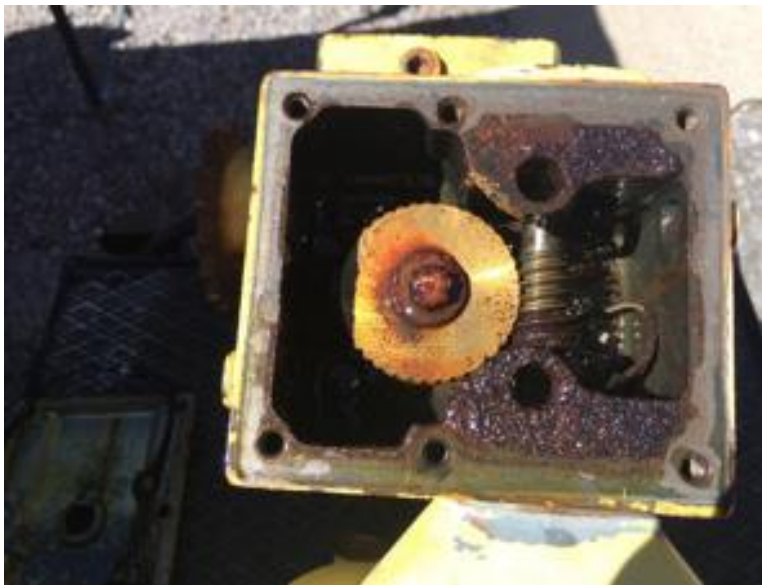
Figure 11- Upper gearbox with the cover off

Figure 11 shows the helical gear secured by a bolt and a washer has some rust and will be replaced. The helical gear has minimal rust but can be cleaned by a wire brush. However, the shaft was able to rotate, but we still to decide if it can work efficiently in the near future.

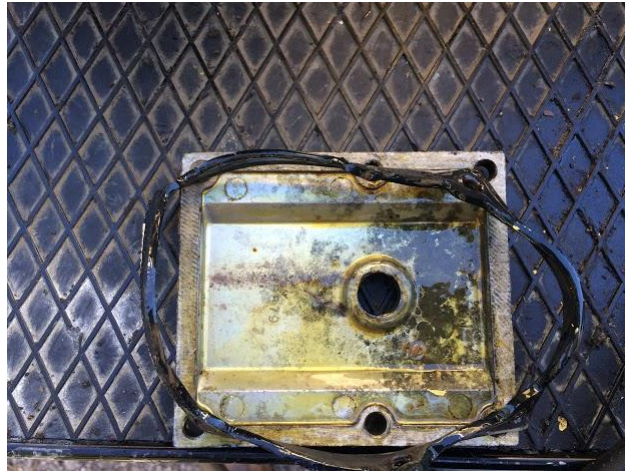
Figure 12: Upper gearbox cover

The rubber gasket has stretched and deteriorated from the weather of Flagstaff. The gasket will need to be replaced before the system is put back online. The defective gasket was the cause of the rusted parts in the upper level gearbox which are pictured in Figure 12. Moisture and condensation found its way through the gasket and the addition of minimal lubrication oil, the results was rust. There is a possibility that the cover plate will need to be replaced, but until it has been cleaned and tested, it will be unknown. The six bolts securing the cover plate will be replaced. The pink, once red in color, filler cap is made of plastic and will be decided at a later time if it needs to be replaced. The drain plug located on the upper level gearbox is in good working condition.

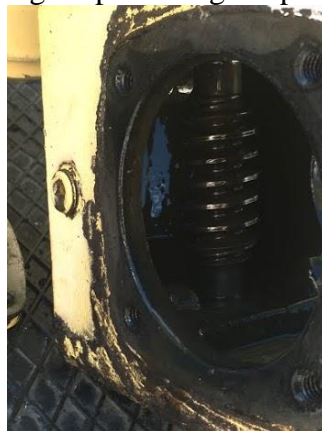
Figure 13- Vertical worm gear connecting the upper level to the lower level gearbox.

After disassembling the side cover mounted to the gearbox to observe the interior of it. It was found that it contains a vertical worm gear connected to the vertical shaft that rotates a helical gear in the same shaft located at the upper gearbox. The worm gear is connected perpendicularly to another helical gear located in the horizontal shaft that rotates the outer small sprocket. The vertical gear coming down has a roller ball bearing attached to it. As seen in Figure 13 the bearing sits between the upper level gearbox and the lower level gearbox to reduce friction and secure the vertical shaft. The roller ball bearing and the vertical shaft are in good condition. This is due to the lubricating oil protecting the parts from condensation and moisture.

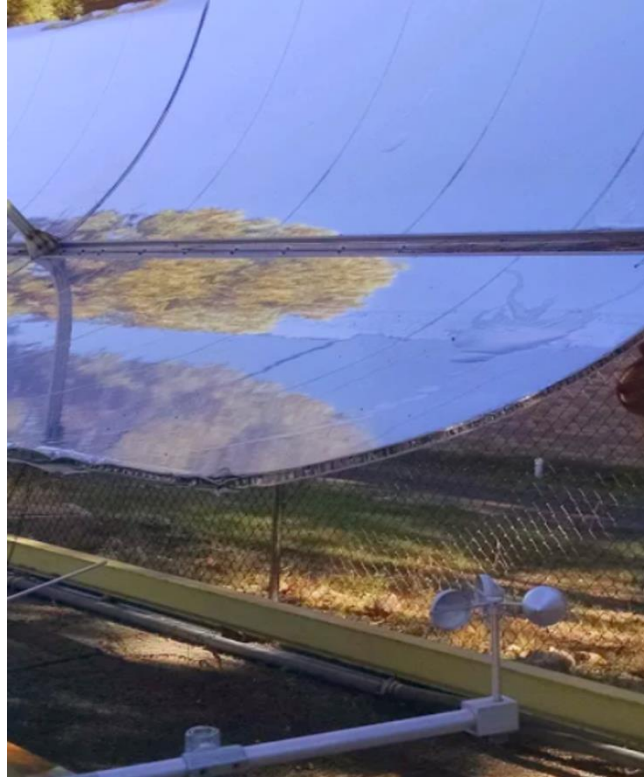
Figure 16 - Initial condition of edges

Due to the trough sitting outside in the environment for so long, the trim around the edges has almost completely broken off. Plastic trim was previously used when the parabolic trough was built, but after over 15 years it has become brittle and aesthetically displeasing. Most of the trim had already broken off, so new trim would be needed in order to seal the edges and also help make the trough look better. Figure 16 shows the previous conditions of the edges when the trough began to be worked on . After measuring the perimeter of the trough, it was decided that 74 feet of trim with a 1 inch channel gap would be needed to enclose all edges.

In order to determine what kind of trim to use, a material that has a long lifespan was desired. Although plastic was previously used, metal became the new material of choice because of the longer lifespan it has over plastic, it was found to be less expensive, and it could also hold down the areas of the edge that were bent, shown in Figure 17. Aluminum specifically was chosen because it is cheap and easy to work with. From Metals Depot, 8ft sections of 1 ¼” length legs, 1 ¼” base width, and ⅛” thickness, giving us the 1” gap needed, were found and were ready to be shipped. Once the material was chosen, ten 8ft sections were ordered to ensure that we would have enough material in case anything during installation went wrong. The total cost of the aluminum trim was \$220.38. Installation is currently in progress, but has been delayed due to weather conditions.

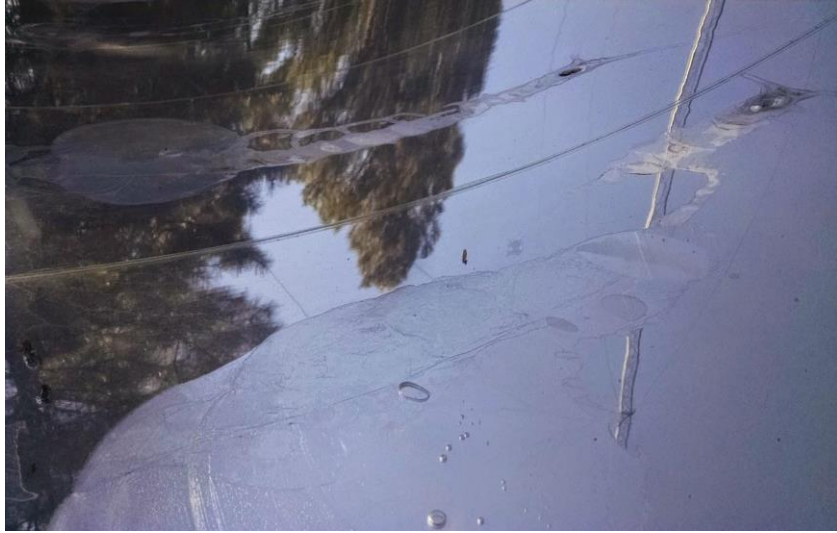
Figure 19 - Holes and water damage in surface

Due to the holes and water damage in the parabolic surface, shown in Figure 19, the reflectivity is hindered and will not be at peak efficiency in this current condition. In order to retain an entire reflective surface, something that could be applied to the surface and still be as reflective as what is on there currently is needed.

For this application, Mylar was chosen due to its low cost, flexibility, and most importantly is reflectivity. Another benefit of this material is that it can be used to cover the trim that will be hanging over the reflective surface. This will help maximize the solar energy that will be absorbed. Using Amazon.com, a 100 ft² (4 feet wide, 25 feet long) roll was found for \$20.00.

Installation of the Mylar has not yet begun due to the trim not being completed yet. Once all of the trim is installed, the Mylar will be applied to the surface and edges, and the trough will once again be able to rest in its upright position, rather than be tied upside down.
