# FHWA: DEEP BEAM DESIGN

**FINAL DESIGN REPORT**

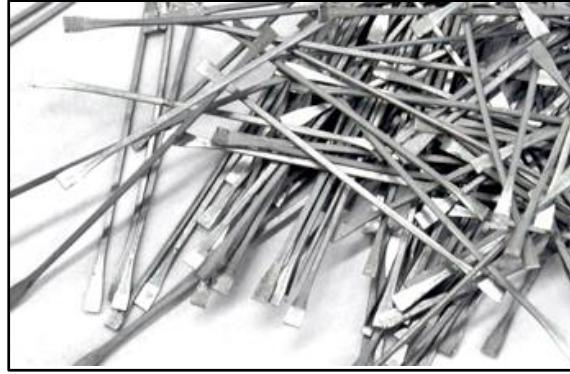
**Figure 2.4: Steel Fibers - with flat heads**

According to the American Association of State Highway and Transportation Officials (AASHTO), deep beams must contain a minimum amount of reinforcement equivalent to 0.3% of the cross-sectional area in both the vertical and horizontal directions. Researchers have shown that this quantity is not a strength requirement. Rather, it is required to control cracking or, limit the maximum crack width to less than 0.016 inches under the application of service loads. Steel fiber reinforcement is known to be highly effective at limiting crack widths in concrete [3]. The steel fibers used in this project can be seen in Figure 2.4. These fibers were 1.5 in. long and added directly to the concrete mix.

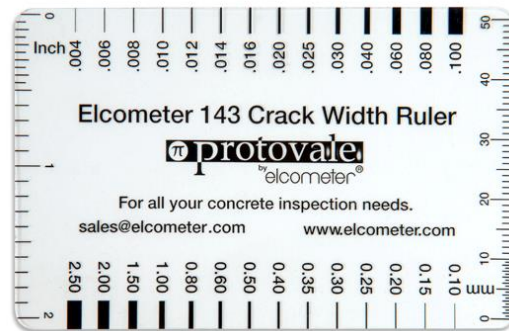
**Figure 4.9: Crack Width Ruler**

The beams were moved into the testing lab by rolling them on steel pipes. Once in the lab room, they were lifted with a manual lift and centered on the supports of the compression machine. All 9 beams were successfully compressed to failure. Throughout the breaking process, the widths of any cracks created within the test region were measured using a crack width ruler (depicted in Figure 4.9) and recorded.

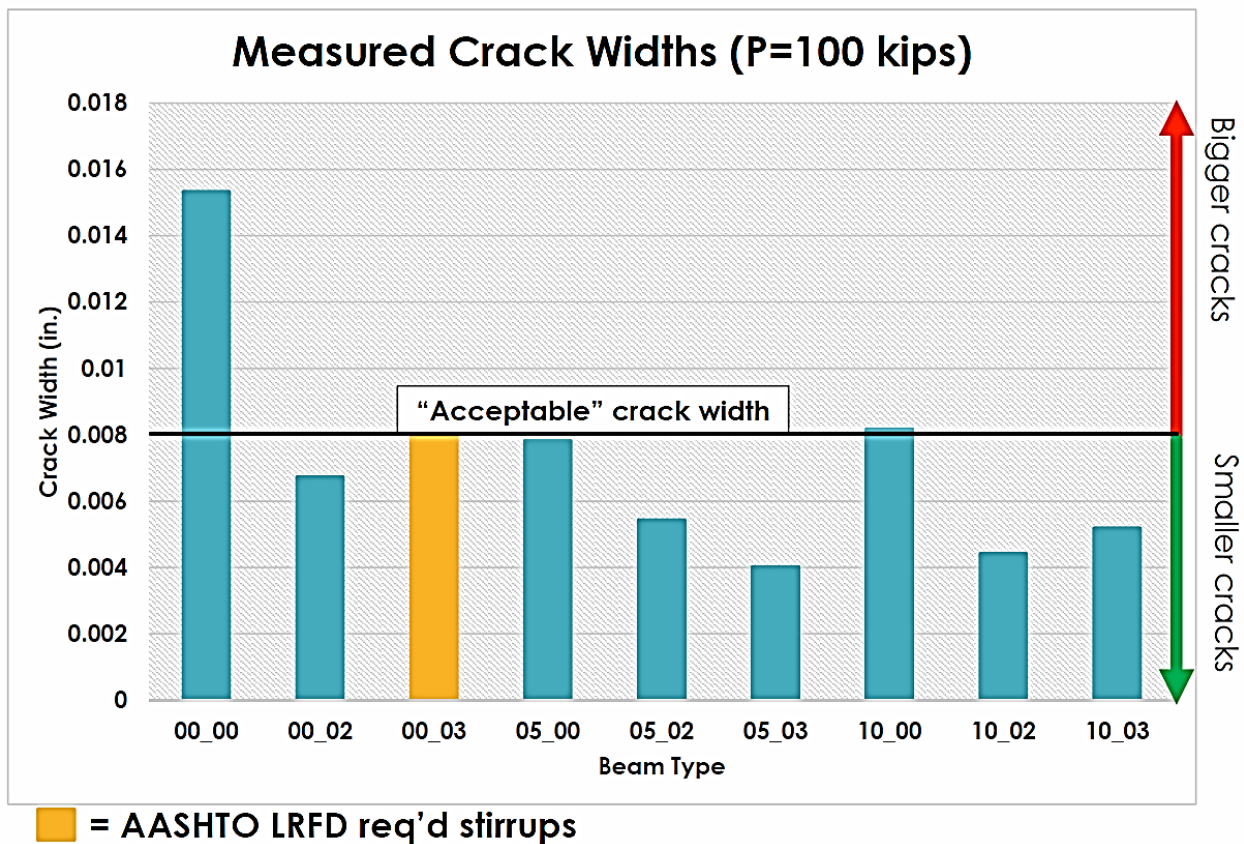
Figure 5.1: Graph of Final Results

As previously stated, all data was collected and organized into excel spreadsheets according to different variables (i.e. stirrup or fiber percentages). These graphs are not individually represented in this report, however they were compiled into one graph to that shows the crack widths compared to load. The graph in Figure 5.1 shows a bar chart with crack width values at 100 kip load. This load is based on the 107 kip design load mentioned earlier in this report. The labels of the blue bars represent the names of the beams depending on material percentages (fiber

% \_ stirrup %). For example, the yellow beam is called 00\_03 because it contains no fiber percentage and 0.3% stirrups. This beam is colored yellow because it is the current standard for deep beam design set by the American Association of State Highway and Transportation Officials (AASHTO). This standard says that deep beams must contain a minimum of 0.3% rebar reinforcement and it does not require fibers. All the other beams broken during this project were compared to this beam, as seen by the black line in the graph labeled “acceptable” crack width. This black line represents the acceptable crack widths that correspond with AASHTO’s standards. The red and green arrows to the side of the graph show how the crack widths are either increasing or decreasing as you move up and down the black line.

From this graph, it can be concluded that adding fibers to the concrete mix resulted in a positive effect to decrease crack widths within deep beams because most of the blue bars are below the acceptable crack width line. There were only two bars that resulted higher than this line and those were the 00\_00 and 10\_00 beams. This was expected because the 00\_00 beam had neither fibers nor stirrups, so the cracks had no reinforcement to control them. As for the 10\_00 beam, it contained no stirrups and 1.0% fibers but the mix had too many fibers to actually help the cracks; meaning it was too fibrous so the concrete was more brittle than the other mixes.
