Memo

Subject: Vegetative Analysis of Schultz Creek Project Site

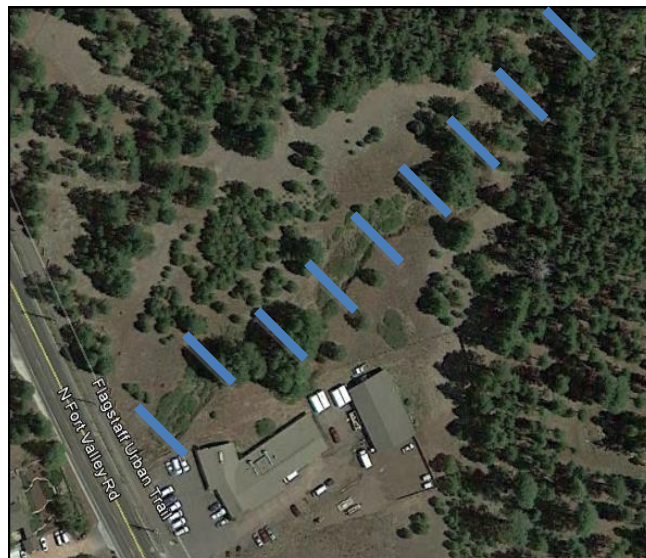
Riparian vegetation is an important habitat and functional component of an riparian ecosystem, and also serves as an indirect link to the process of bank and soil stabilization. Riparian area plant community structure and composition were measured using methods based on the Southern Colorado Plateau Network Riparian Monitoring Protocol (SCPN) of the National Park Service (NPS) Standard Operating Procedure (SOP) #6, Nested Plot Sampling Methods. Regulations for the vegetative analysis were provided in the SOP #8. The SOP method obtains frequency and cover estimates of herbaceous, shrub and grass species within cover class categories and tree seedling density using nested plot sampling. The plots must be evenly spaced along the transect with nesting of the 1 m², 5 m², and 10 m² plots at a given plot location (SOP #8, 2007). A total of 8, 10m² quadrant plots were established along the channel from the culvert opening to the end of the reference reach, as seen in Figure 1 below.

Figure 1: Vegetation Monitoring Site Locations

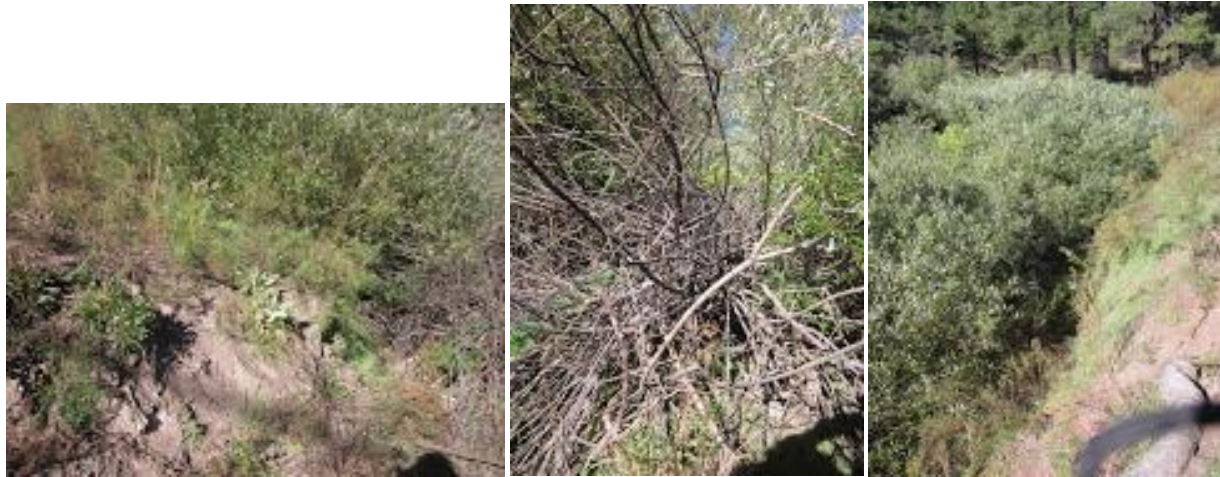
Figure 2: Coyote Willow: left bank, channel bed, and right bank

The coyote willows on the left bank, seen on the left in Figure 2, are a great example of how they stabilize the bank. However, the coyote willows in the channel are a poor example of bank stabilization because they have shifted to the center of the channel from the bank eroding and sliding. The area does not suggest new sprouts grew there because the willows are the same relative size as the ones on the bank. Maintenance on coyote willows must be maintained to prevent sprouts from growing in the channel bed.

depth (.92m) of the root system to get a total of 1.84m^2 . The cross sectional area of the soil, A_s , was determined to be 4m^2 . The total number of roots in the system was determined to be 6. The total tensile strength of the root system was determined to be 16.12kPa . The tensile strength of coyote willows is effective for the use of a bank stabilizer to prevent erosion. One thing to monitor is the reproduction of coyote willows to ensure none grow in the channel bed. Coyote willows reproduce by sprouting shoots from the roots, so it is very easy for them to reproduce sporadically, as seen in Figure 2 below.
