# TSEGI WASH - 50% DESIGN REPORT

2/28/2014

Daniel Larson, Leticia Delgado, Jessica Carnes

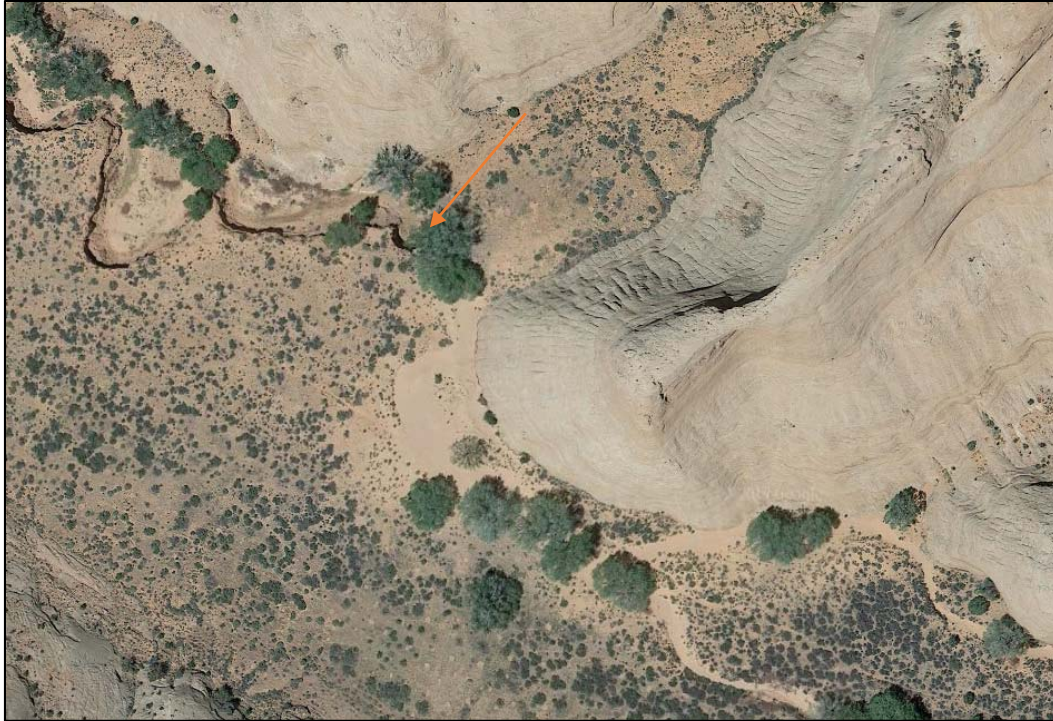
**Figure 3. Site Location (Google Maps)**

The image in Figure 3 presents a close up view of the headcut located beneath the tree denoted by the arrow.

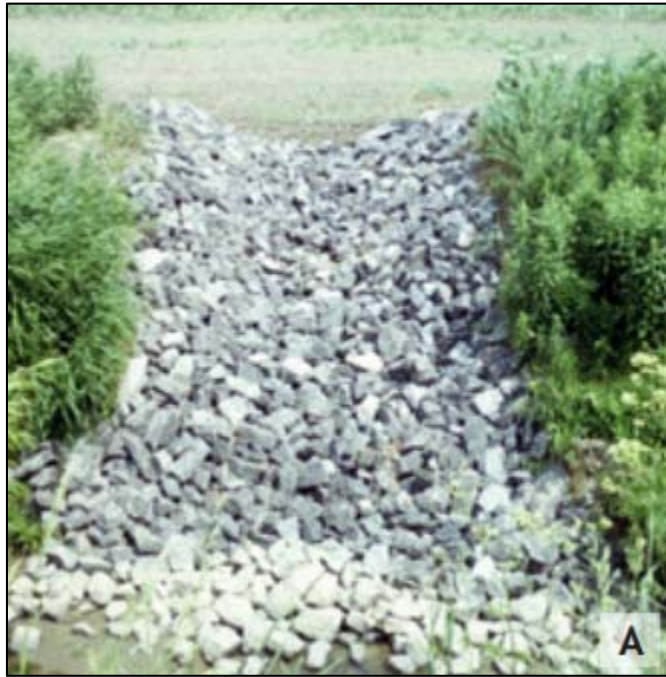
Figure 4. Rock Chute Spillway (Agriculture Canada)

Hard armoring is the technical placement of various sized rocks along a channel slope or streamline, reducing the flow energy of the stream and stabilizing the headcut. An example of hard armoring is a rock chute spillway that prevents erosion at the lower layer of the headcut, as can be seen in the image below.

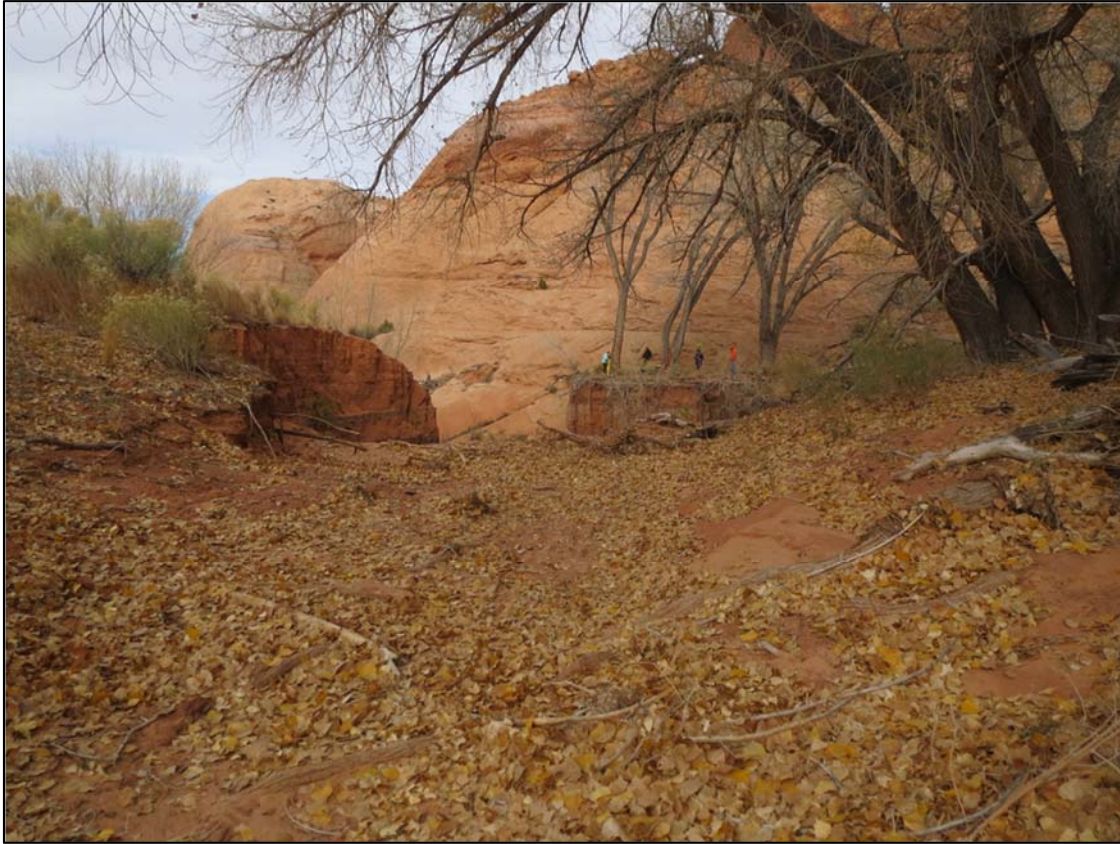
**Figure 5. Bed Material (Tsegi Wash Group)**

As seen in the figure above, the channel composition is mostly soil with tree litter and relatively little shrubbery is present.

The final factor was determined by averaging coefficients for “Earth channel – clean” and “Earth channel – gravelly” as the reach mainly consists of sandy soil with intermittent rocks spaced throughout. The image on the following page shows the composition of the channel bed material at the time of the site visit.
