TSEGI WASH DESIGN REPORT

5/1/2014

1.0 Project Description

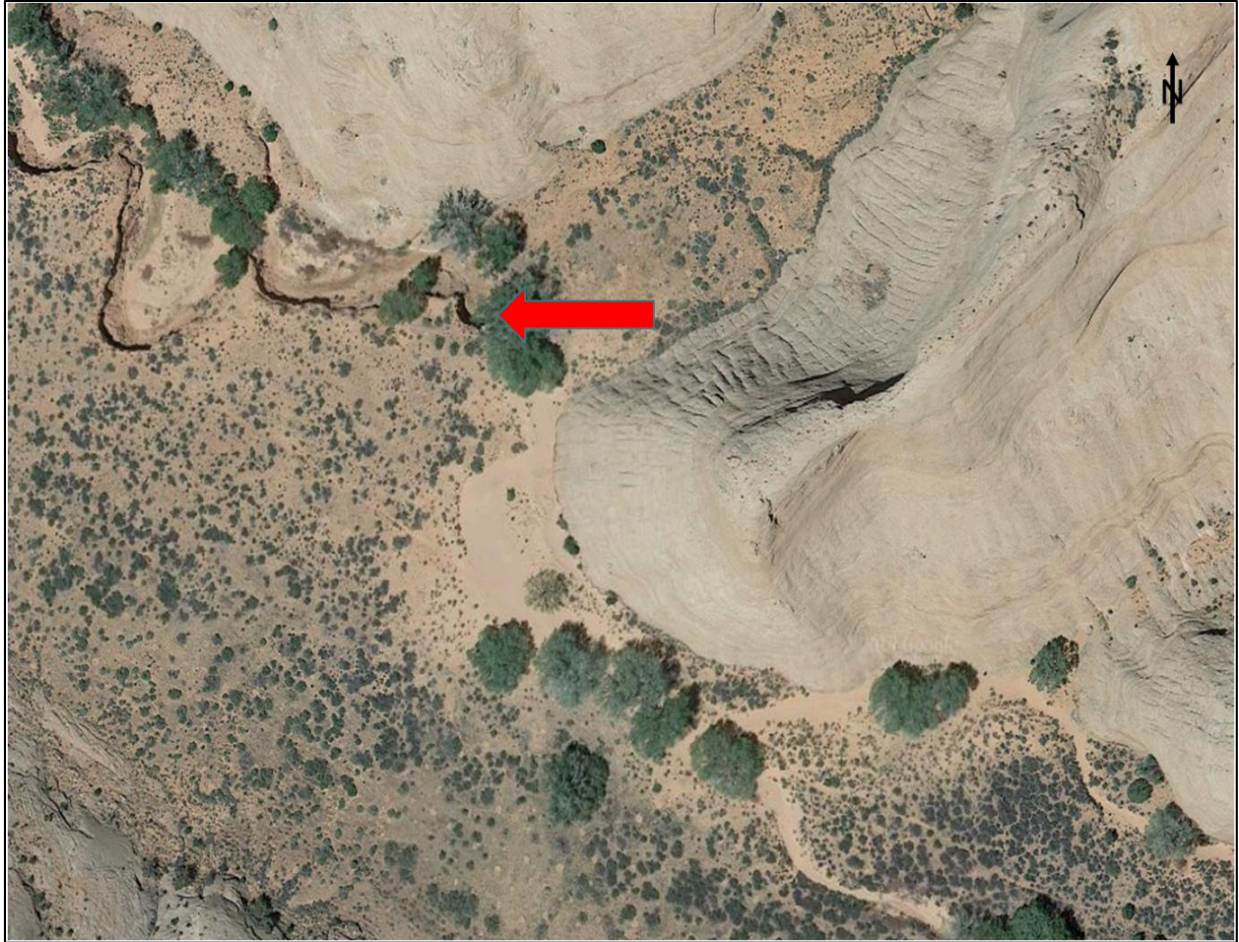
Figure 3. Site Location (Google Maps)

The image in Figure 3 presents a close up view of the headcut located beneath the tree denoted by the arrow.

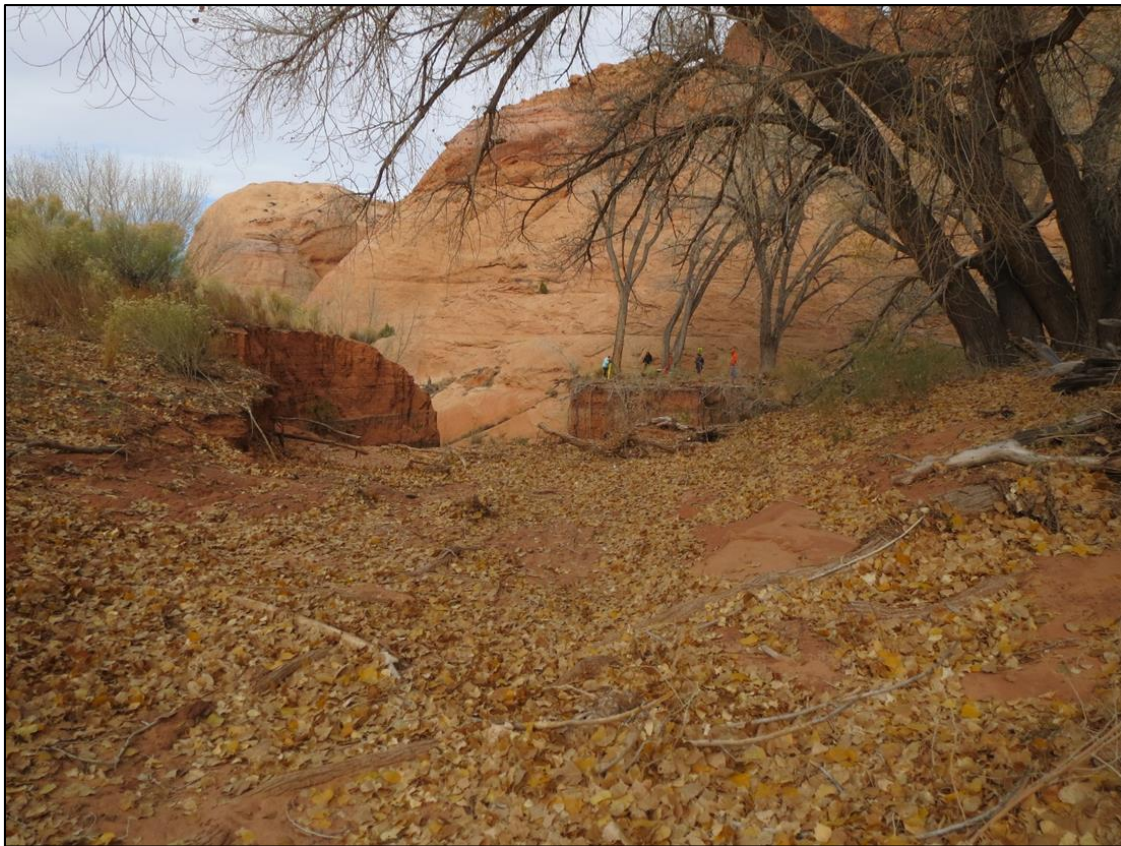
Figure 5. Bed Material (Tsegi Wash Group)

As seen in the figure above, the channel composition is mostly soil with tree litter and relatively little shrubbery is present.

The final factor was determined by averaging coefficients for “Earth channel – clean” and “Earth channel – gravelly” as the reach mainly consists of sandy soil with intermittent rocks spaced throughout. The image below shows the composition of the channel bed material at the time of the site visit.

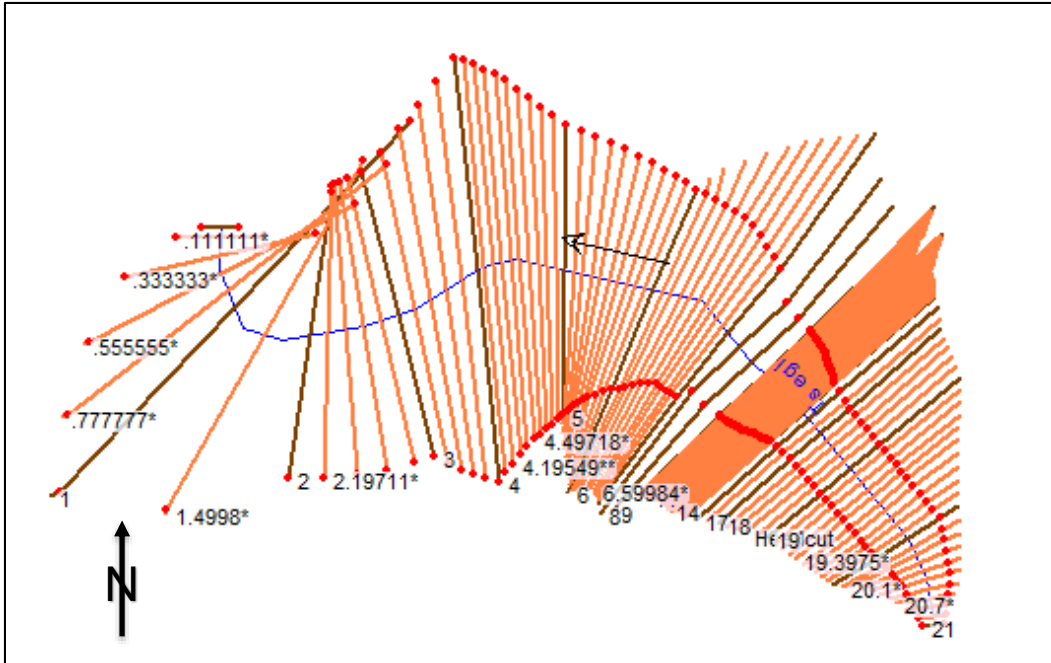
Figure 10. HEC-RAS Reach with Interpolated Cross Sections (HEC-RAS)

Figure 10 above displays the final HEC-RAS after interpolated cross sections had been created.

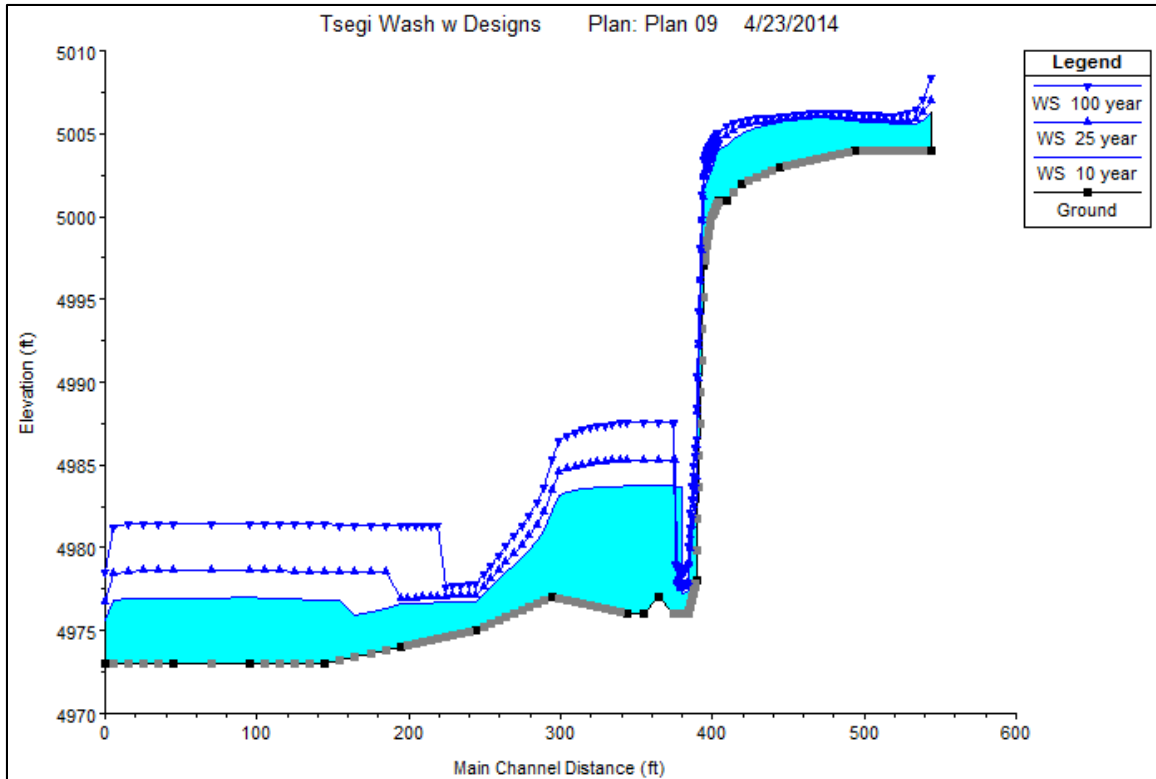
Figure 11. Profile View of Channel Reach (HEC-RAS)

The profile in the figure above shows the stream velocity beginning at a supercritical flow as it approaches the headcut. Directly below the drop off at the headcut the velocity changes to a subcritical flow as energy accumulates in a pool at the bottom, scouring the base of the headcut. The energy created at the bottom of the headcut causes the stream to exit the plunge pool at a supercritical flow, eventually returning to a natural subcritical flow.

A Steady Flow Analysis was run once again with the additional cross sections. A profile view of the stream after analysis was performed can be seen in Figure 11.

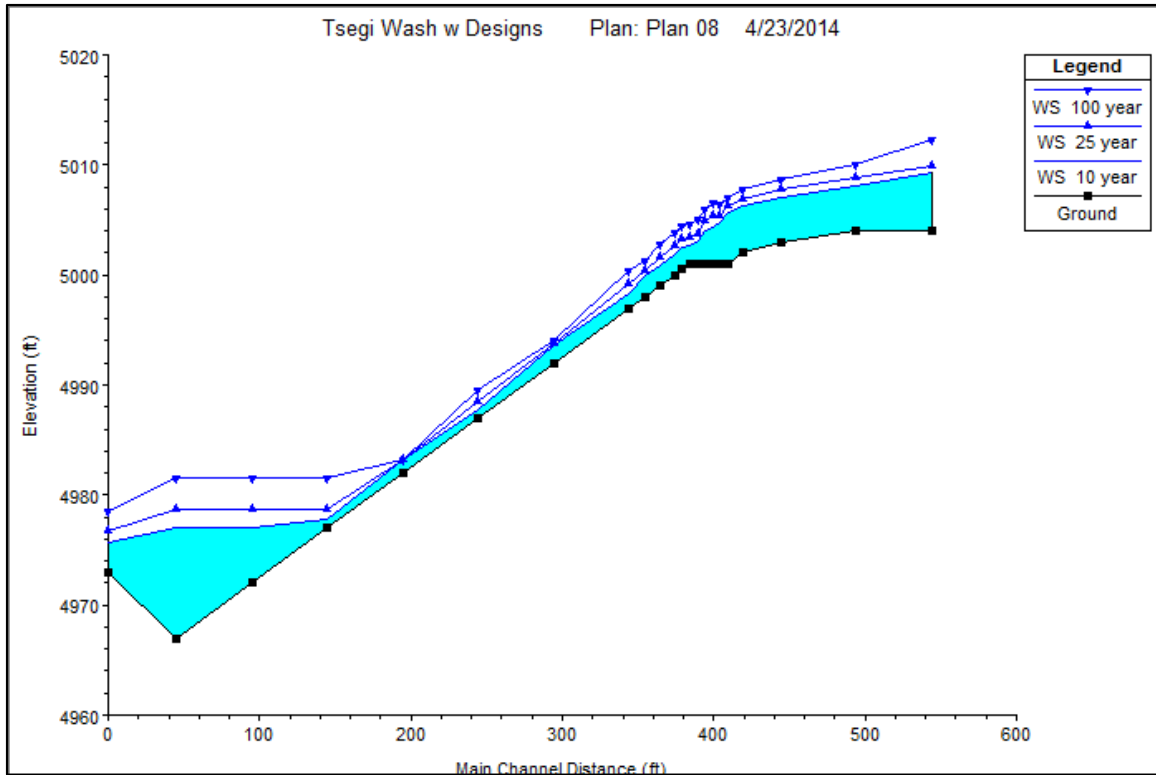
Figure 14. Live Vegetation Profile (HEC-RAS)

The profile shows the new flow levels for a 10, 25, and 100 year flow with the adjusted cross sectional elevations and manning's coefficients for the vegetation design.

The channel reach profile after a steady flow analysis was run using the HEC-RAS software with the final vegetation design is seen in Figure 14 on the following page.

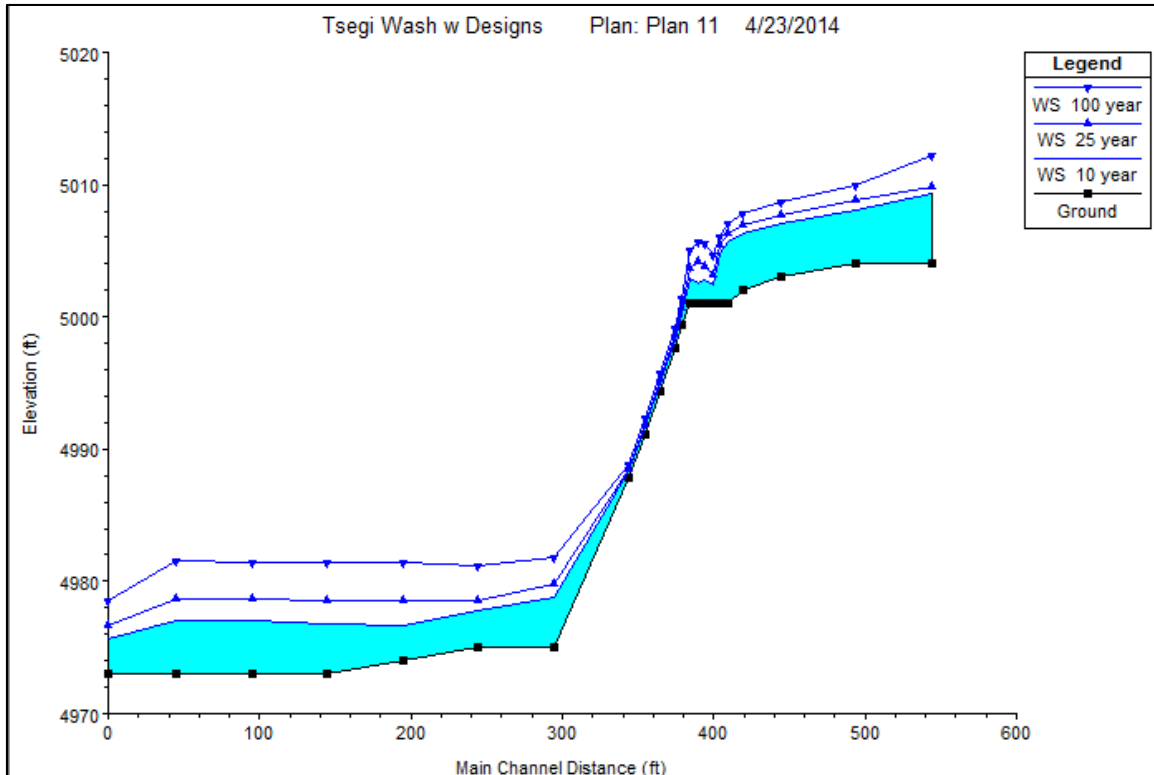
Figure 18. Hard Armoring (HEC-RAS)

In the figure above, the channel profile shows the 10, 25, and 100 year flow throughout the channel after rock armoring has been implemented and the channel has been taken out at a 3:1 slope.

An overall channel profile from HEC-RAS can be seen in Figure 18 after a steady flow analysis was run using the rock armoring design.

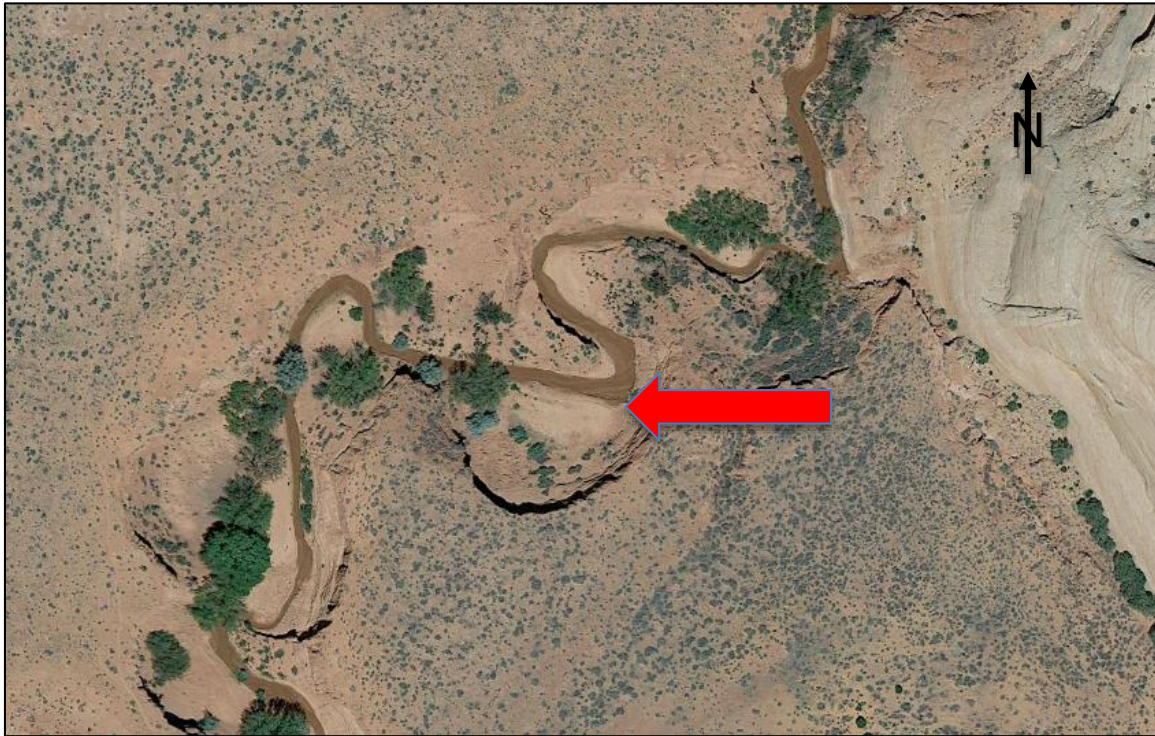
Figure 20. Completed Oxbow

The above figure shows a stream that at one time was flowing in the curved area indicated by the arrow. The stream eventually cut a new path which is what is predicted of current site streambed.

The figure on the following page shows a channel that exhibits this finalized behavior in a neighboring canyon.
