Final Design Report

Vulture Mine Site
Maricopa County, Arizona

May 2015

Gold Member Inc.
2112 S Huffer Lane
Flagstaff, Arizona 86001

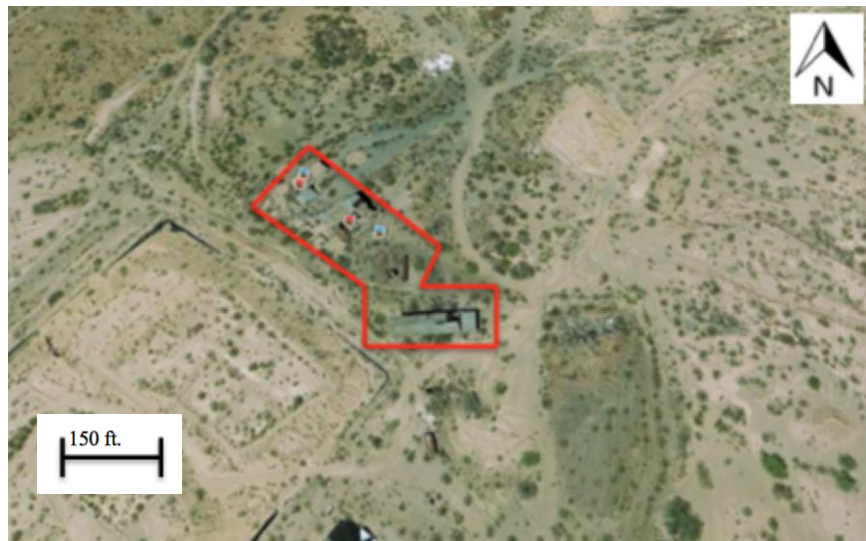
Figure 1.2 Google Earth image of the Vulture mine [3]

The site's known primary contaminants of concerns (COC) are lead and copper. Other COC's that are known are arsenic, antimony, molybdenum, and vanadium. The mine tailings from the site migrated into a wash south of the mine through rain and flooding events. The tailings have been identified from one mile to a mile and a quarter from the cyanide leaching plant. The mine is located on private land and is currently vacant. The wash south of the mine, where there appears to be thousands of tons of mine tailings, is on public land. The Vulture mine is located in an arid climate and has a Sonoran Desert landscape. There is little vegetation and may be home to threatened species such as the desert tortoise, mountain plover, and the California leaf-nosed bat [3]. The various types of vegetation found in the Sonoran Desert include palo verde, mesquite, desert ironwood trees, cat claw, chollas, and saguaro cacti. The red boundary lines shown Figure 1.2 represent the location of the Vulture mine with respect to the surrounding land.

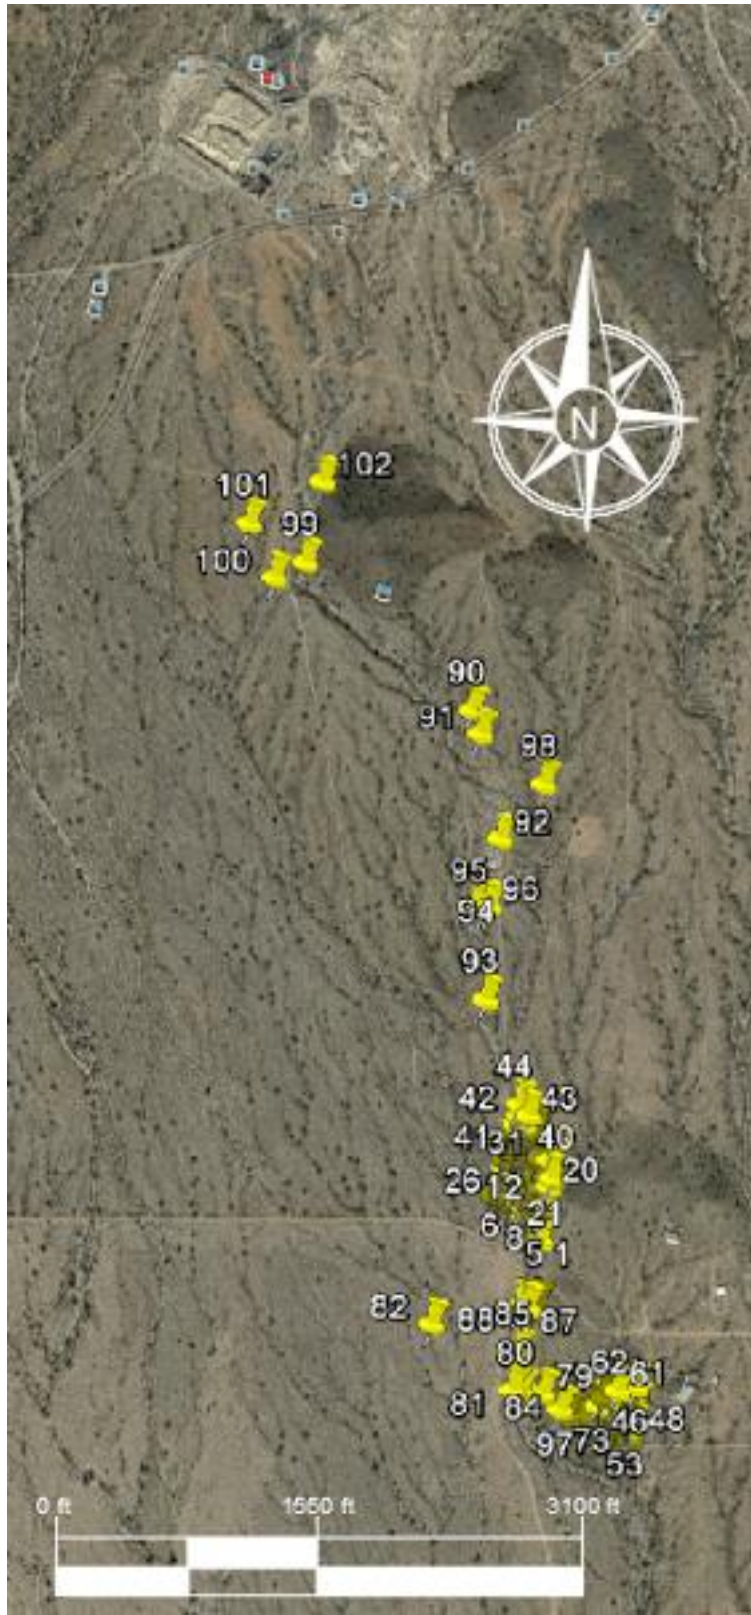
Figure 3.2 A map representing the locations of soil samples collected from the site

Figures 3.1 and 3.2 show the difference in the SAP proposed grid compared to the actual locations samples were collected. BLM Project Manager, Matt Plis, wanted to focus on the areas just north of Whispering Ranch Road, shown in Figure 3.1, and the south end of the wash close to residential property. Gridding in these areas were in accordance with the SAP. Samples were not collected on a grid south of the road or the northern most part of the wash. Three points were sampled 50 feet apart for 1/3 and 2/3 of the way down the wash south of the road and in the upper northern region of the wash in order to collect samples throughout the entire site. Refer to appendix B for team field notes.

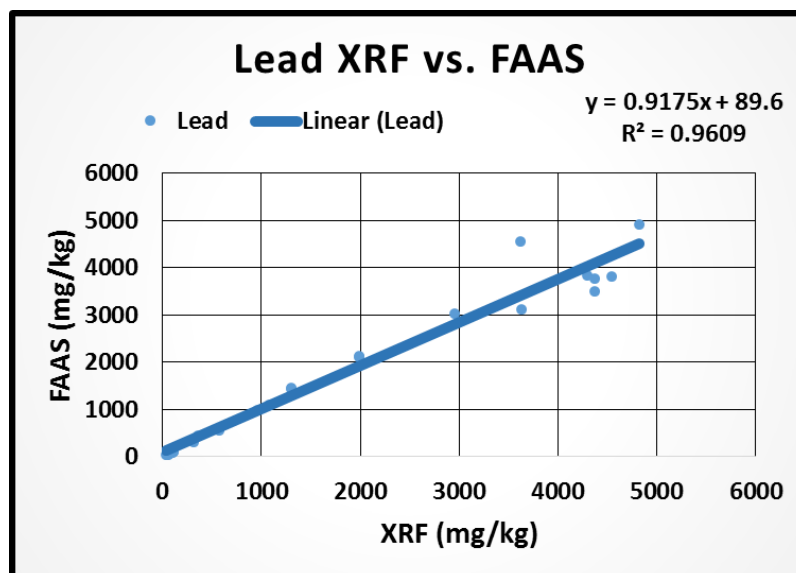
Figure 4.1 Lead Correlation

A linear trend line produced a correlation equation for comparing the data to each other. This equation was used to determine what the concentrations would have been for all the samples if they were going to be run through a FAAS. The R^2 value represents the validity of the correlation. The closer the R-value is to 1.0, the more accurate the correlation. Taking the square root of the R^2 value represents the sufficiency of the data. Anything above a 0.9 indicates a decision can be made off of the results from the data correlations. The lead and copper graphs shows that a linear correlation can be applied and get sufficient results.

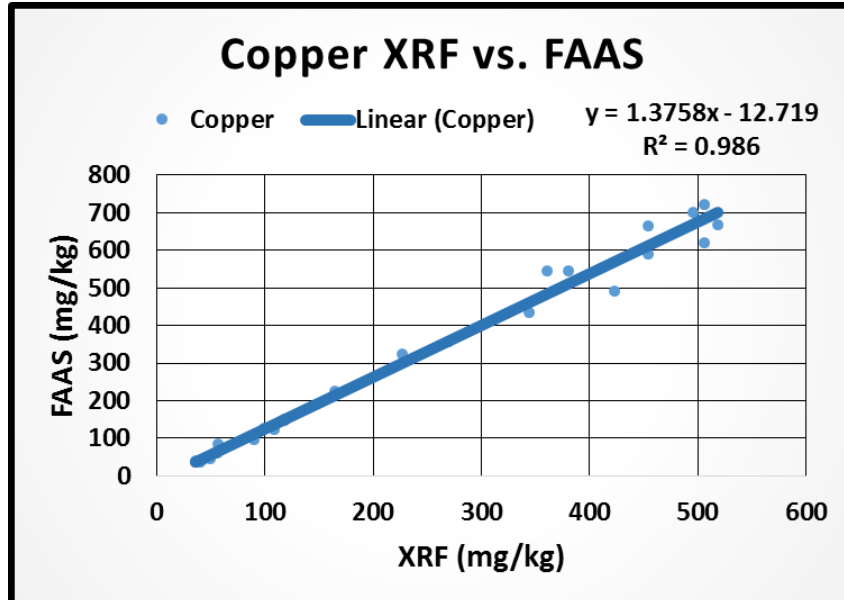
Figure 4.2 Copper Correlation
