This report discusses the initial conditions of an ephemeral stream called the Sinclair Wash. An assessment including site visits, surveying and, performing a hydrologic and hydraulic analysis ultimately proved the Sinclair Wash does not meet city specifications when conveying the 100-year and 50-year floods.

The Sinclair Wash is located in Northern Arizona and is a part of the Little Colorado River Watershed; more specifically it is a part of the Canyon Diablo Drainage Area [1]. Its headwaters reside at the base of Woody Mountain. Flowing east, Sinclair Wash ultimately ends at South Lone Tree Road where it connects to the Rio De Flag (See Appendix A for site map).

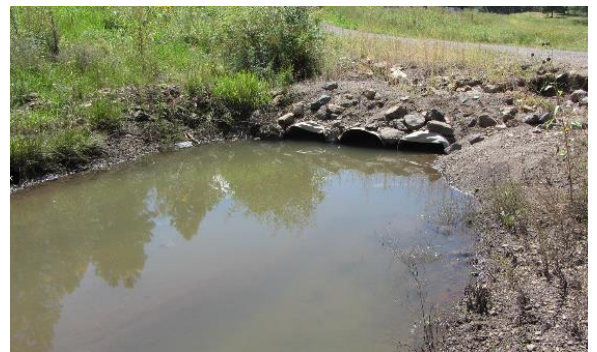
Figure 1: Pooling at CMPs [3]

Biologically, invasive plant species reside along the stream. Pooling water is present at all of the corrugated metal pipes at trail crossings as well as at the double box culverts, creating breeding

grounds for insects like mosquitos. Garbage and other debris along the wash facilitate harmful bacteria that eventually end up downstream.

All of the trail crossings fail in the event of a 50-year storm event. This is due to the poorly maintained and undersized CMPs. Many of them have been warped and the slopes lessened, again, encouraging pooling at the entrance and exit of each pipe. This could also explain why some of the capacities were so low. With weeds impeding in the pipes with little slope, only a small amount of water actually heads through the pipe, instead, going over the trail. Some of the road crossings fail at the 100-year storm event. This seems to be due to a lack of slope, not necessarily an under design of the size. The whole wash seems to lack slope. The channels, however, are over designed in some areas. Near the Big 5 and Walmart parking lots, the channels have a free-board of about three feet even when conveying the 100-year storm. Because such a deep channel was dredged in these areas, it took some potential elevation away from areas downstream again lessening the slope.

considering redesigning any culverts passing under roads. All of the culverts at trail crossings fail. Since these do not require a redesign of current roads, it would be ideal to remove the culverts completely, leaving an open dip at each crossing. This would allow water to flow freely through the channel. Side slopes could even be altered to prevent potential safety issues when people are using the trail.

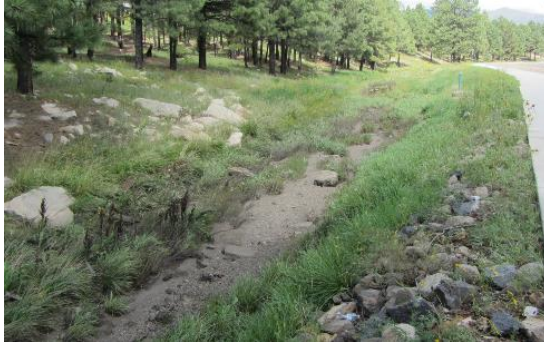
Sinclair Wash is the product of human encroachment. Physically, the wash has been straightened and narrowed due to construction on both sides of the banks. This has affected the stream health negatively because sinuosity and a wider bed help prevent a supercritical flow, which in turn prevents scouring, plant life depletion and excess sedimentation deposits.

Figure 2: Sinclair Wash along McConnell Drive [3]

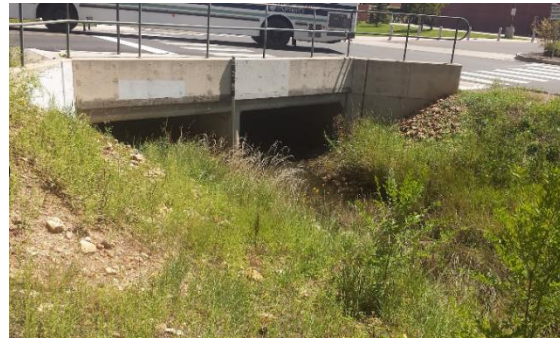
Figure 3: DBC Crossing Under Knoles Drive [3]

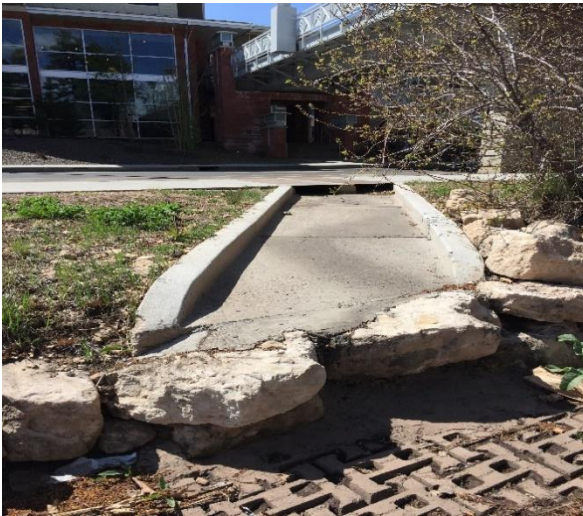
*Note, open inlets for the purpose of this inventory were gutters that lead to the wash in a small, shallow concrete channel-like structure as pictured below.

Figure 7: "Open Inlet" After Pedestrian Bridge on McConnell Drive
