Saginaw Hill Erosion Control

M.A.R.S. Consultants

Fall 2015

NORTHERN ARIZONA UNIVERSITY
CENE 476 Capstone

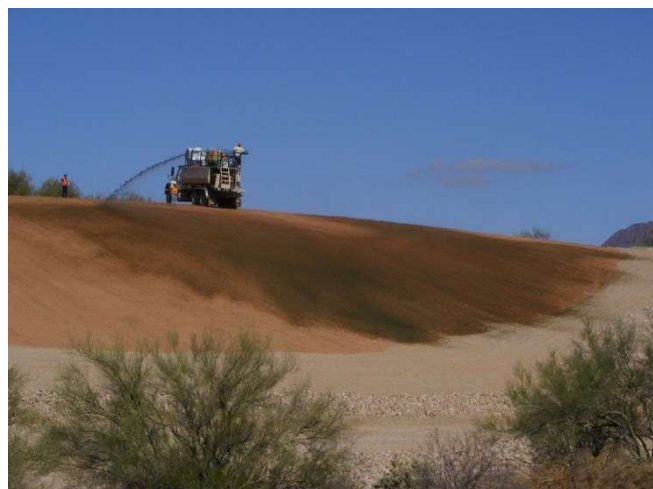
Figure 1.4: Revegetation efforts on top of repository cap [2].

bottom of the first clay layer is. Vegetation was planned for the top layer to minimize erosion, a picture of installation is shown in Figure 1.4 [2]. Gravel caps were used to cover the excavated areas. Additionally, Red J constructed drainage channels and stabilized existing washes with multiple layers of soils, aggregate, and fabrics.

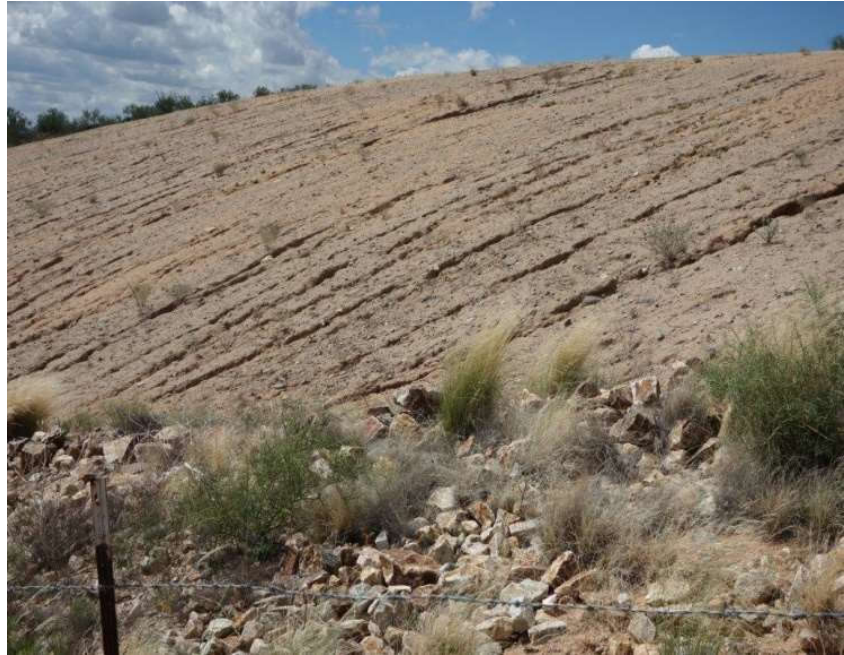
Figure 1.5: Vegetation is sparse and erosion is evident on the repository cap [6].

appeared to be damaged by erosion. There was sedimentation in the diversion channels and the repository cap's vegetation layer was missing entirely. Figure 1.5 shows the current condition of the cap. The exposed marker layer and wire-netting geotextile fabric can be seen in Figure 1.6.

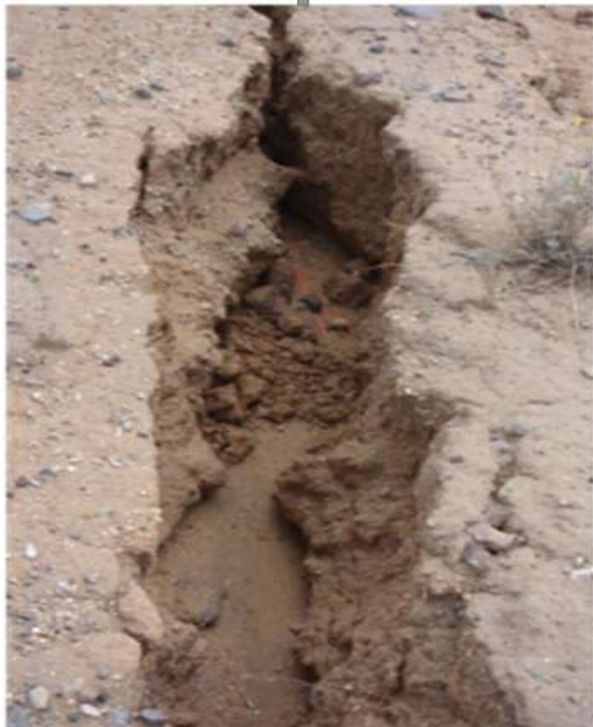
Figure 1.6: Exposed marker layer and mesh wire-netting [6].
