Coyote Springs Riparian Stream Habitat Restoration

AARK Stream Restorations, LLC

Abdullatif Albeaijan, Alexander Comito, Rachel
Joaquin, Kyle Depugh
NORTHERN ARIZONA UNIVERSITY
COLLEGE OF ENGINEERING, FORESTRY, AND NATURAL
SCIENCES

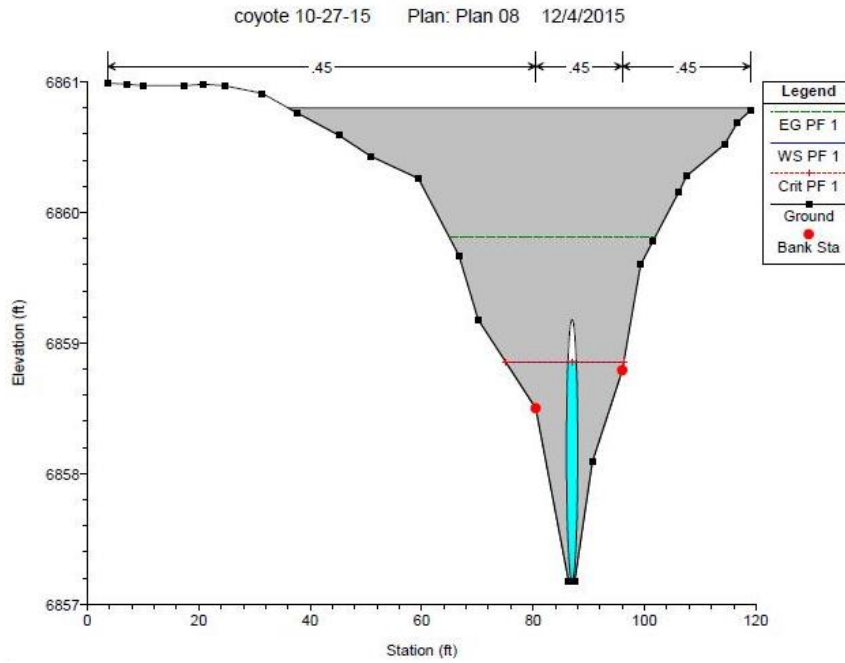
Figure28: Proposed Stream Cleaned Out Culvert 3 Example

Along with this change and the maintenance of the streams culverts and plants the stream is able to flow at stable rate and possibly less problems in the future. Example images of the existing and cleaned culverts with the flow represented are shown below in Figure 27 and Figure 28 respectively.

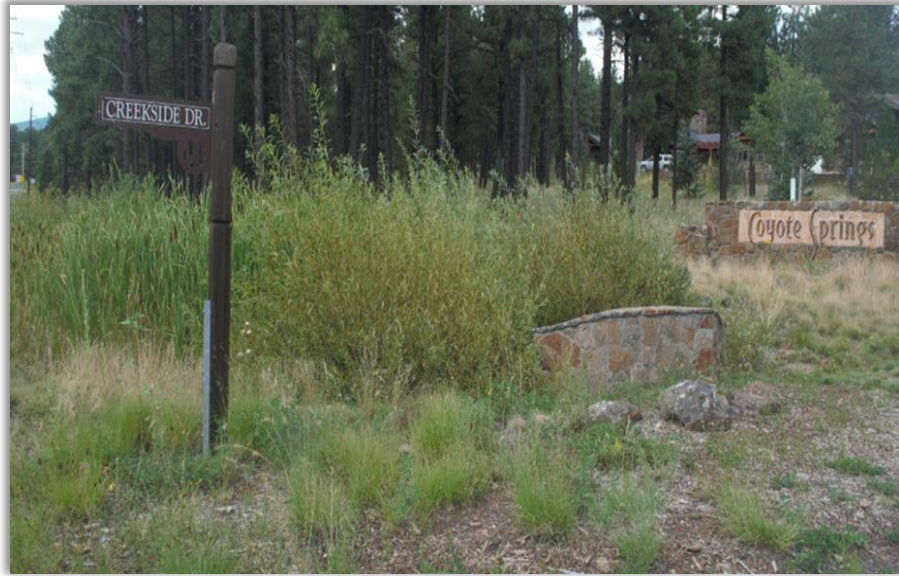
Figure 3: Pooling Area Overgrown with Vegetation at Creekside Drive and HWY 180

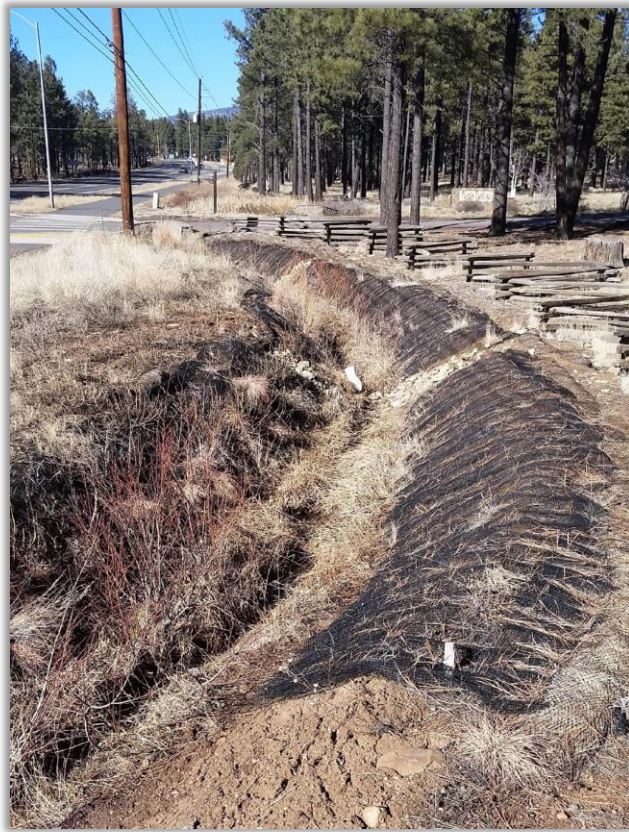
Figure 4: Turf Reinforcement Netting at Downstream End Looking Northwest

The site conditions have been monitored and evaluated by the team throughout the past year to observe the vegetation and topography. The initial observation of the area concluded there were artificial rocks, slope stabilization netting that looked unnatural, overgrown vegetation, and a trickling stream; the stream had water throughout the year. Following the field evaluation, the team concluded further analysis regarding the stream's characteristics, using surveying equipment and computer software to determine existing channel conditions, is to be completed.

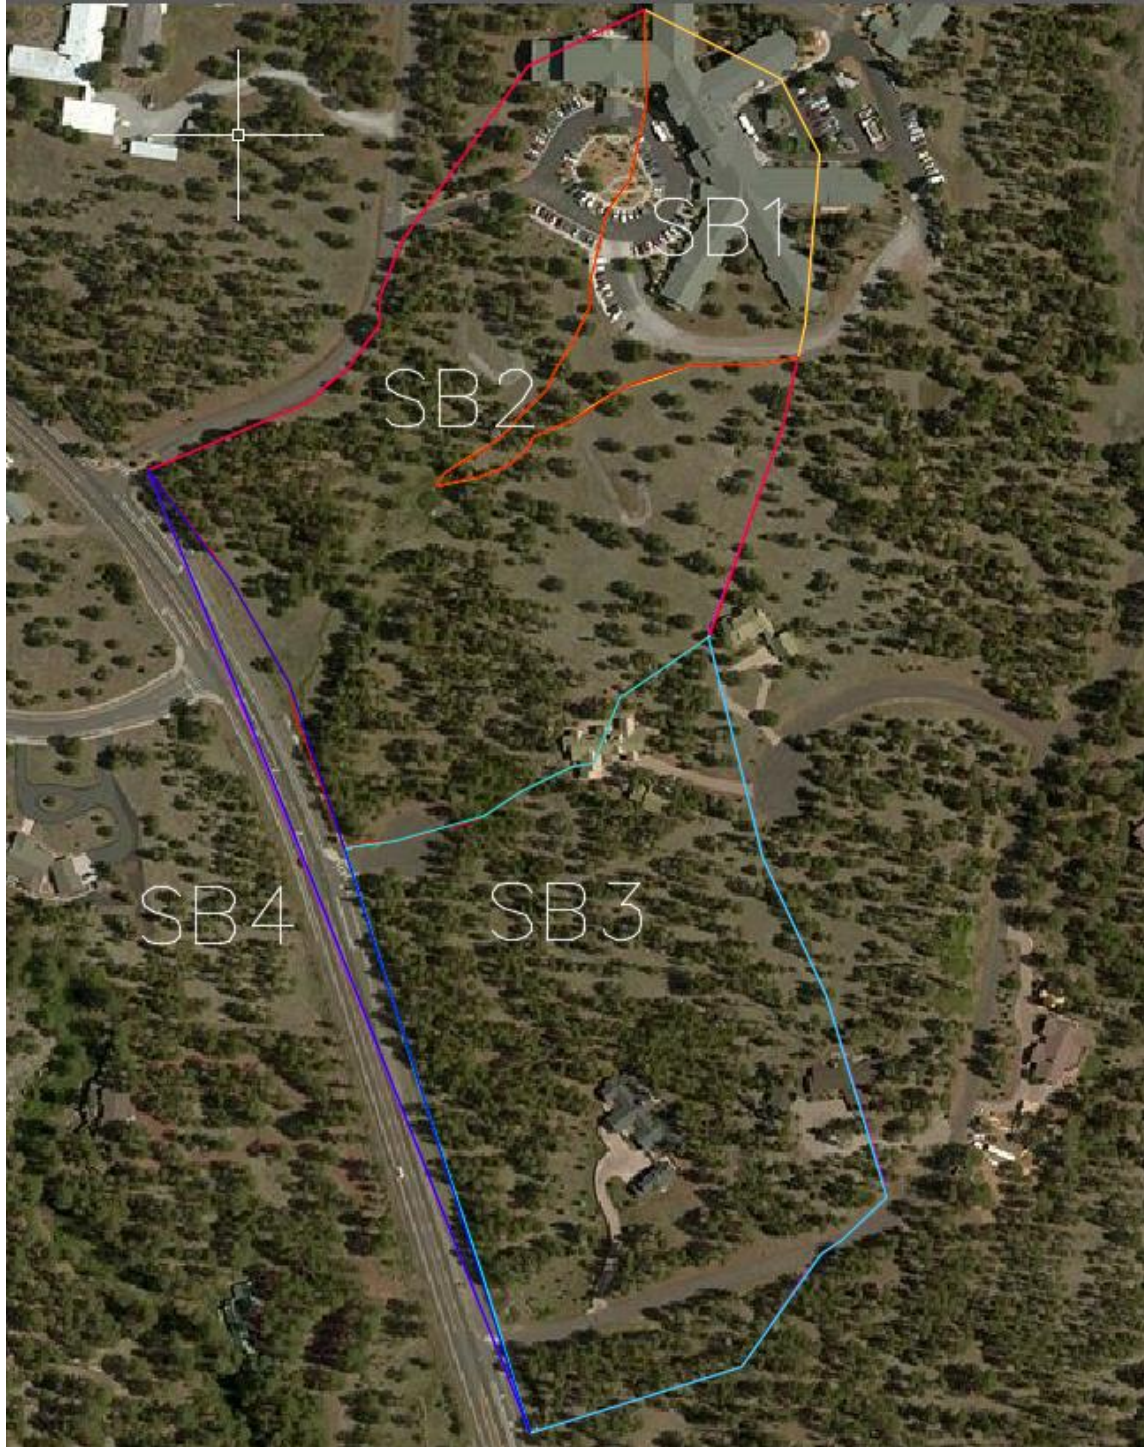
Figure24: Watershed Sub-Basins

Watershed delineation for the entire area was found to be 24.35 Acre which technically does not satisfy the 20 acre requirement to use the rational method for Coconino County. For this project since our watershed delineation was very close to the 20 acre requirement we decided that the representation of the rational method was suitable and so did our technical advisors. The watershed delineation can be seen in with each sub-basin in Appendix H.
