FLAGSTAFF FAMILY FOOD BANK – FLOOD REMEDIATION PROJECT

Final Design Report

5/12/2016

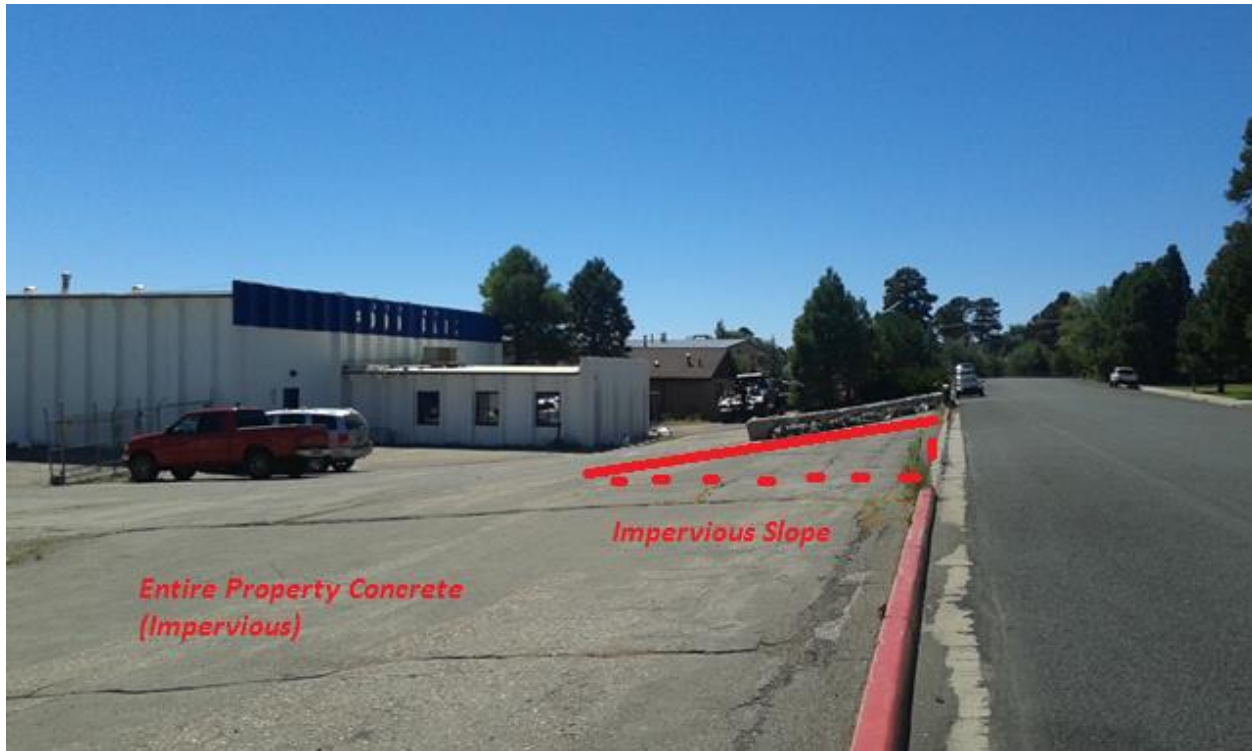
Figure 1.5 - Impervious Slopes & Surfaces

Another site specific condition that adversely effects the flooding problem on the FFFB site is the amount of impervious surface surrounding the site. With no natural infiltration or drainage on site, a higher volume of storm runoff can accumulate. Additionally, impervious slopes of the property lead water to the FFFB building, escalating the intensity of the flooding issue on site. These impervious surfaces and slope conditions are illustrated in Figure 1.5.

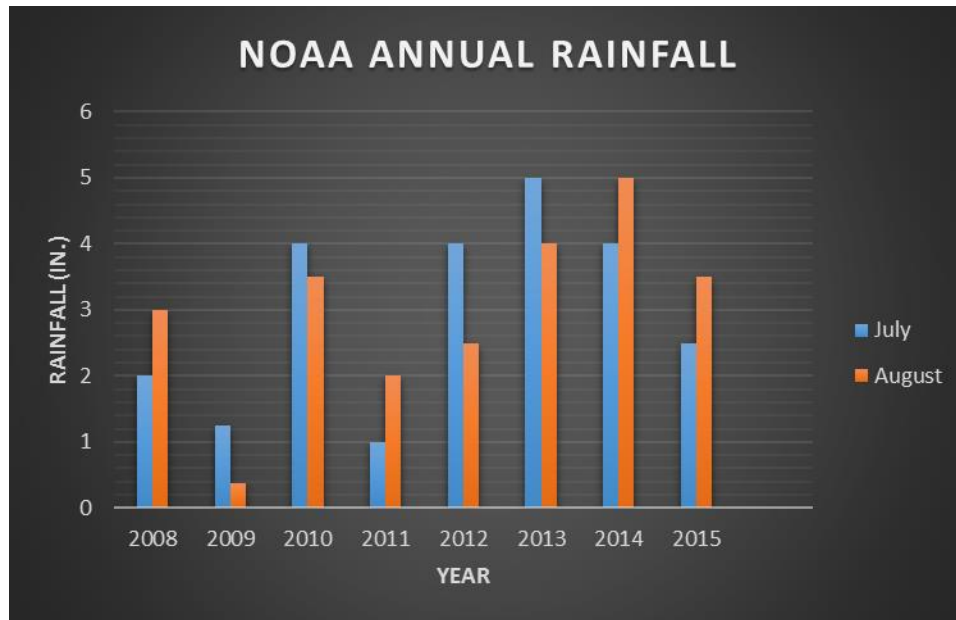
Figure 3.1 - NOAA Annual Rainfall for July and August

The annual rainfall for the monsoon months of July and August was also tabulated, seen in Figure 3.1, using data from NOAA Atlas 14. Figure 3.1 indicates that the rainfall is significant during the years of 2013 and 2014, with a slight dissipation in 2015. This same pattern can be expected to repeat in the years ahead. Additionally, rainfall in August has become more significant over the last 4 years, and this pattern is expected to repeat itself.

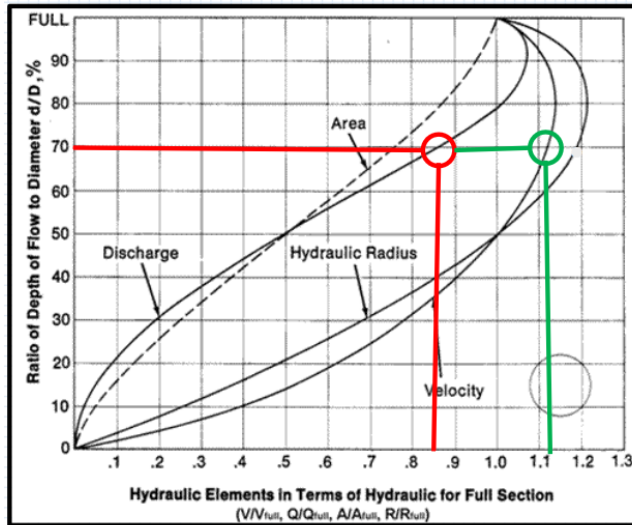
Continuity and Manning Equation:

$$Q = VA = A \left(\frac{1}{n} \right) R^{2/3} S^{1/2}$$

$$\frac{Q_{actual}}{Q_{full}} = 0.85$$

$$\frac{V_{actual}}{V_{full}} = 1.12$$

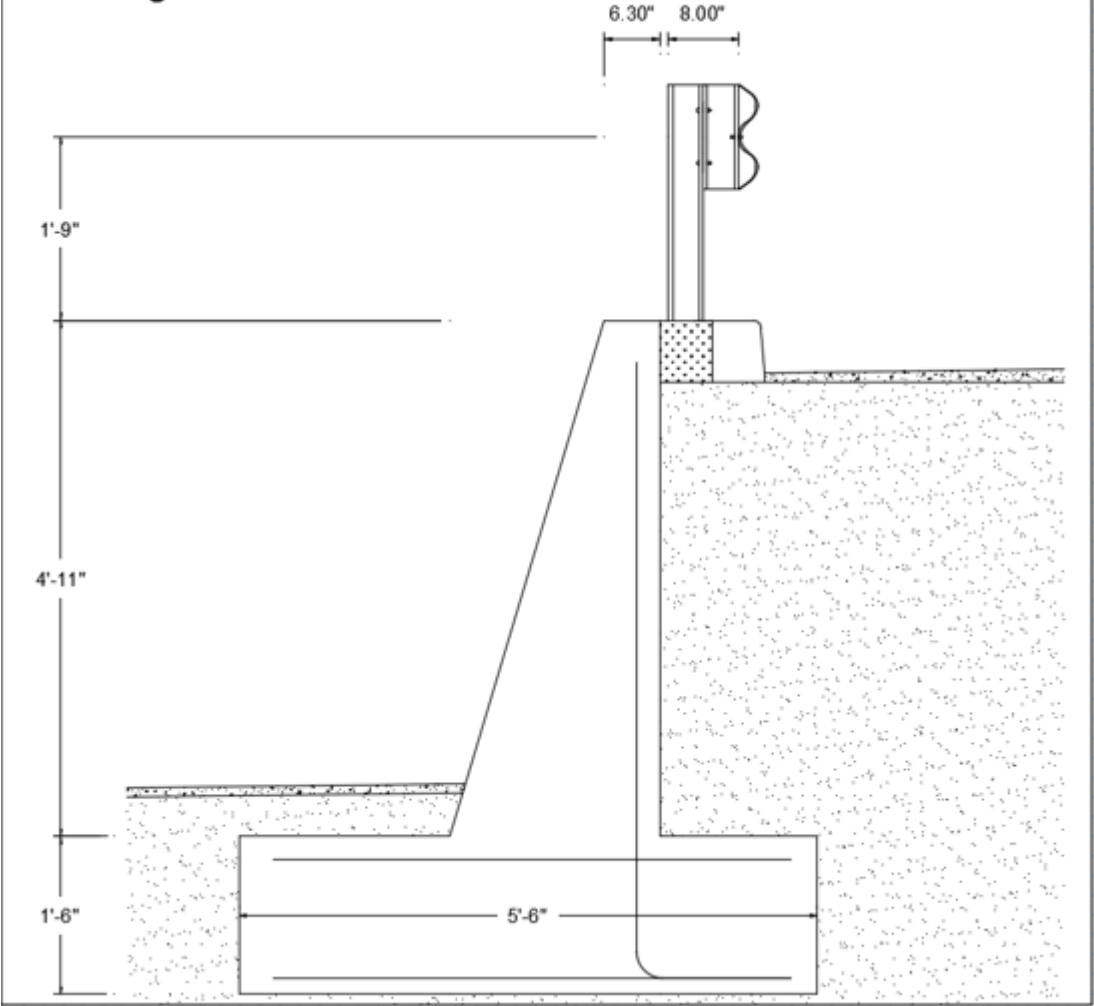
Retaining Wall

I	13.86	ft ⁴	
q _{com}	2004.681	psf	
q _{max}	1119.701	psf	
q _{min}	442.4897	psf	
q _u	8086.759	psf	
FS	7.222247	CHECK > 3	yes
