**DUNCAN, ARIZONA**

**FLOODPLAIN ANALYSIS AND LEVEE ALIGNMENT**  
**ALONG THE GILA RIVER (50% COMPLETION)**

**DELIVERED BY**  
**NORTHERN ARIZONA UNIVERSITY UNDERGRADUATE ENGINEERING STUDENTS**

**FALL CAPSTONE PROJECT**  
**OCTOBER 22<sup>ND</sup>, 2015**

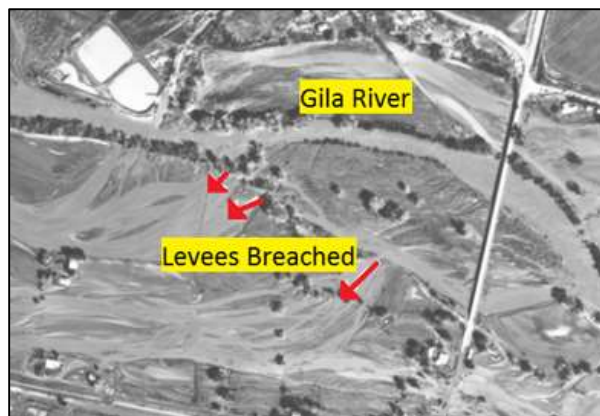
Figure 4-Aerial photo of the 1978 Duncan flood [4]

With the Gila River flowing on average of 200-400 cfs [3], the river is nearly always contained. For small-scale flooding events, less than 10 years, an agricultural dike serves to protect Duncan along the focused river reach. Under larger flood events, the dike lacks sufficient engineering and has been breached multiple times. The worst flood on record occurred in December of 1978 when the Gila River reached a flow of nearly 60,000 cfs [4]. The flood severely damaged local infrastructure and brought siltation and erosion damage to the agricultural properties. Damage was estimated to a total of 9 million dollars (adjusted to the 2015 dollar) [5]. Figures 1.4 and 1.5 depict the conditions of Duncan during a flood.

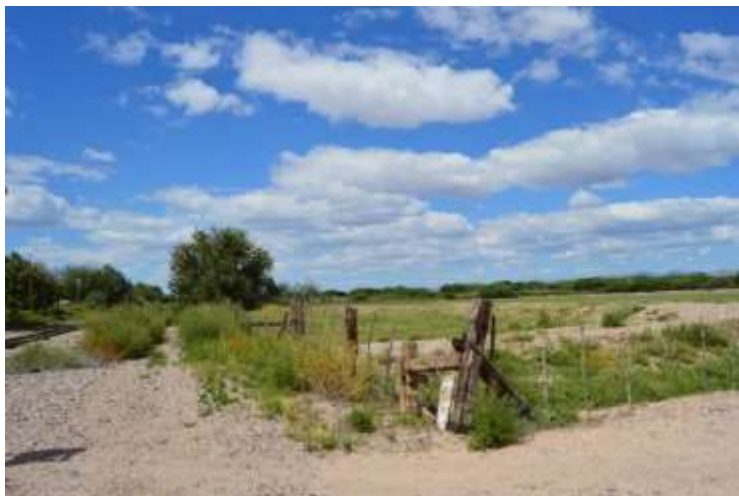
Figure 6-Section of Agricultural Dike

The first section of the dike that NAU Crown Engineering visited is shown in Figure 6. The dike runs next to, and then ties in to the railroad tracks that go through town. The left side of the picture shows the railroad tracks, and the right side shows the dike that is currently protecting Duncan. At this particular location, the group was able to see how the neighborhood behind the railroad tracks still experiences flooding. This means that the dike is not long enough. The levee that will be designed will need to tie in farther upstream.

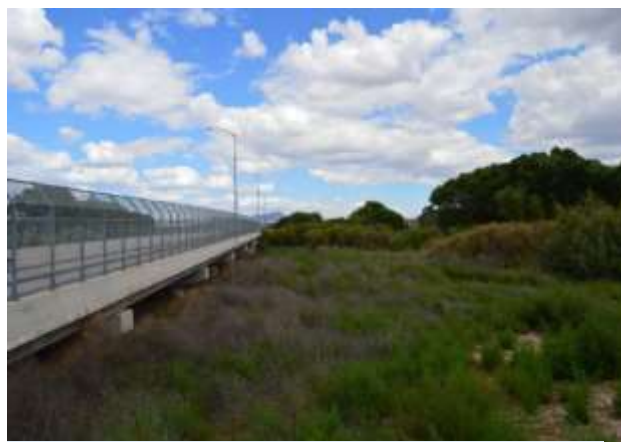
Figure 7-Highway 75 Bridge

The second location that the group was able to view was the intersection of the dike and the bridge. As shown in Figure 7, this area of the floodplain is covered heavily in vegetation. The three main types of vegetation in this reach of the Gila River floodplain are: willow, cottonwood trees, and tamarisk. The client led the way to the Gila River bed, and the group was able to see the river flowing at approximately 400cfs. This flow looked like a trickle through the area of undisturbed floodplain. The client estimated that the floodplain for the Gila River along this stretch is about 1,300 feet wide. Figure 8 shows the Gila River as it was flowing on September 25<sup>th</sup>, 2015. This 400cfs flow can be compared to the 48,000cfs flow will be used as the 100 year flood. Imagining a flow rate 120 times greater than what is shown in Figure 8 flowing through the confines of the dike, it is easy to understand how the current dike fails after large storm events. It is also easy to see how these failures cause severe damage to the town.

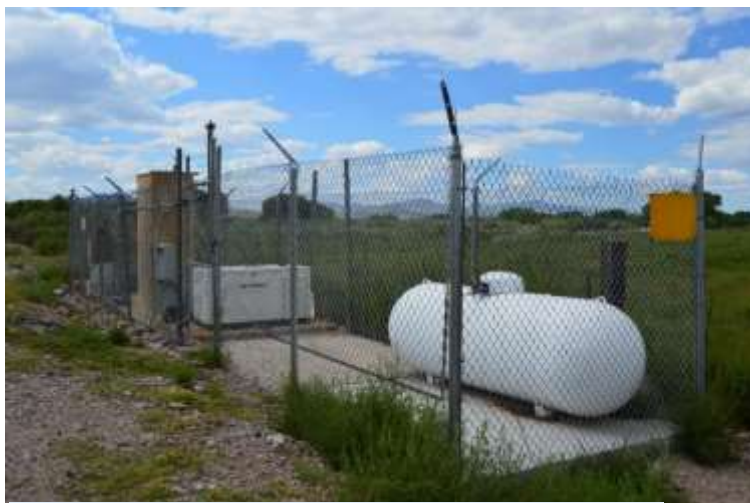
Figure 9-Wastewater Treatment Plant

After the bridge, the group visited the old wastewater treatment plant. Figure 9 shows the surrounding area. Although the river was barely visible at this location, Mr. Ronnerud explained that this area becomes completely submerged in large flood events. This submersion causes potential contamination issues in the Gila River. Putting an end to this contamination output will help towns downstream of this wastewater plant to have cleaner, safer water.

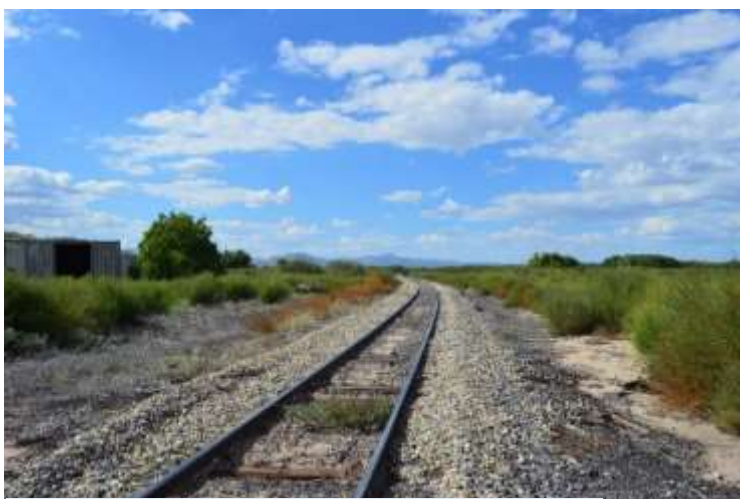
Figure 10-Downstream Tie in Location

The last location that the team visited on this site assessment was the other end of the dike. This side of the dike also ties into the railroad tracks. Figure 10 illustrates this tie-in location. This area is flat, and flood water occasionally comes over the dike and floods the road near the town's high school.
