Agassiz Consulting Engineers Sinclair Wash Riparian Habitat Enhancement Feasibility Study

FAHAD ALYATAMA MAYA HUFFMAN MOHAMMED ALMOUSAWI SIERRA HOLLOWAY SKYLER QUINN

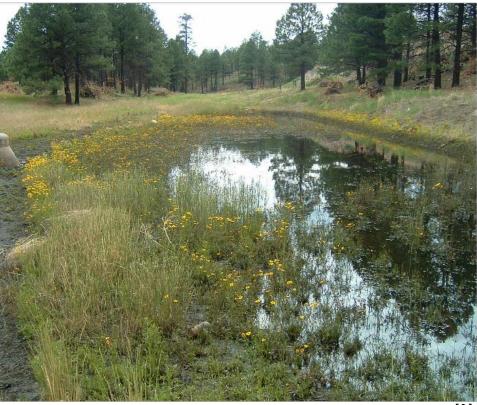
Figure 2: West View of Sinclair Wash

- Erosion at Flagstaff Urban Trail System crossing
- Sedimentation build up
- Scour pools downstream of culverts
- Invasive Species
- Unwanted ponding
- Steep side slopes

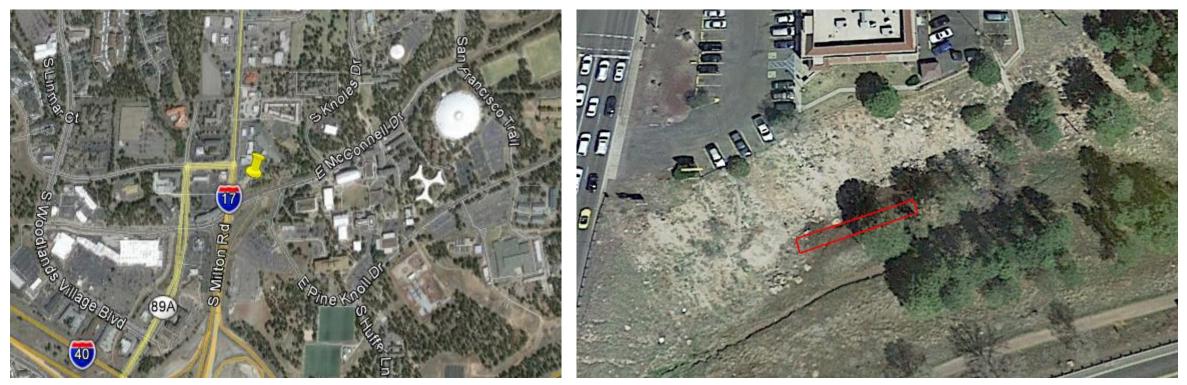
Figure 9: Location of Proposed Detention Basin

Area of Interest #2 (E. McConnell Dr. and S. Milton Rd.)

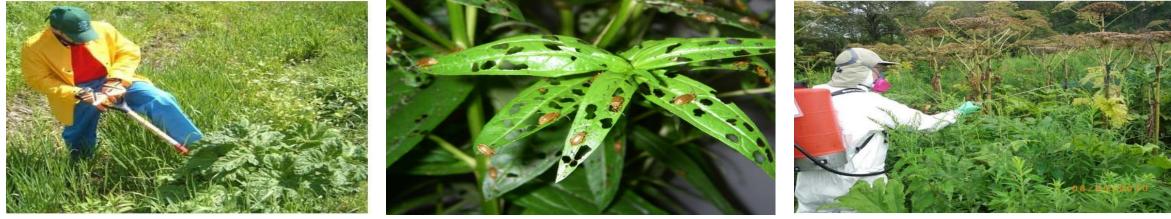
Figure 22: Physical removal

Figure 23: Biological removal

Figure 24: Chemical removal

Physical Removal (10)	Biological Removal (10)	Chemical Removal (10)
Feasible	9	7	7
Cost	6	5	4
Environmental Impact	9	2	2
Total	24	14	13
