SINCLAIR WASH RIPARIAN HABITAT ENHANCEMENT FEASIBILITY STUDY

Agassiz Consulting Engineers 100% Design Report

May 12, 2016

CENE 486: SINCLAIR WASH ENHANCEMENT

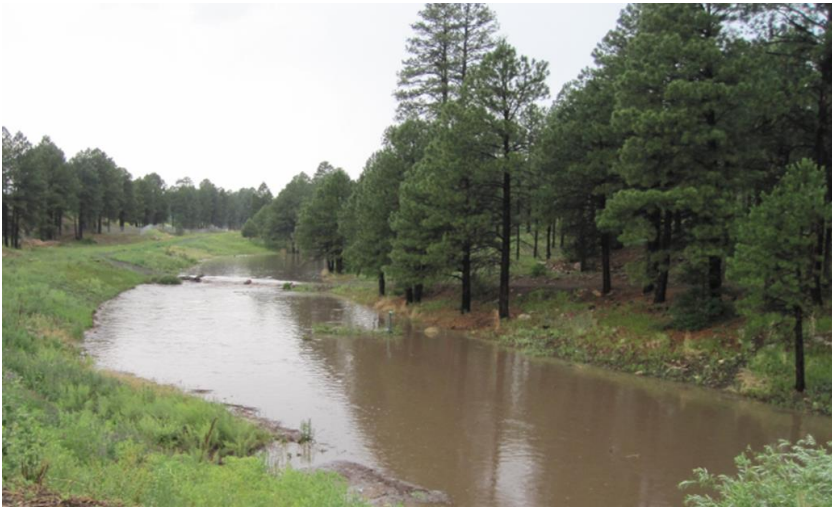
Figure 2: Flooding of FUTS Trail by Lone Tree Road

from flood flows have changed the geomorphology and stability of the channel. Sinclair Wash east of San Francisco Street has shown signs of flooding during major storm events and has a tendency to overflow the Flagstaff Urban Trail System, creating a hazard to trail users. This is shown in Figure 2 below. Some of the reaches of Sinclair Wash have been reported to show signs of over sedimentation by the existing trail system. Garbage has piled up in front of and behind culverts and is affecting the water flow in the wash. The pooling of water creates an environment for harmful bacteria to grow and mosquitos to breed. An example of this is shown

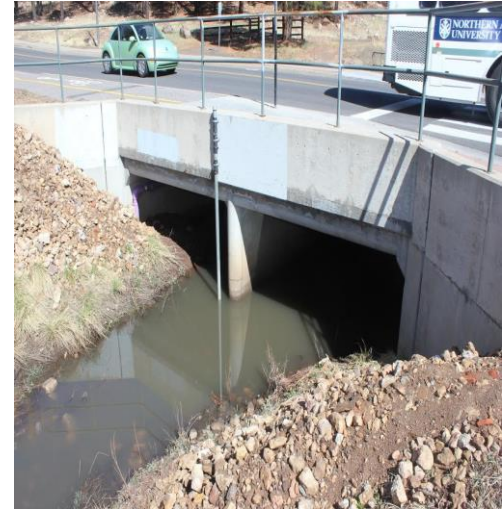
Figure 3: Culvert under South Knoles Drive

Many of the stream crossing infrastructure in the channel attenuate flows or are lacking maintenance and will be evaluated for redesign and replacement. Sedimentation buildup from low flows as well as erosion and scouring

below in Figure 3.

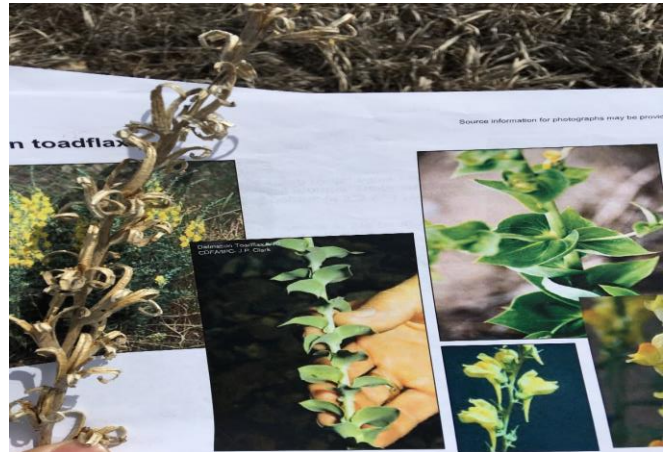
Figure 4: Toadflax found in Sinclair vs Example Picture Comparison

The previous Sinclair Wash capstone team 2014-2015 identified invasive species in the wash which included diffuse knapweed, yellow starthistle, dalmation toadflax, prickly lettuce, kochia, cheatgrass, and diffuse knapweed. These invasive species have been detrimental to the health of the channel and need to be mitigated in order to preserve the native wildlife along Sinclair Wash.
