**TRIP REPORT
FIELD EVALUATION
AND
RECOMMENDATIONS**

**ALLAN LAKE WETLAND RESTORATION
USDA Coconino National Forest**

Prepared for:
Arizona Department of Game and Fish
February 2004

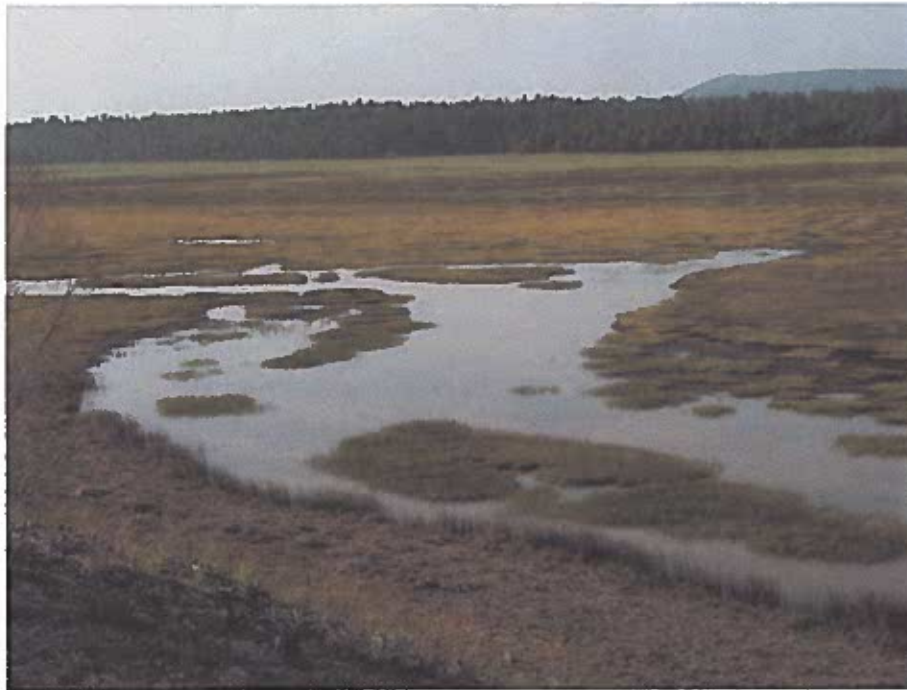
Figure 2. Lake Mary wet meadow. Photo taken in May 2003 (NCD).

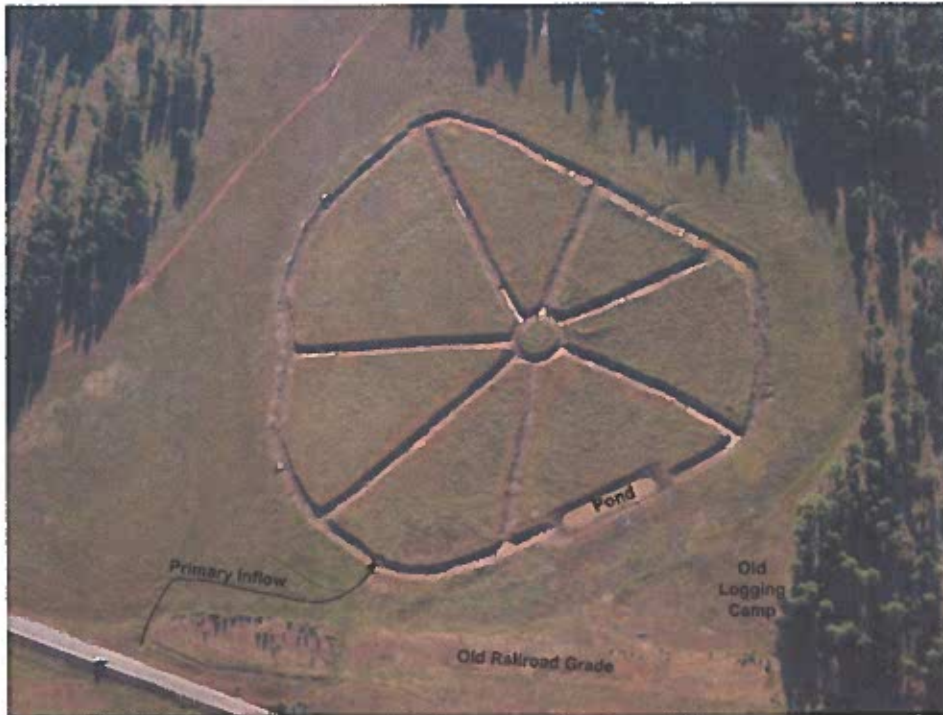
Allan Lake was originally an ephemeral wetland within a small closed basin. During the late 1800's a logging camp was established adjacent to the Lake and a pond was dug to provide water. In 1986 explosives were used to excavate a series of canals in the rough shape of a wagon wheel (Figure 3). The figure is nearly 600 to 800 feet in diameter. Individual channels are approximately 30 feet wide and 5 to 6 feet deep (Figure 4).

Figure 3. Allan Lake aerial view. Original logging camp pond is in the lower right part of the "wheel". Photo taken in October 2003 (NCD).

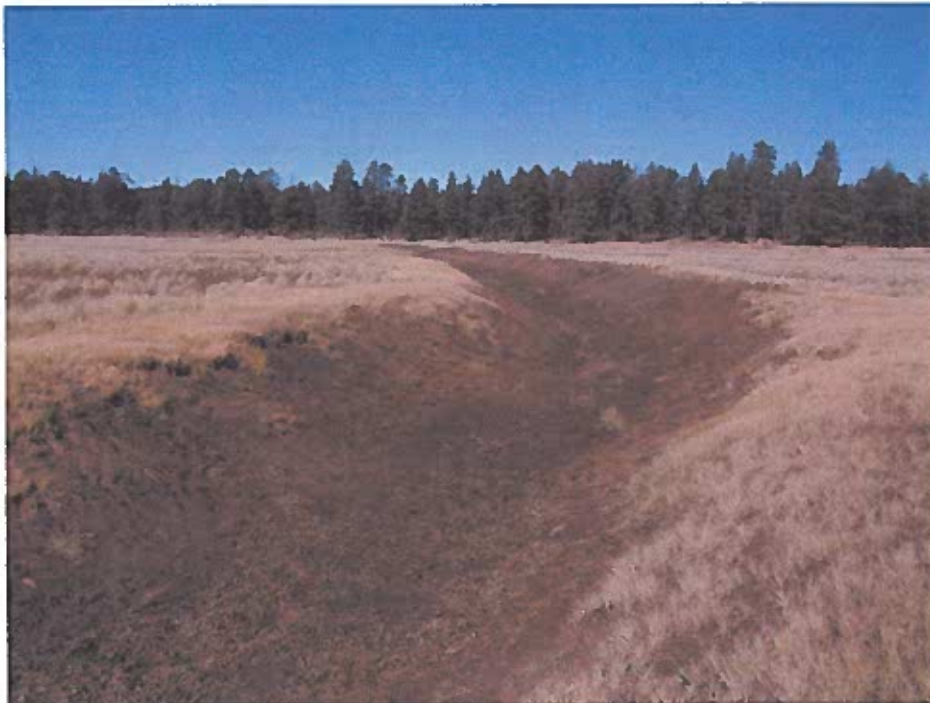
Figure 4. Allan Lake excavated channel. Note the lack of moisture and vegetation in the channel sides & bottom. Photo taken in November 2004 (NCD).

The logic of the shape of the excavation is not known but the feature was almost certainly excavated to create nesting islands and increase open surface water. In that objective it failed, as the excavated channels no longer hold water for any appreciable time. As a result, the ground water table is commonly 5 to 6 feet or more below the basin/meadow floor. Lateral moisture movement by capillary action is restricted by the channel network. Wetland vegetation can no longer reach the common ground water depth and upland grass species have replaced them.

- 1) Excavations may have penetrated the thin clays that sealed the basin. Once broken, the basin floor can no longer hold water. An attempt to reseal the channels using bentonite was unsuccessful.
- 2) Explosives used to blast/excavate the channels may have fractured the impervious bottom allowing water to soak through. The fact that the original pond, dug by hand over a century ago still holds water despite its greater depth lends credence to this possibility.

- **Restore Natural Water Depths:** The ground water table needs to be elevated to the historic condition for wetland vegetation to be re-established. This requires filling the excavated channels to a higher elevation.
- **Reduce Seepage Loss:** Plans for reducing seepage losses by sealing the basin bottom should be part of the design components. The problem of reducing seepage losses is one of reducing the permeability of the soils to a point where the losses become tolerable. The failure of previous efforts using bentonite makes a simple sealing of the existing channels difficult. Filling the excavated channels in compacted layers and using chemical additives for sealing may be used to decrease seepage.

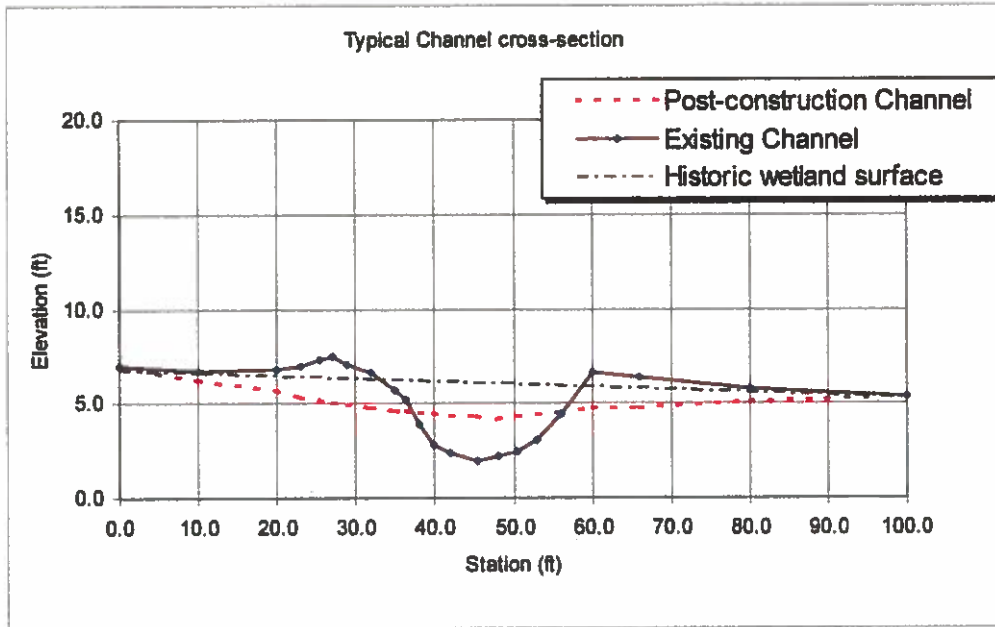
1. **Do Nothing:** The old logging pond would continue to hold water and the excavated channels will continue to have excessive seepage losses. The vegetation in the basin would remain upland grass species. Existing channels are shown in Figure 5 Cross-Section and Figure 6 Estimated Water Table.

2. **Completely fill existing channels:** The old logging pond would remain. All channels would be filled back to the basin floor elevation. Total earthwork volume is about 16,000 cy. Because the explosives blew the channel material to powder (i.e. smithereens) there is not sufficient earthfill available to fill channels back historic elevation. (See historic wetland surface in Figure 5 Cross-Section.)

Figure 5. Cross-Section (Showing existing, historic wetland surface, and proposed partially filled channel)

3. **Partially fill existing channels:** The old logging pond would remain. All channels would be filled and compacted in layers upto 2.5 to 3 feet above the existing channel elevation. This would create 100 feet wide shallow depressions (around 2 feet deep). Total earthwork volume is about 9,500 cy. Earthfill would be available from the widening of the channels. The post construction channels are shown Figure 5 and Figure 6. The water table should rise to within 2 feet of the original basin (see Figure 6.) By keeping the existing pond there may be additional seepage loss. A chemical additive (vegetable oil based resinous polymer emulsion) for sealing the shallow depressions may be used.

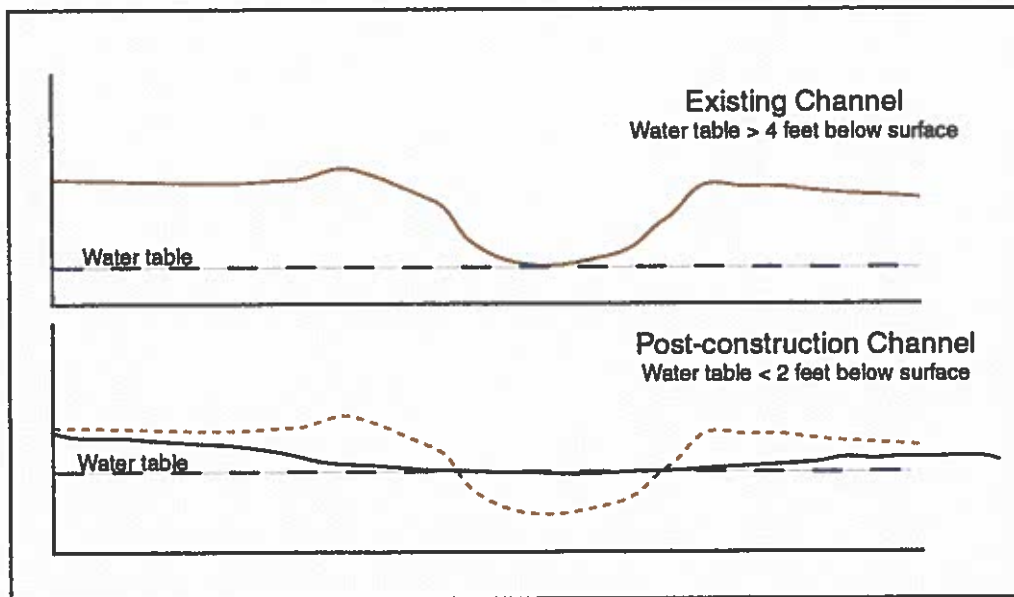
Figure 6. Estimated Water Table (existing channel and post-construction channel)
