ALLAN LAKE RESTORATION

CENE 486

Capstone Presentation

4/28/17

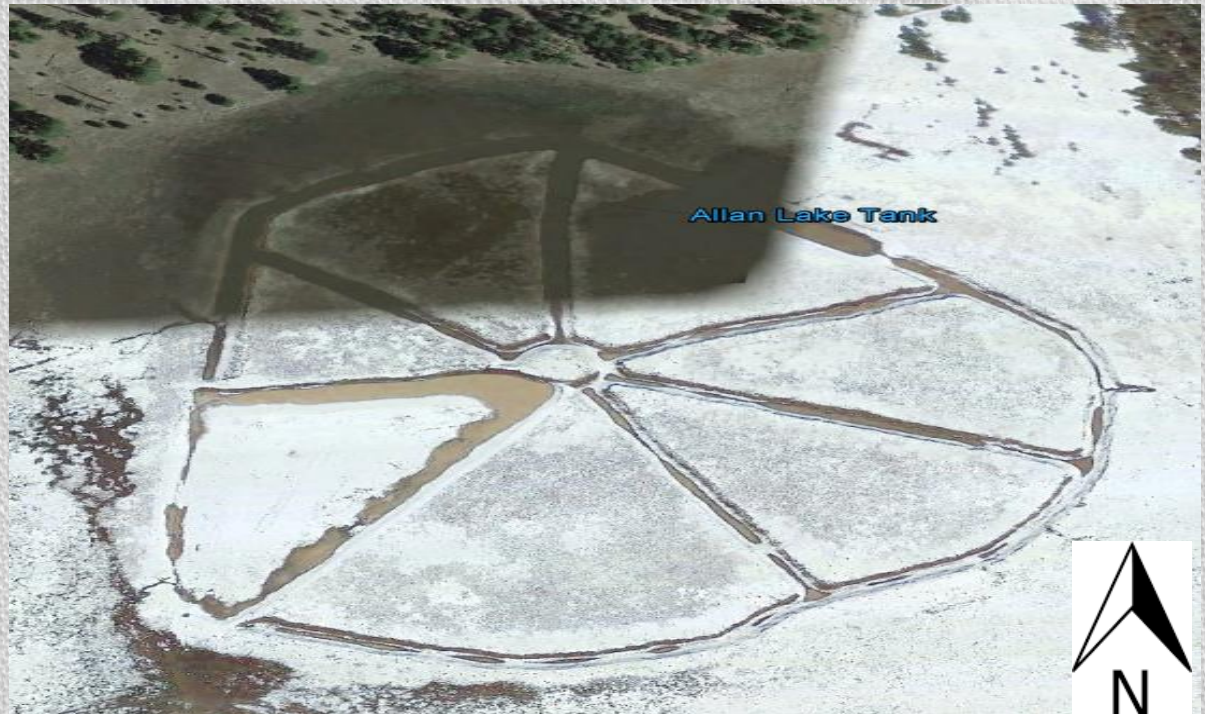
Figure 2: Allan Lake aerial picture [1]

- Disturbed/penetrated clay layer
- Less native wetland plants
- Area within trenches is 17 acres
- The trenches are about 5-6' deep

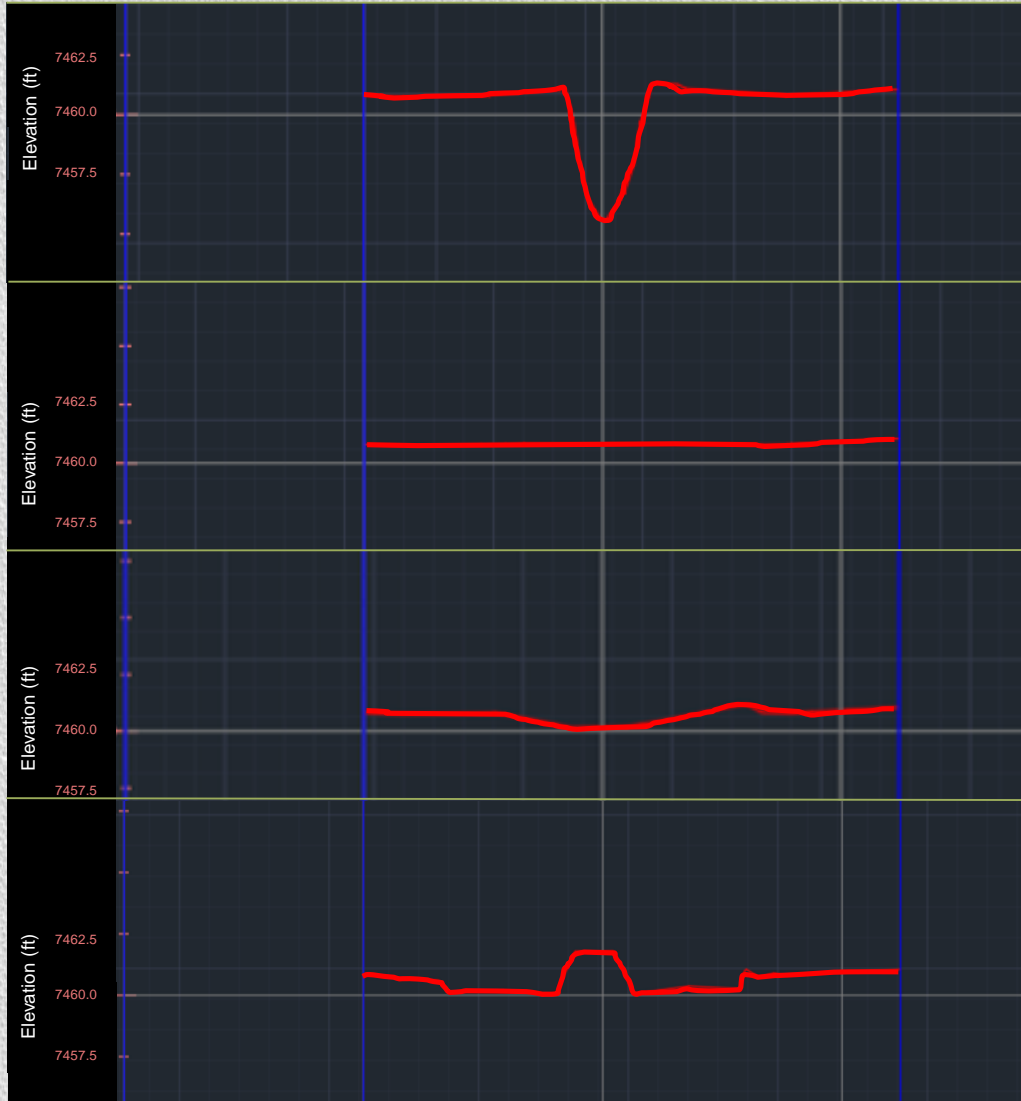
Figure 11: Current trenches

Figure 12: Pre-existing grade (estimated)

Figure 13: Alternative 1

Figure 14: Alternative 2

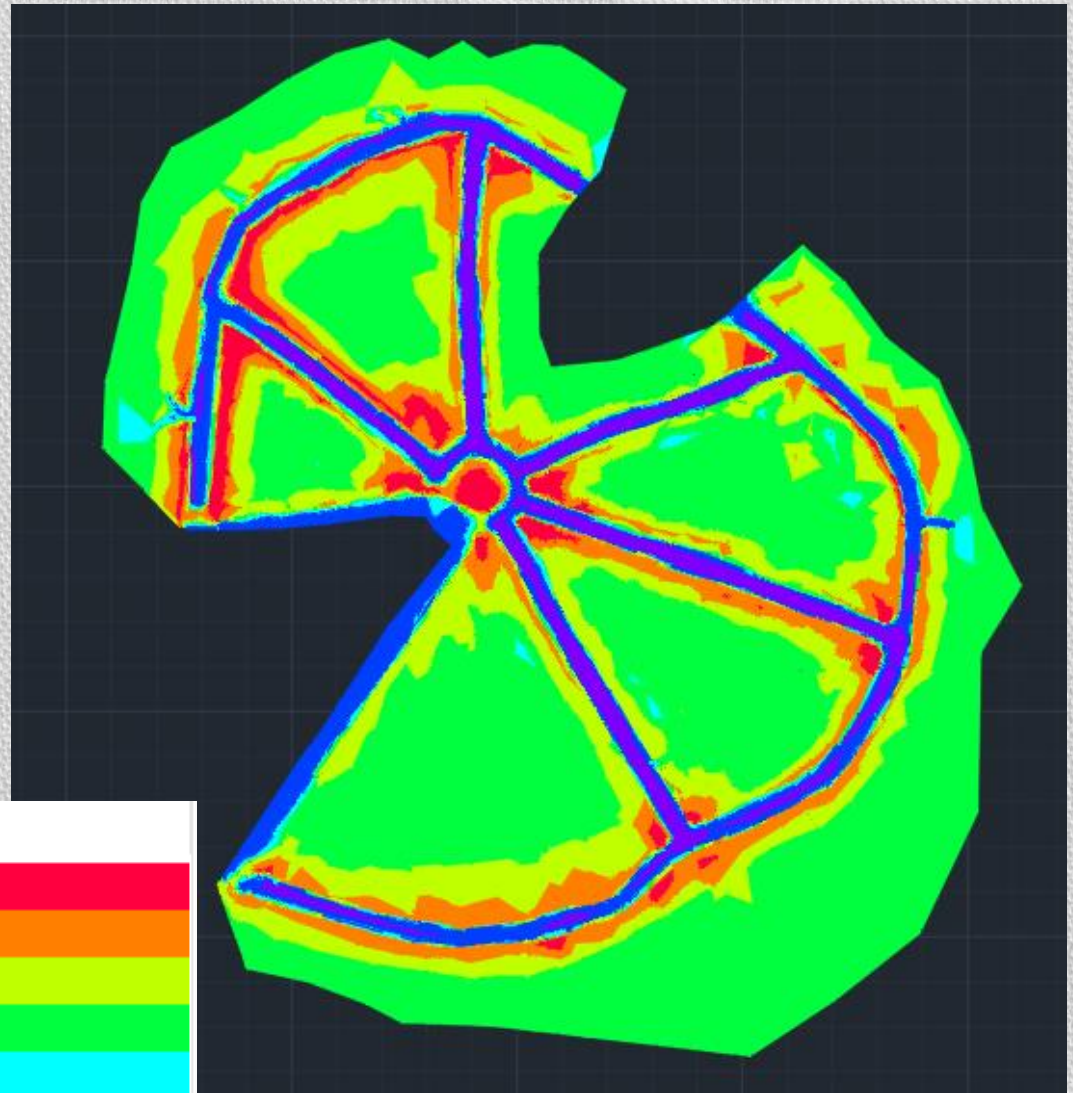
- 21,000 yd³ clay cut
- 21,000 yd³ clay fill
- 12,800 yd³ topsoil cut
- 12,800 yd³ topsoil fill

Figure 19: Proposed cut and fill

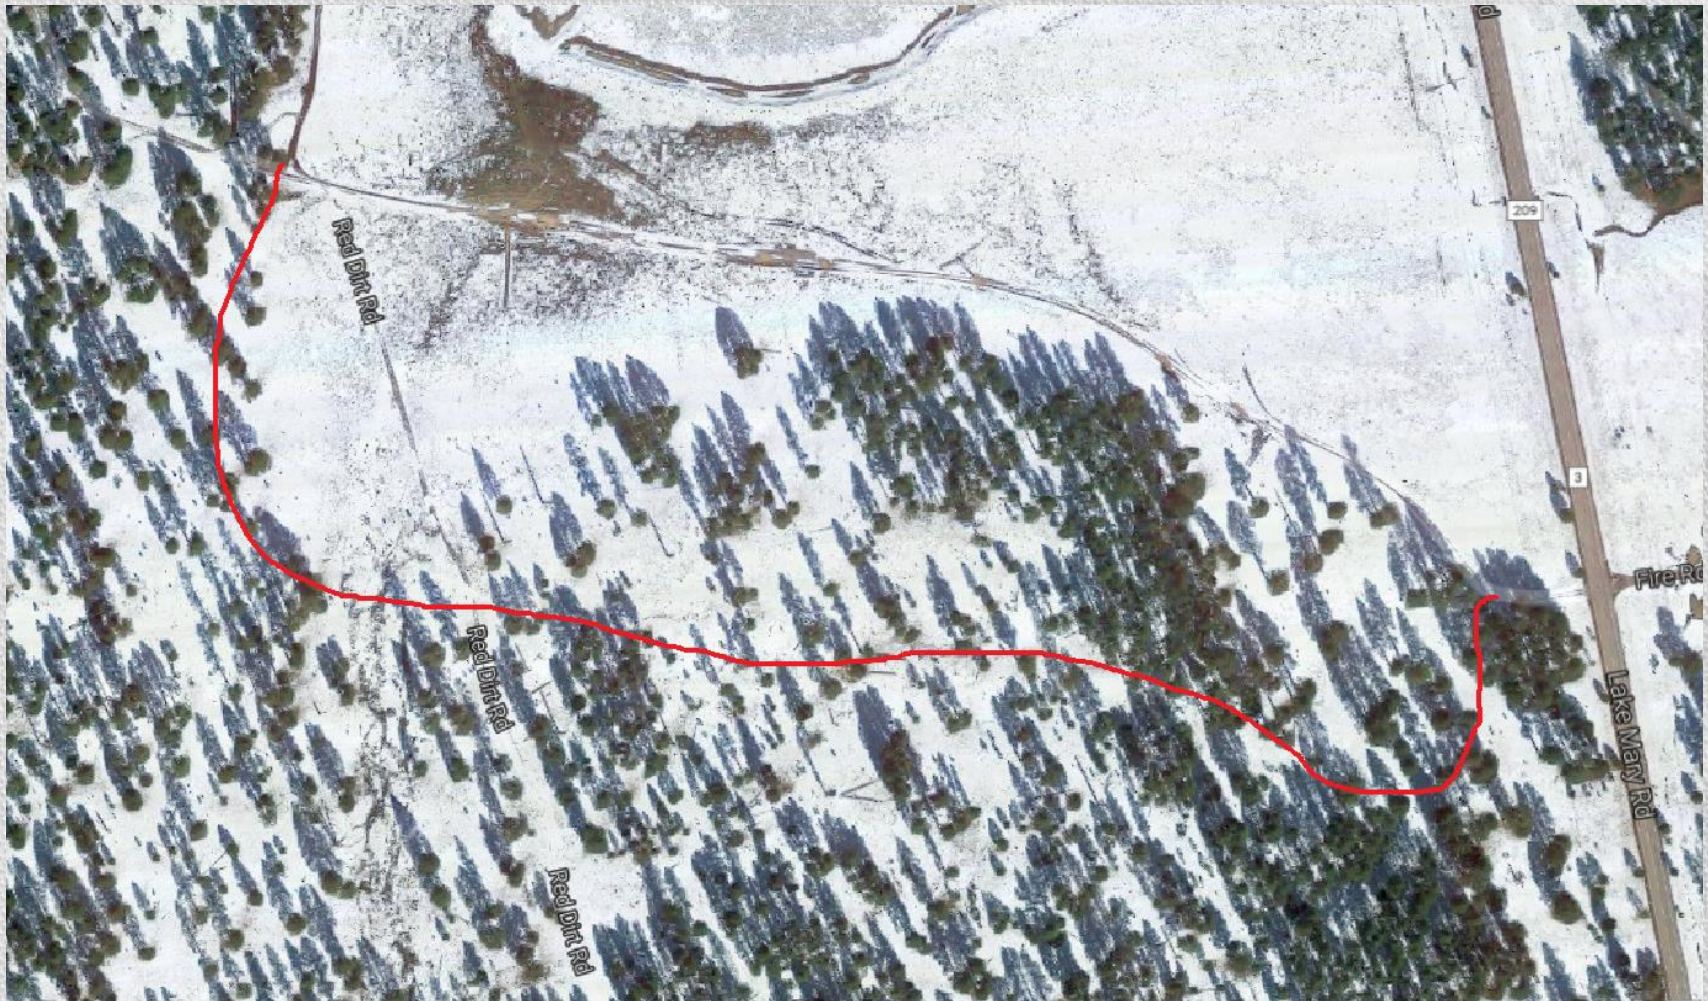
Image 2: Proposed route [11]

- Survey of the proposed road route
- Acquire permits for earthwork
- Building a dam
- Build a fence to keep elk and bovine out of wetland
