DUNCAN FLOOD MITIGATION ANALYSIS

Final Presentation
December 9, 2016

- Client
 - Phil Ronnerud, P.E.,
Greenlee County Engineer
- Technical Advisor
 - Tom Loomis, P.E., RLS,
CFM, Flood Control District
of Maricopa County
- Request
 - Analyze possible mitigation
measures for Duncan
flooding
- Purpose
 - Provide analysis for
structure-based, vegetation
management, &
encroachment removal

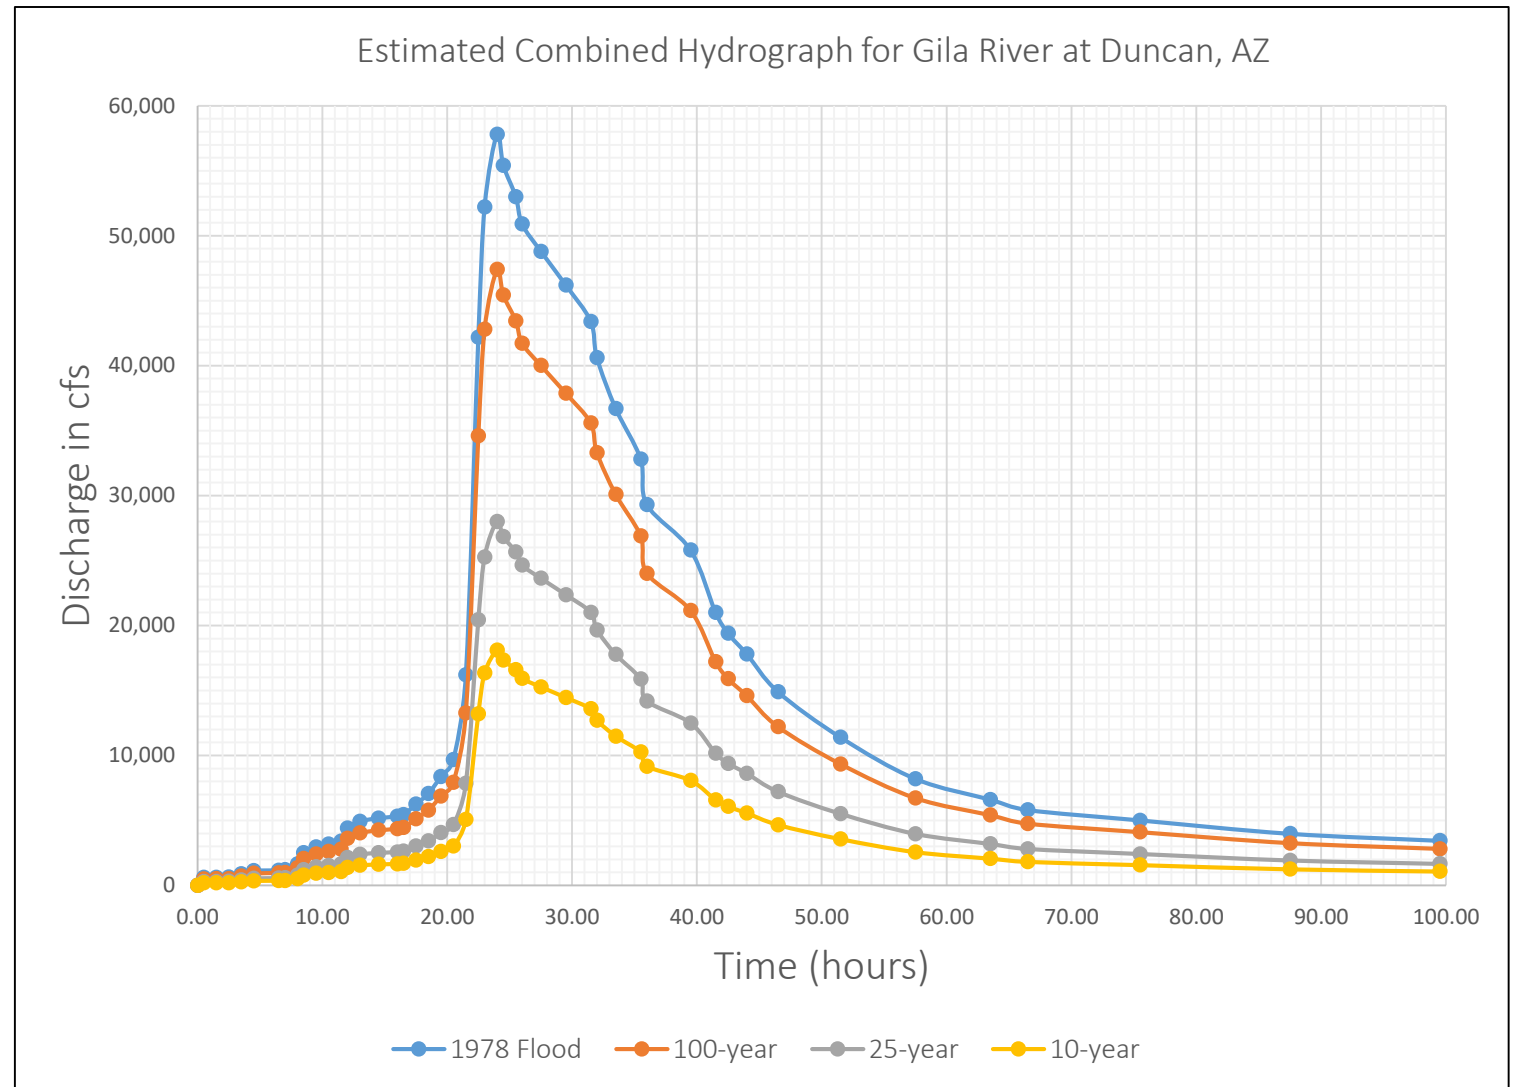
- 1978 Flow: 57,800 cfs
- 100-year Flow: 47,400 cfs
- 25-year Flow: 28,000 cfs
- 10-year Flow: 18,100 cfs

Figure 4: Hydrograph for varied flows

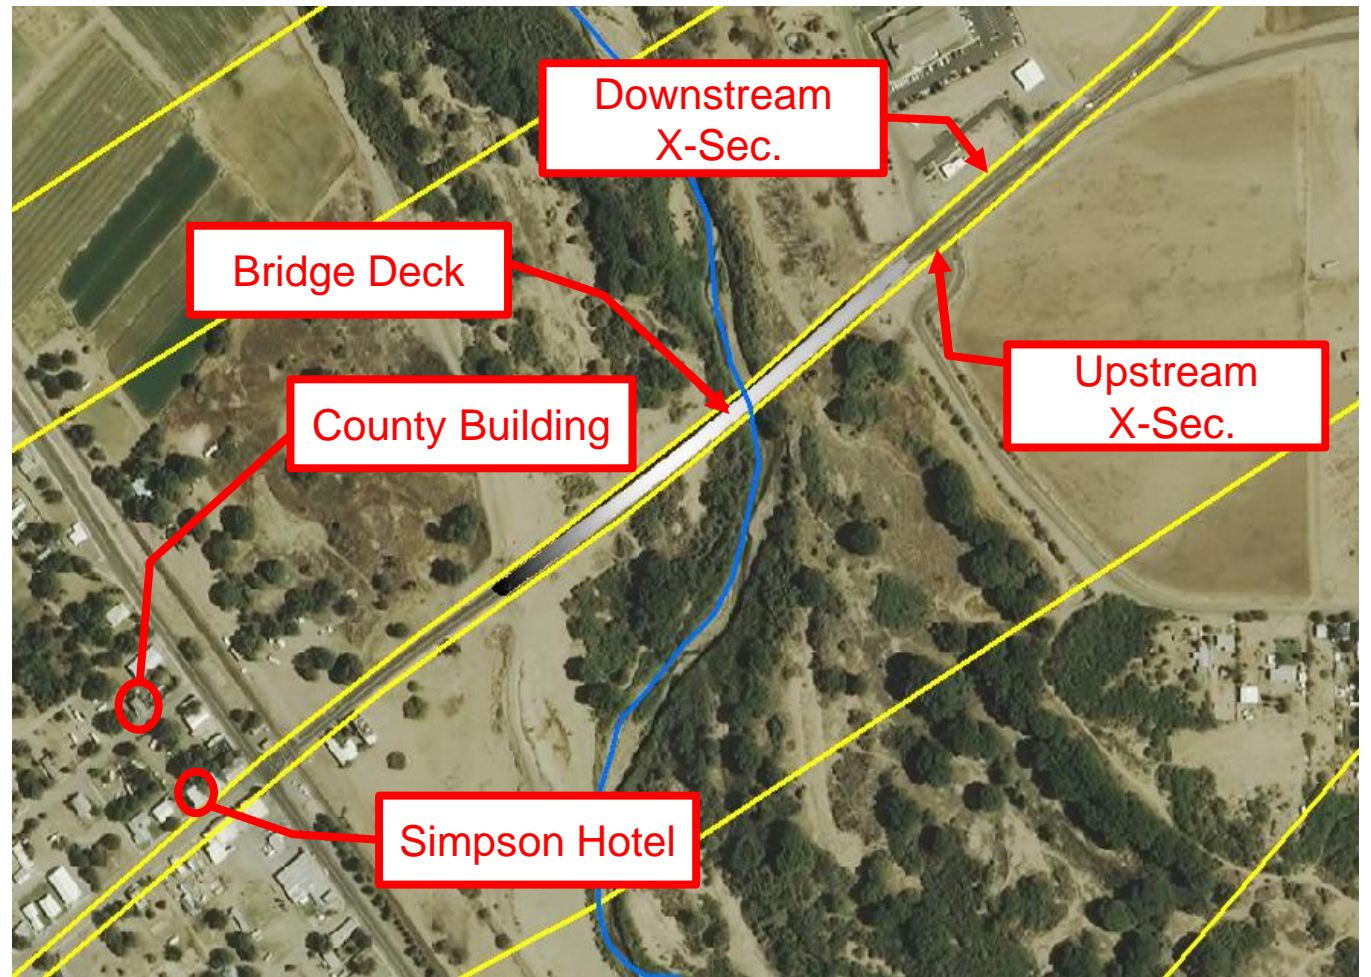
- ArcGIS
 - Cross-sections close to bridge
 - Added Vertices
- Site Visit
 - Simpson Hotel
 - High Water Mark = 9.3 ft
 - Low Water Mark = 2.4 ft
 - County Building
 - High Water Mark = 6.5 ft
 - Low Water Mark = 1.8 ft

Figure 5: Bridge Deck Cross Sections

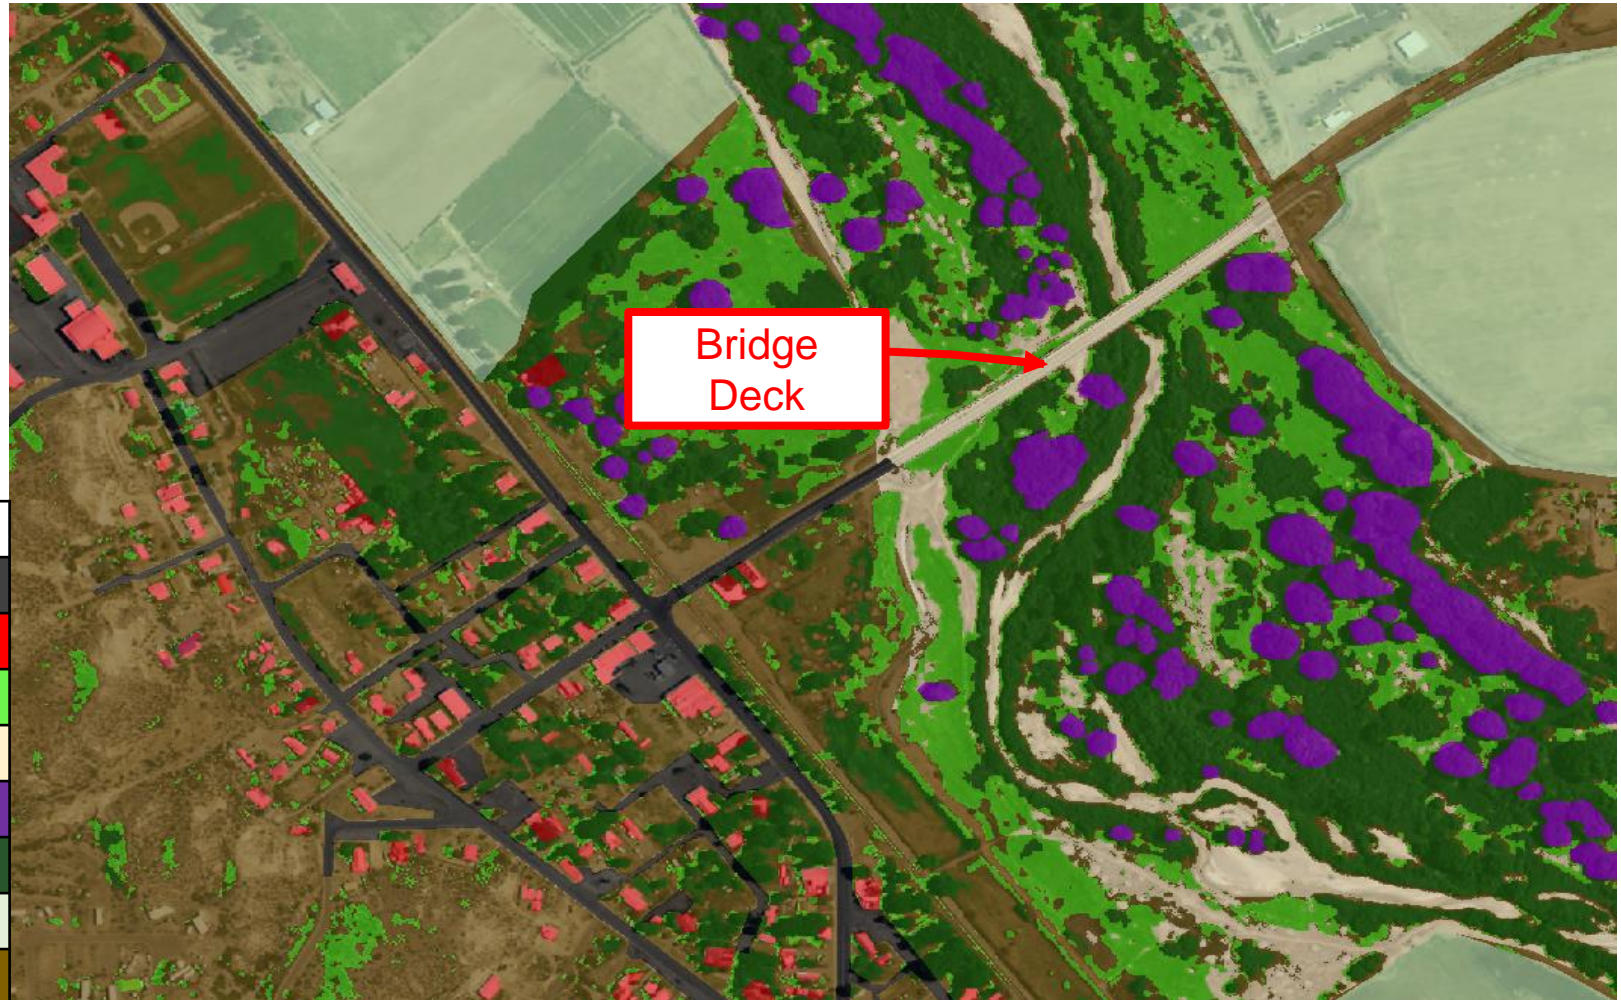
- ArcGIS
 - Surface feature characterization
 - Defines spatially-varied roughness
 - Defines flow obstructions

Priority	
1	Paved Surface	Grey
2	Buildings	Red
3	Low Vegetation	Light Green
4	Wash Bottom	Yellow
5	Cottonwood	Purple
6	Heavy Vegetation	Dark Green
7	Agriculture	Light Green
8	Bare Ground	Brown

Figure 6: Surface feature Characterization

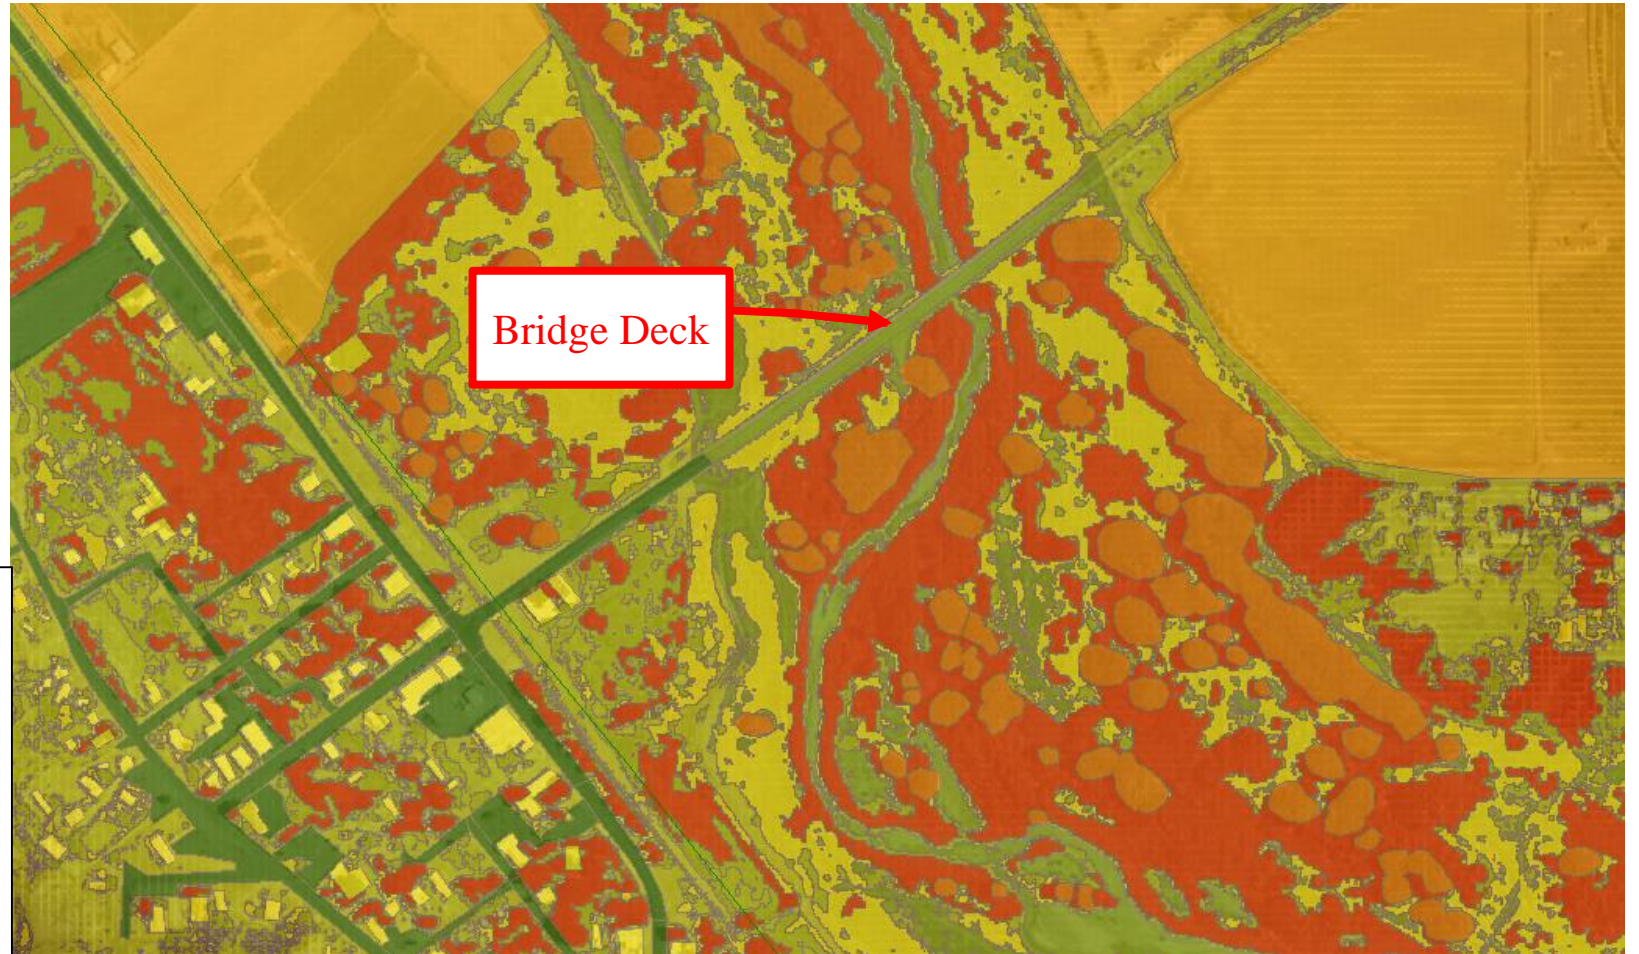
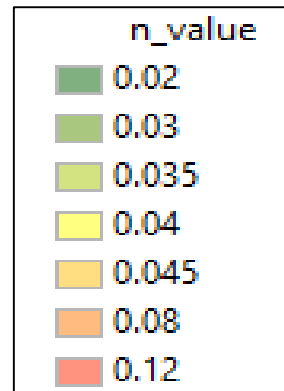
- Friction Loss (Manning's n)
 - Obtained n -value from manuals and technical advisor input
 - The n -values points varies along each surface feature characterization

Figure 7: ArcGIS n-values layer

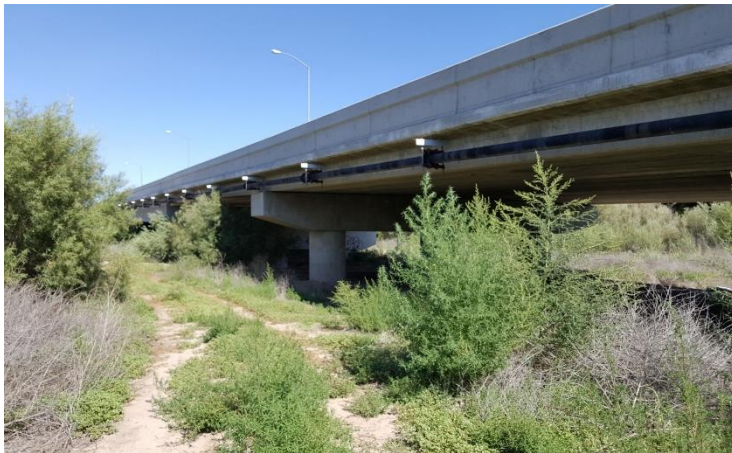
- HEC-RAS
 - Overbanks
 - Bridge deck elevation
 - Model Piers
 - Change in Bridge Capacity

Figure 8: Downstream view of bridge

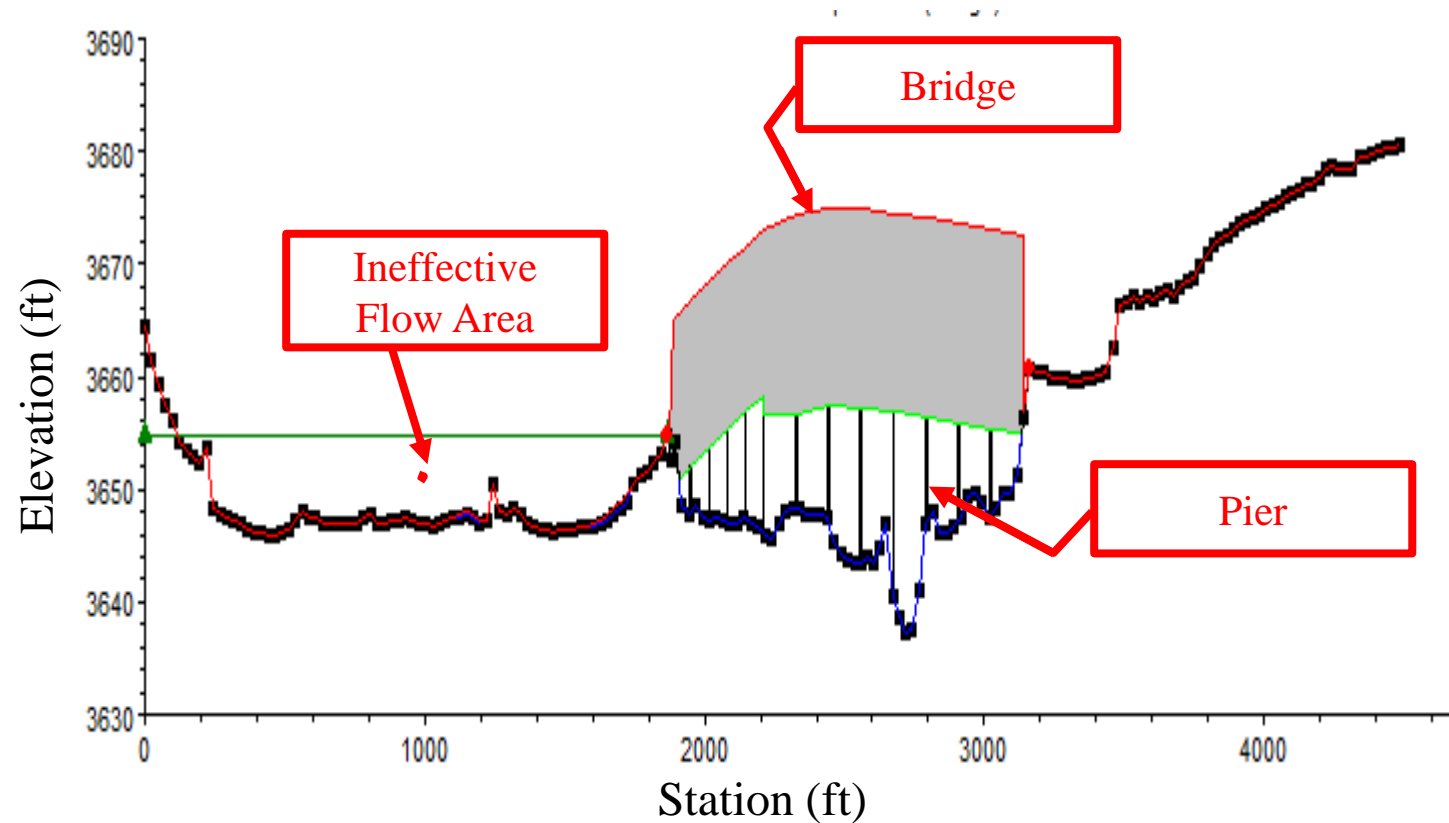
Figure 9: Upstream cross section view with bridge and piers

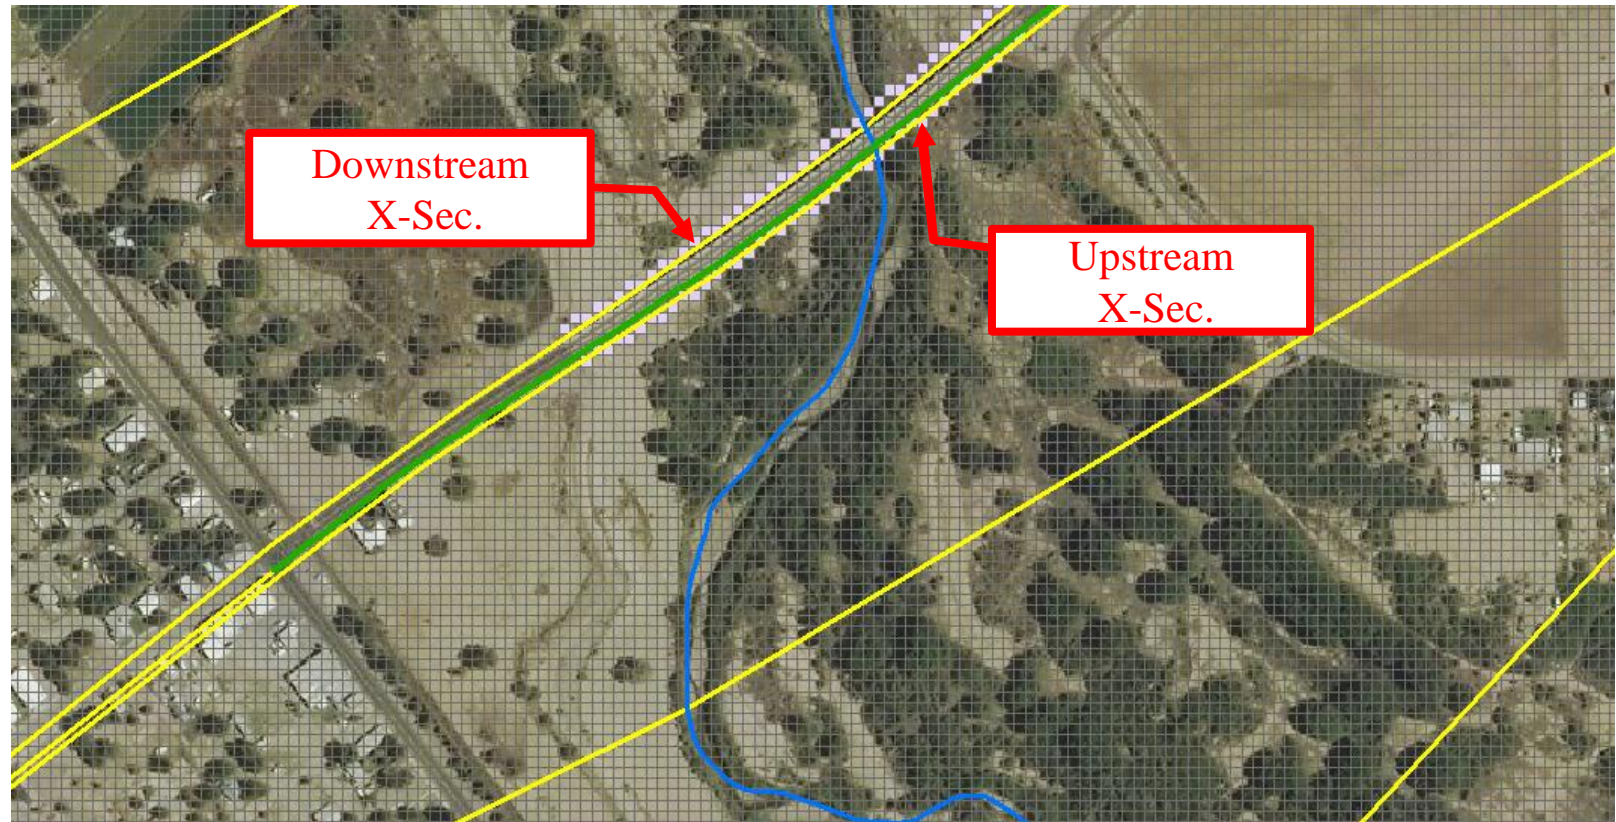
- HEC-RAS
 - Define depth vs. discharge
 - Model hydraulic structures
- Flo 2D Pro Model
 - 271,399 grids
 - Allows manual flow input

Figure 10: 25' x 25' Grids- ArcMap

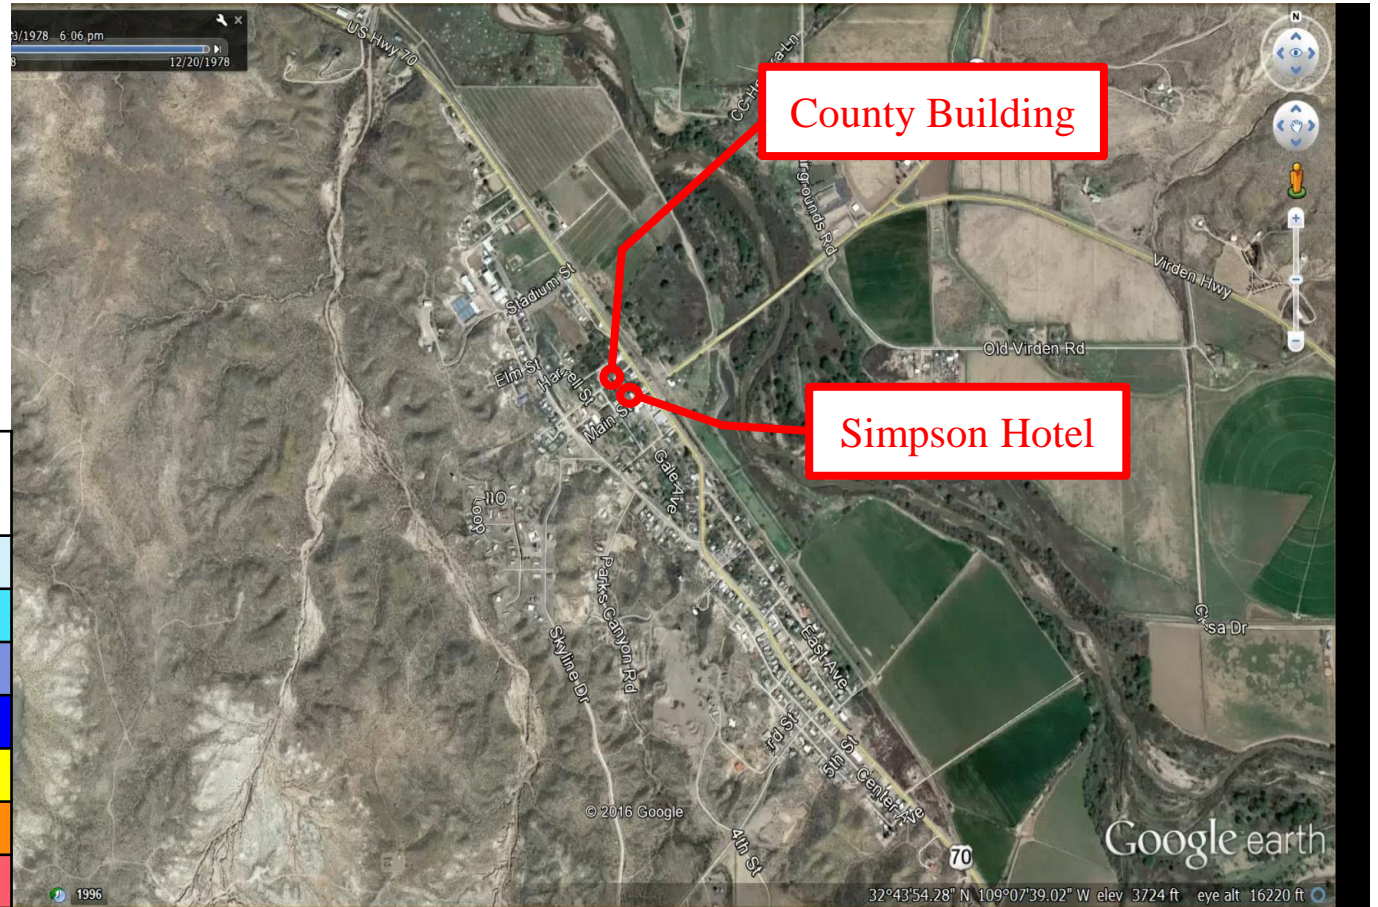
- 1978 Flow: 57,800 cfs
- 23 hours to reach town
- 25 hours to reach max depth in town

Max Depth Range (ft)	
0 - 1	
0.5 - 1	
1 - 2.5	
2.5 - 5	
5 - 7.5	
7.5 - 10	
10 - 24

Figure 11: Maximum depth results of existing conditions model

Table 1: Survey data from site visit

Location	Max Survey Depth (ft)	Model Depth (ft)
Simpson Hotel	9.3	7.5
County Building	6.5	7.5

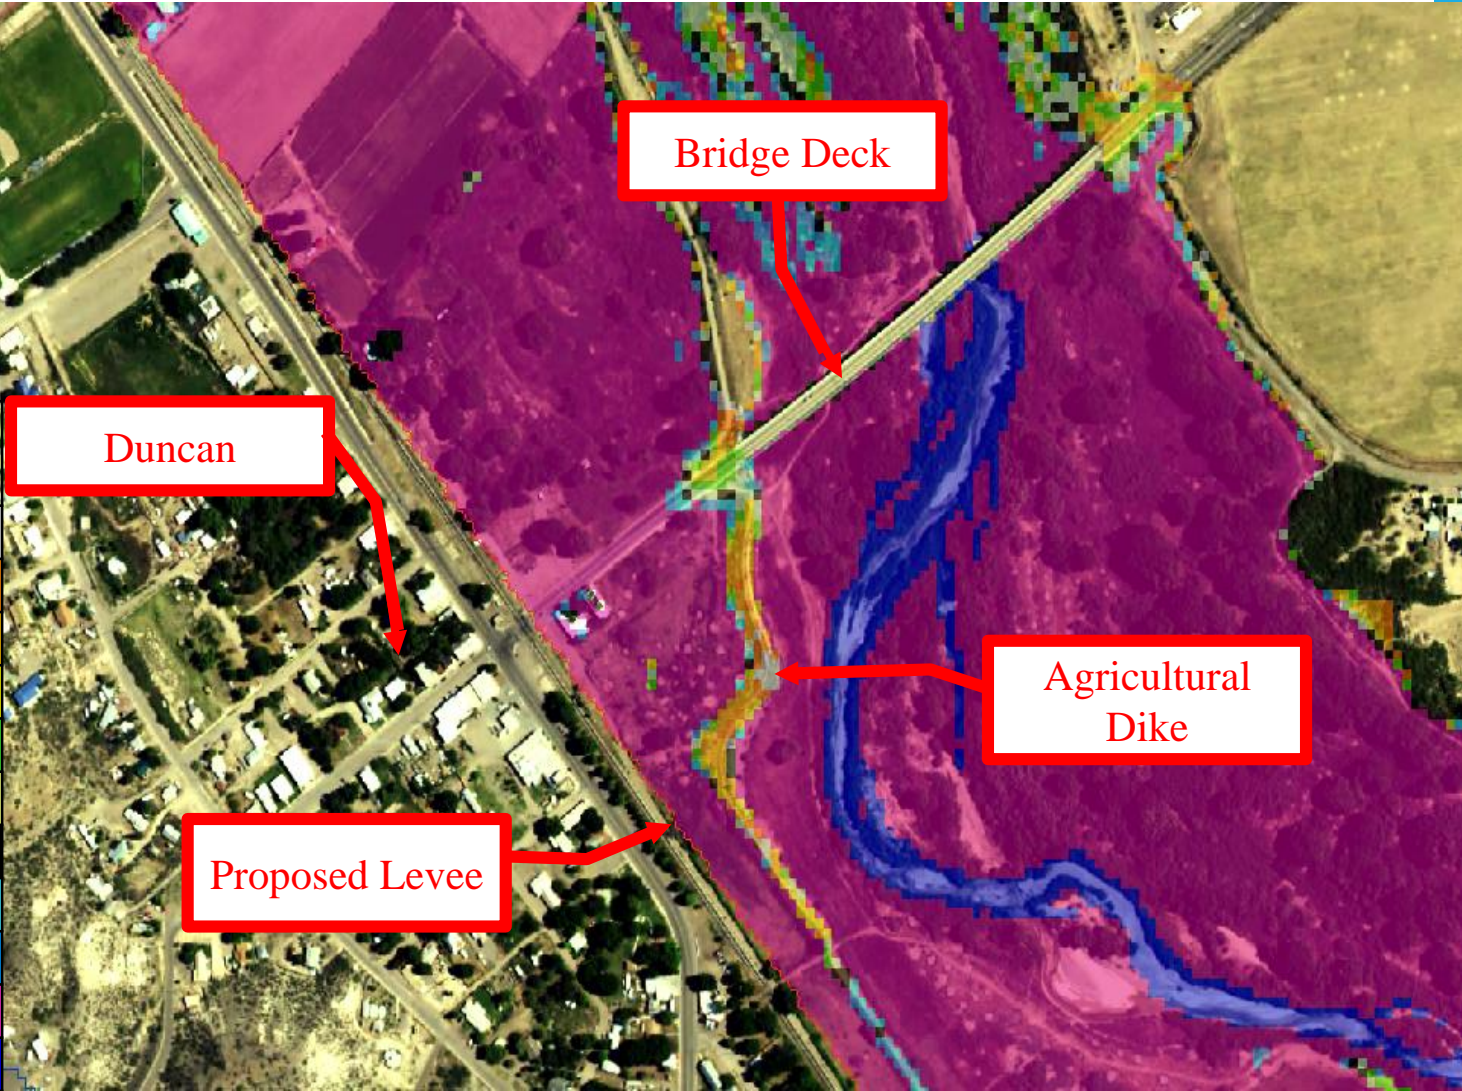
- Proposed levee with Gila river restoration and WWTF removed
- 100-year Flow: 47,400 cfs
- Levee height: 20 ft

Max Depth Range (ft)	
0.0005 - 0.16	Grey
0.16 - 0.5	Orange
0.5 - 1	Yellow
1 - 1.5	Light Green
1.5 - 2	Green
2 - 2.5	Light Yellow
2.5 - 3	Black
3 - 3.5	Cyan
3.5 - 4	Blue
4 - 17	Magenta
17 - 50	Dark Blue

Figure 14 : Proposed levee with Gila river restoration and WWTF removal
