KUAE Consulting Engineers Final Report

Northern Arizona University

Subject: Sinclair Wash Riparian Habitat Enhancement Feasibility Study: Final Report

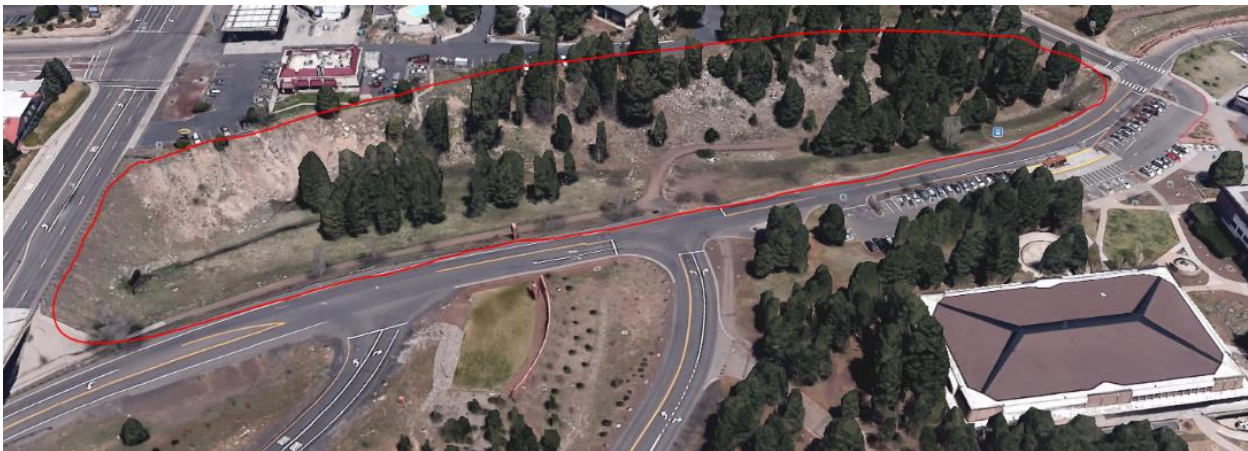
**Figure 2: Aerial Image of the Reach**

The reach is within the campus of Northern Arizona University and the city of Flagstaff limits. It is located at the intersection of East McConnell Drive and the State Highway, I-17. The reach total length is 814 ft. Figure 1 shows the location of the chosen reach within the city limit. Figure 2 below shows the detailed aerial photo of the reach.

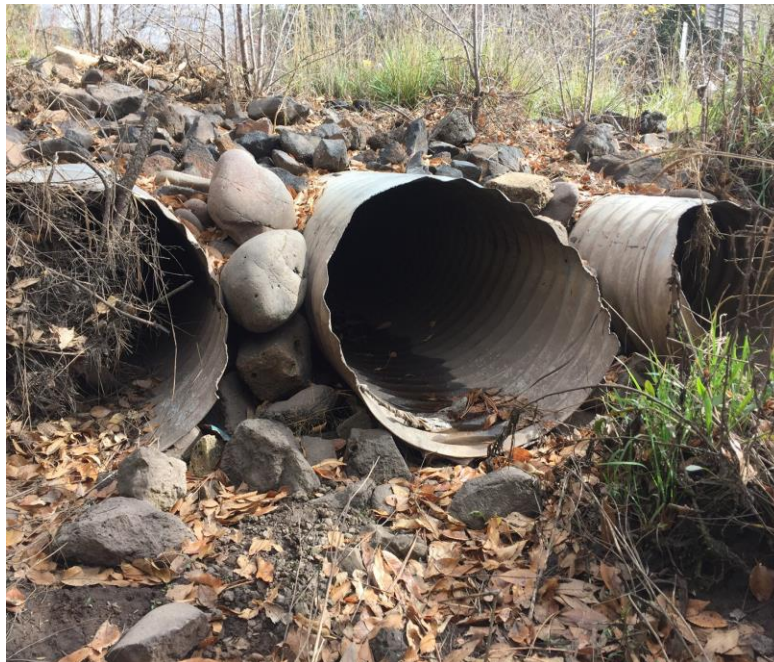
**Figure 3: FUT Culvert**

The overall condition of the reach is in a decreasing manner. This is due to its location that is within the campus of Northern Arizona University, which make the reach under a lot of urban development changes and modifications leading to the reach losing its natural health. The reach shows signs of flooding during storms events, which create a hazard on the life of FUT user. It has several infrastructure utilities including culverts and valve boxes. Conditions of the culverts are acceptable overall but some culverts need maintenance such as the one shown in Figure 2. Figure 3 shows an example of the open valve boxes that also need to be closed on maintained due to safety concerns. Furthermore the team noticed a 1.5 feet deep scour pool located downstream of the Flagstaff Urban Trail system trail. Figure 4 shows the scour pool.

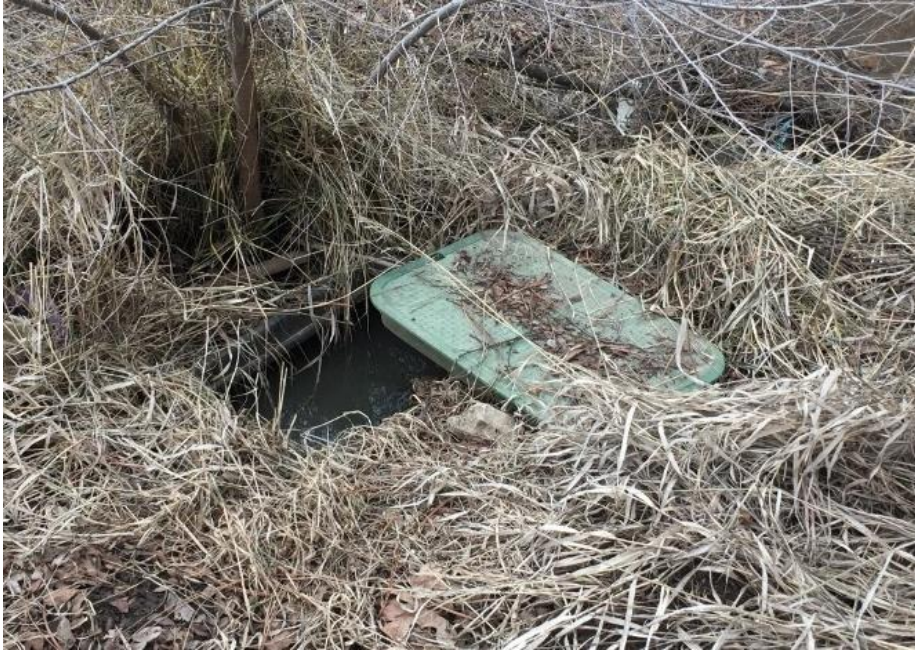
**Figure 4: open Valve Box**

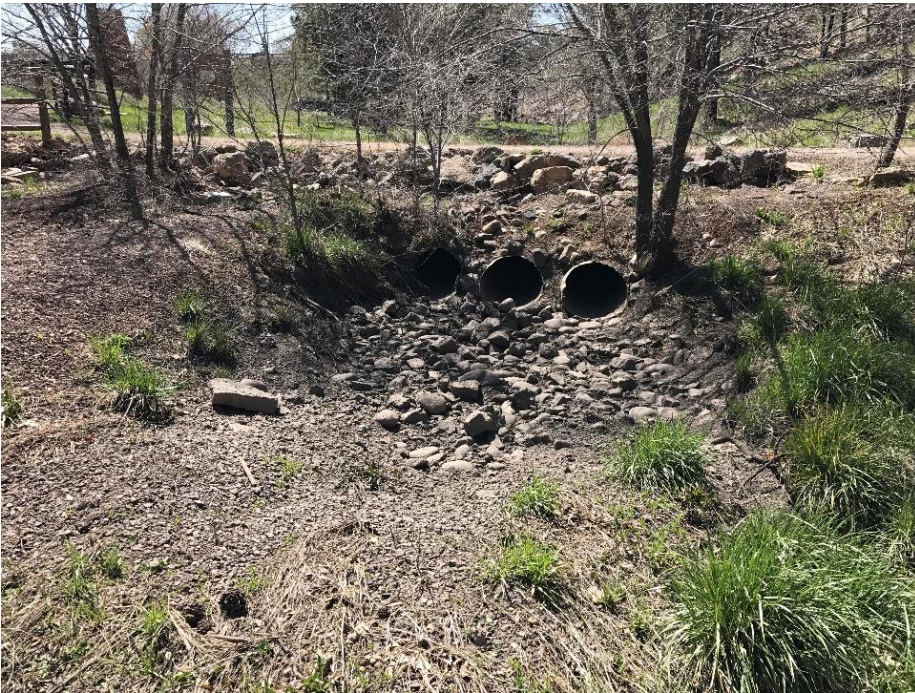
**Figure 5: Deep Scour Pool**

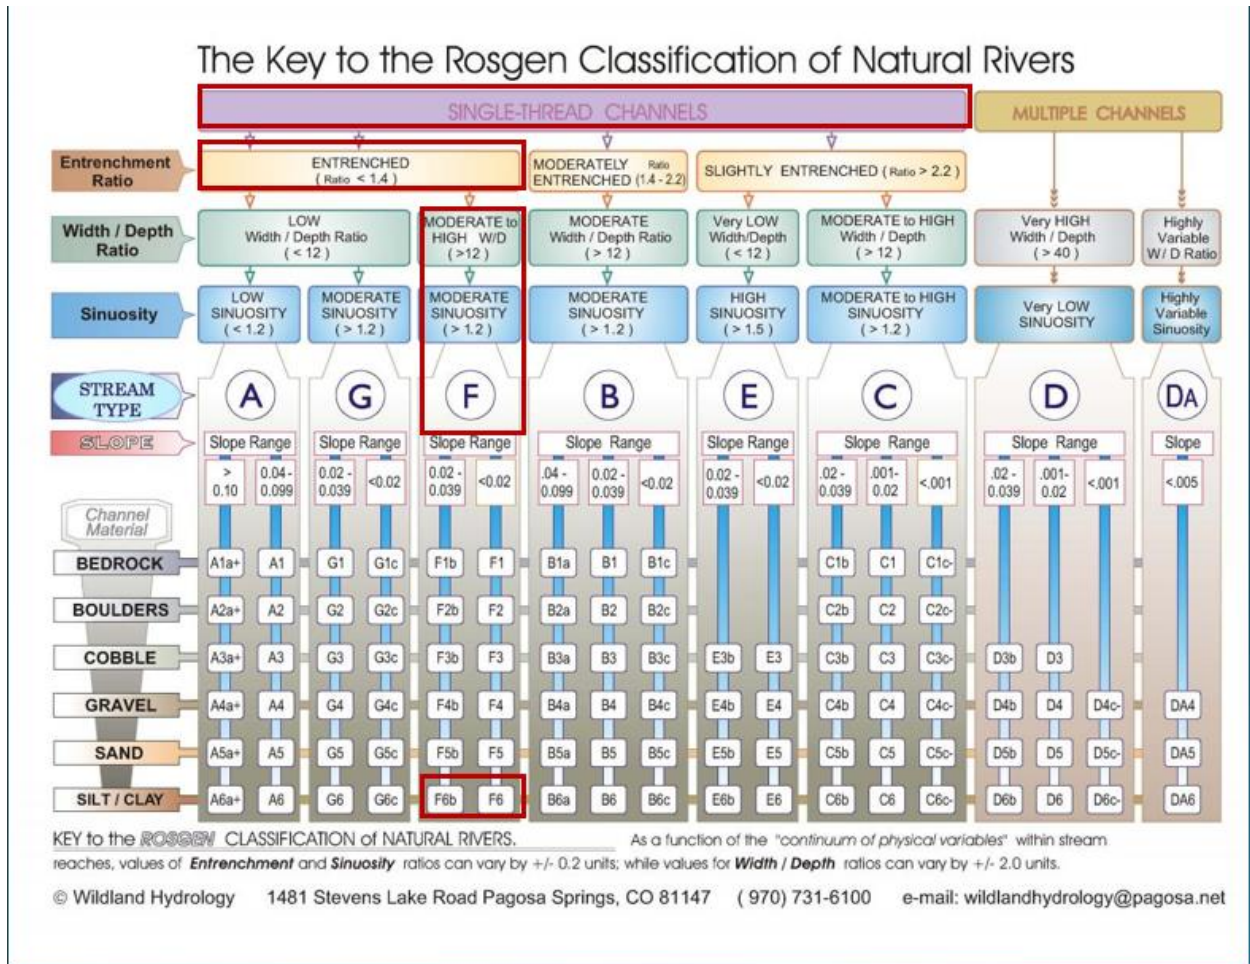
Figure 11 Rosgen Method

The team started the stream classification to increase the knowledge about the stream. Different classifications methods were available for the reach classification. The team decided to choose Rosgen classification method, which requires to be familiar with the stream morphology. The reason for choosing Rosgen method is because it is the most widely used classification method in US. Furthermore, the method is easy to apply and it saves money, and no expensive materials are required for the method. Rosgen method can be used to collect the raw data for predicting channel stability, channel enlargement, erosion risks, and hydraulic relations. Rosgen method consists of four main levels which are geomorphic characterization, morphological description, stream condition, and validation level. The process for our stream start with single thread channel then the entrenchment ratio which is 0.14 then the width and depth ratio which is about 14.06 and finally the sinuosity that is bigger than 1.2. The result of the classification shows that the stream is type F which can be described as the classic entrenchment channel, morphologically unstable, and actively down cutting. The stream classification will help the team to get a better understanding and increase the knowledge about the reach, and it plays an important role in stream restoration for the project. For Full Reach Classification Results Refer to Appendix A.
