# American Society of Civil Engineers Environmental Design Competition

CENE 486C - Status Update #3 Alex Anzar, Shelby Carawan Paige Reilly, Cameron Rhodes

### Project Summary

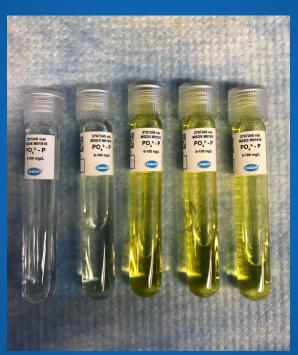
Figure 4: Turbidity testing results. Figure 5: Orthophosphate testing. Photo courtesy of Alex Anzar.

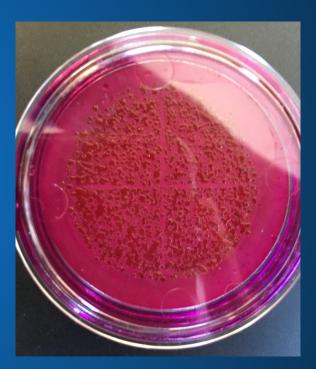
Figure 6: Coliform testing results. Photo courtesy of Shelby Carawan.

| Test | Method | Raw Water Results | Testing<br>Results | Ideal Results |
|---|---|---|---|---|
| Total coliforms | HACH 8074 | Inconclusive | | Not present |

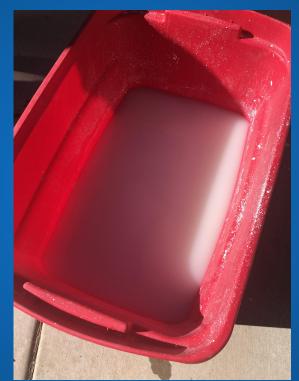
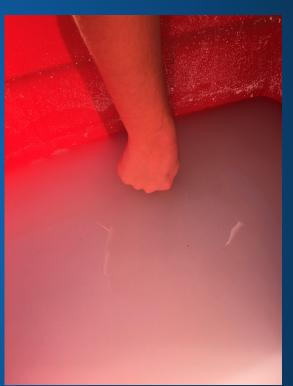
- Sedimentation Bin
  - Nine minute settling time
  - Very little clay sedimentation
  - Need to increase bin's surface area and add microfilters

Figure 8: Sedimentation at t=0. Figure 9: Sedimentation after t=9. Photo courtesy of Shelby Carawan. Photo courtesy of Paige Reilly.

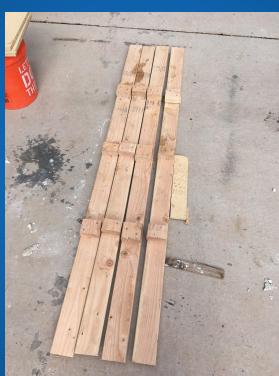
- Constructed system frame and labeled parts
- Drilled holes in plywood bases & buckets
- Need to obtain
   materials for design
   modification

Figure 10: System frame.
Photo courtesy of Alex Anzar.

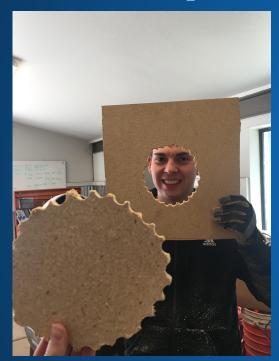
Figure 12: Holes in plywood base. Photo courtesy of Paige Reilly.

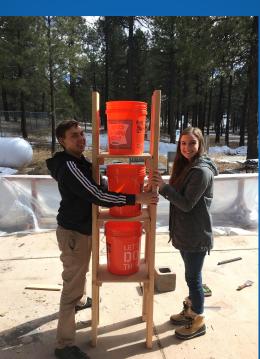
Figure 13: Constructed System. Photo courtesy of Alex Anzar.

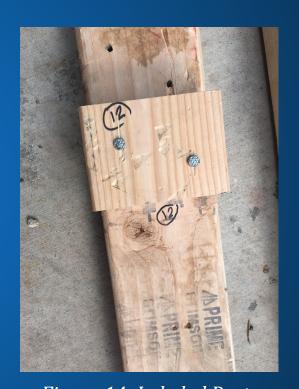
Figure 14: Labeled Parts.
Photo courtesy of Paige Reilly.
