# Alternative Septic System Update 2

# Project Background

- Located at 1955 North Echo Canyon Rd. Page Springs, AZ
- Alternative septic system design selection
- Irrigation design for vineyard
- Water quality analysis of well water
- 1-ft topographic map of property

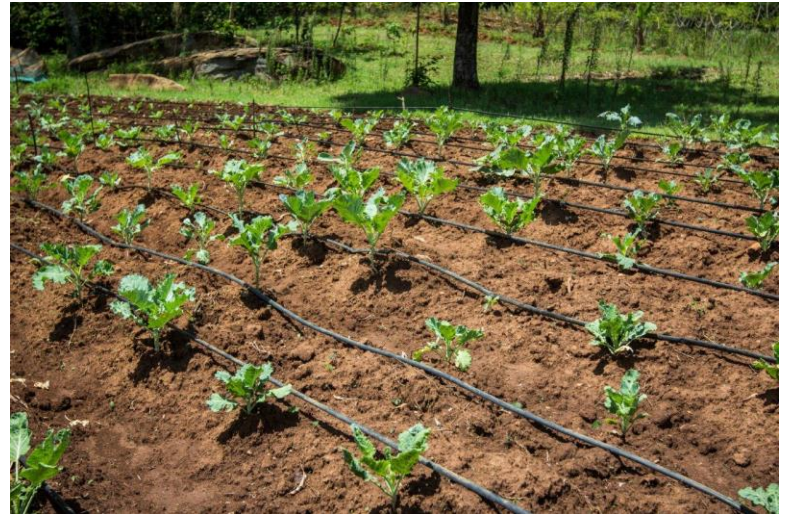
Figure 4, Drip Irrigation [4]

- Drip
  - Water runs through pipes slightly above the ground and drips almost directly onto the crops and roots.
- Subsurface Drip
  - Drip lines are installed below the soil's surface, typically at a depth of 20-40 cm.
- Low Elevation Spray
  - Suspends sprinkler spray heads close to the soil surface, typically less than 12 inches above the ground.
