Re: Signal Mill Project Proposal

SIGNAL MILL

PRELIMINARY ASSESSMENT/SITE INVESTIGATION

CENE 486C – ENGINEERING DESIGN

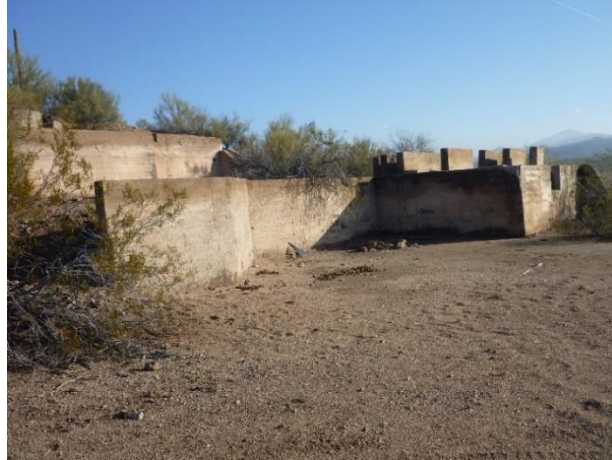
Figure 1.4 Abandoned Structure at Signal Mill

As of today, only crumbles remain of Signal Mill. There are broken and abandoned structures scattered throughout the site. An image of the mill's remains is shown below in Figure 1.4. The site is also frequented by recreational users. During the site investigation a group of all-terrain vehicle users was encountered on the site along with tourists visiting the mill.

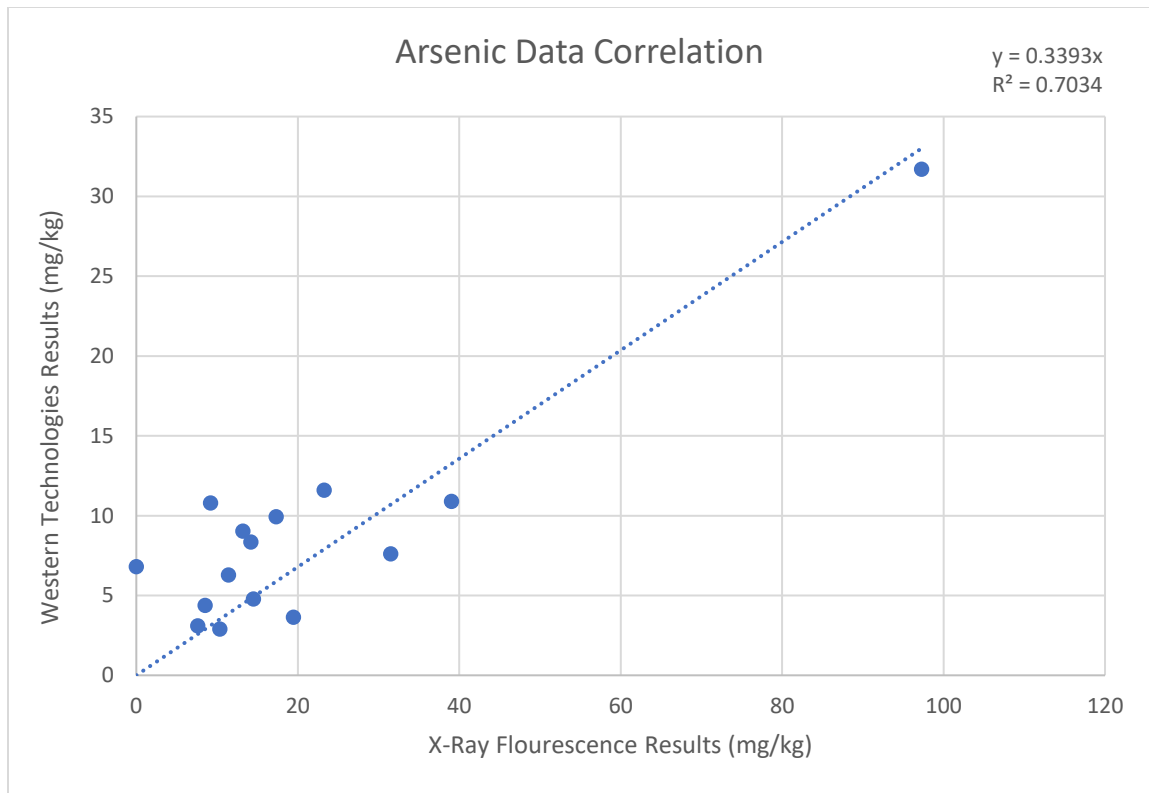
Figure 4.7 Corrected Arsenic Data Correlation Results between XRF and Western Technologies

The data was assessed and XRF readings with high levels of lead were removed from the correlation. The samples that were removed include SMG 52, SMG 47, SMG 45, SMG 36, and SMG 9. Data selected for removal was aided by the team’s technical advisor. With the removal of these points a new scatter plot was formed and can be seen in Figure 4.7. This new chart produced a r-value of 0.8387 which confirmed the lead interference with the arsenic readings from the XRF device. This correlation ($y=0.3393x$) was used to correct XRF arsenic data for further risk assessment.

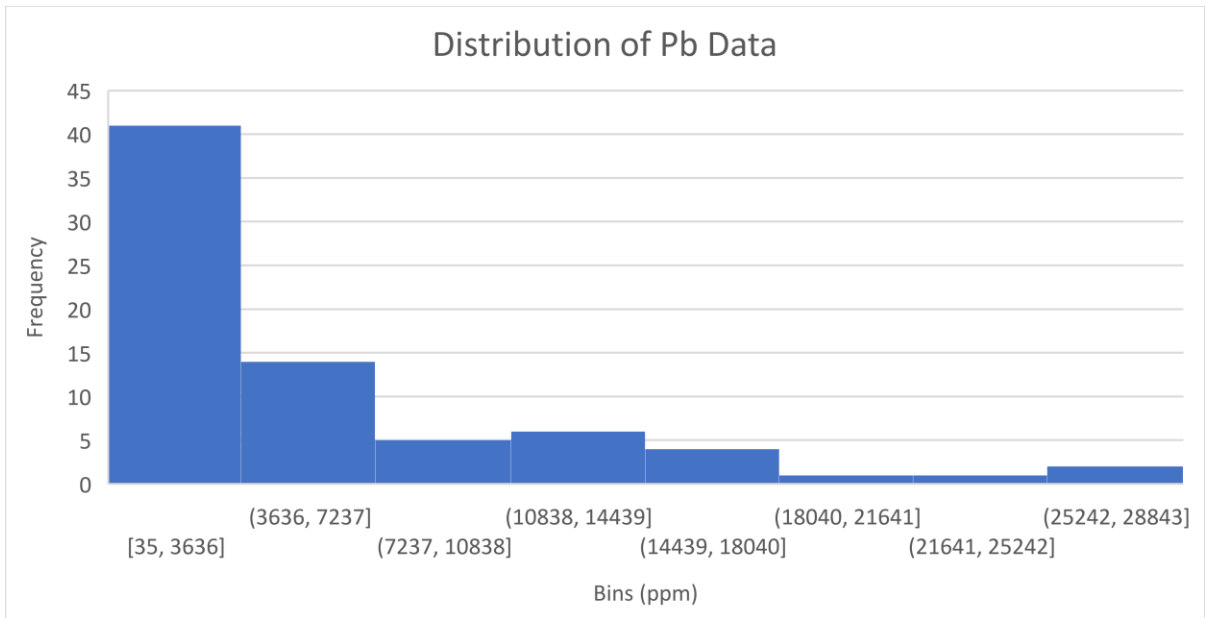
The adjusted XRF data was utilized to create distributions for each element. This information is presented in Figures 5.1 - 5.3.

Figure 5.1 Distribution of Arsenic Data

Figure 5.2 Distribution of Manganese Data

Figure 5.3 Distribution of Lead Data

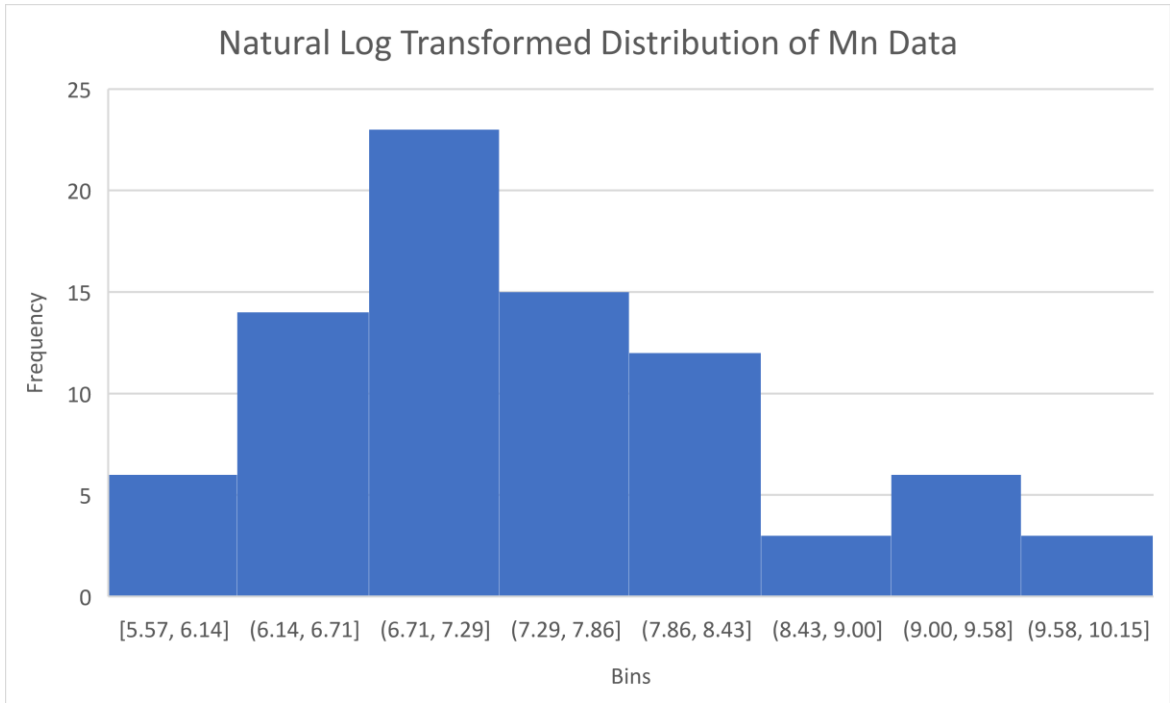
log distribution for manganese, arsenic, and lead. These distributions are shown in Figures 5.4 – 5.6.

Figure 5.4 Natural Log Distribution of Arsenic Data

Figure 5.5 Natural Log Distribution of Manganese Data

Figure 5.6 Natural Log Distribution of Lead Data

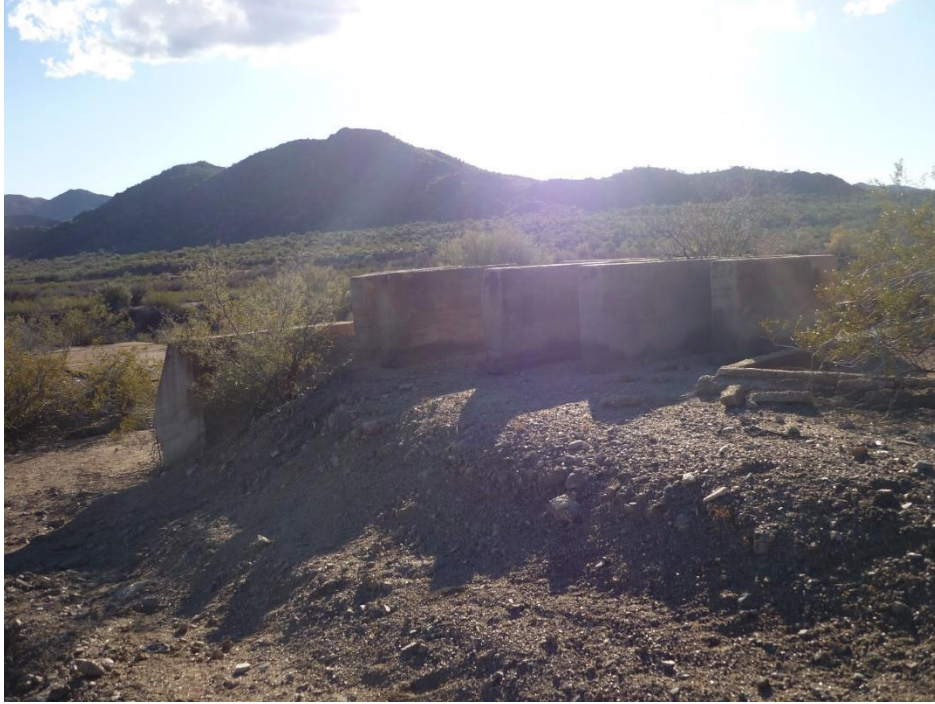
Figure C83. Signal Mill Old Concrete Structures in the Middle of the Site

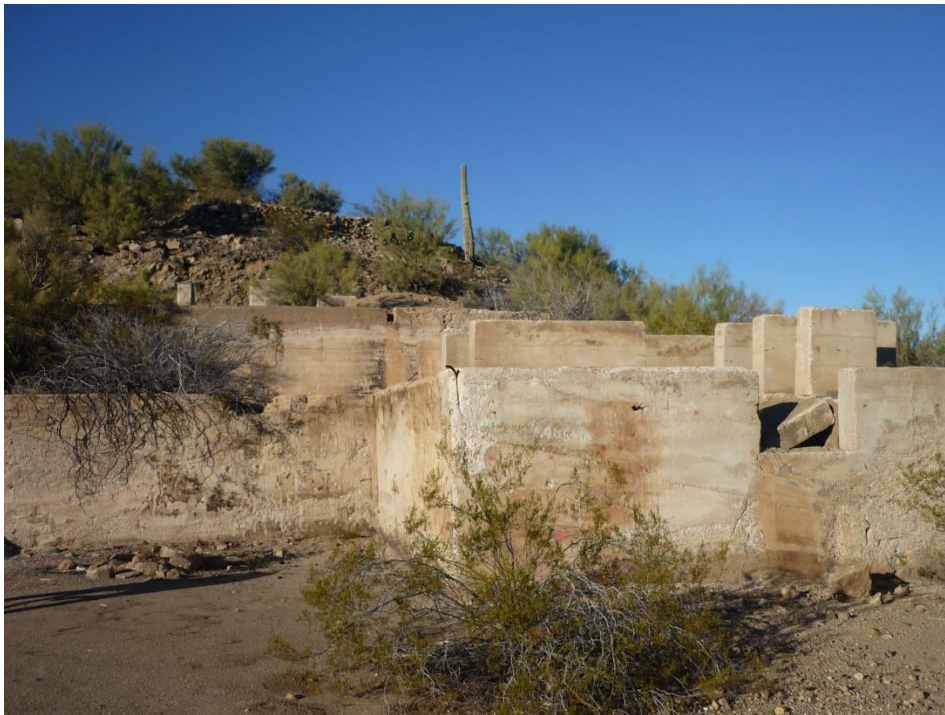
Figure C83. Signal Mill North Facing View of Concrete Structures on Site

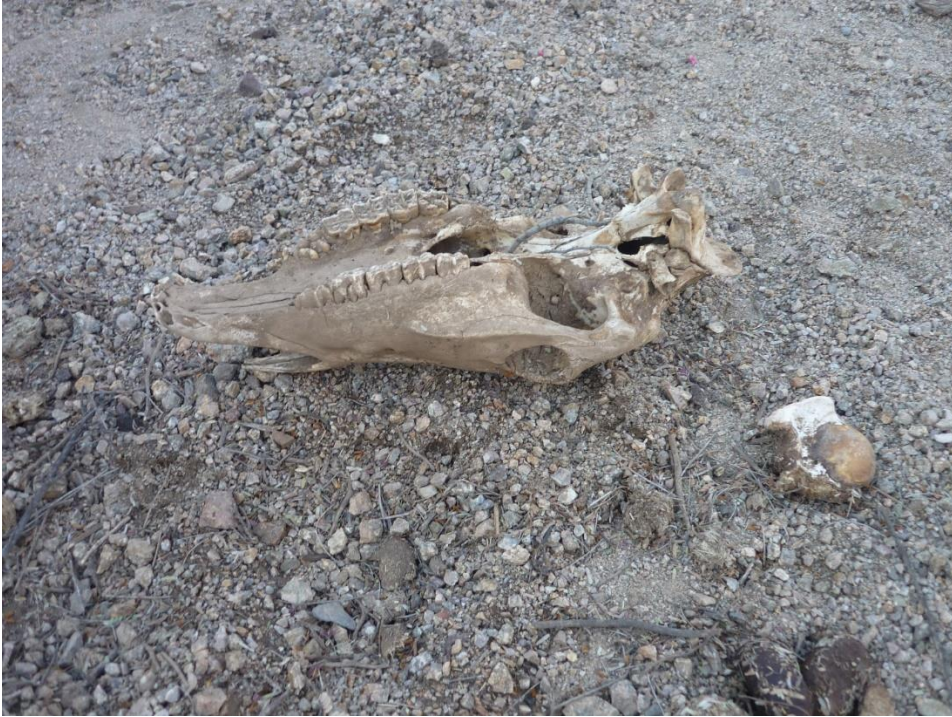
Figure C84. Signal Mill Evidence of Wild Burros/Cattle on Site
