# Tyro Mill PA/SI Report

Caitlin Adams, Joy Crutchfield, Eryn Guevara, Hamad Mohammad  
May 7th, 2019

ACGM Engineering has developed this Preliminary Assessment and Site Investigation Report (PA/SI) to provide the Bureau of Land Management with information on the contaminants present on the site, where the current contamination is located on the Tyro Mill site, and information on the potential human health and environmental hazards that these contaminants present for the Tyro Mill site located in Mohave County, Arizona.

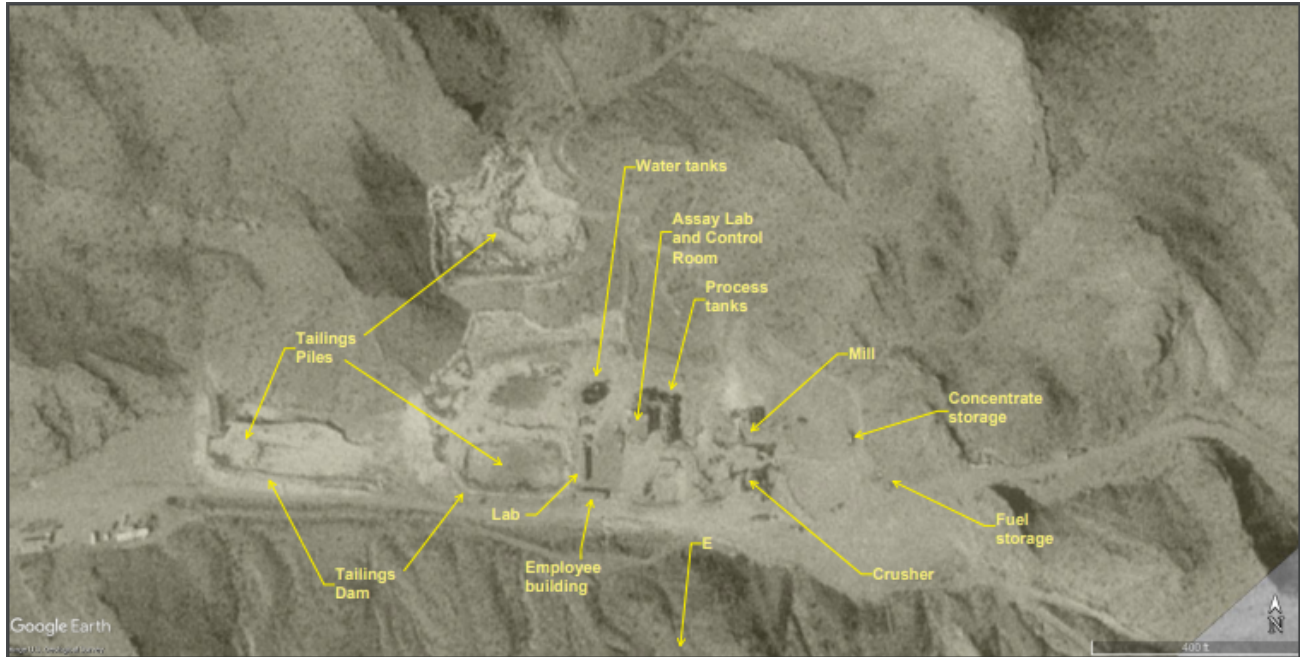
*Figure 1-3. Tyro Mill Historic Operations [1].*

Tyro Mill consisted of a cyanide mill that processed precious metal ores (primarily gold and silver) from local mines, the exact start date of the mill is unknown along with the owners/operators of the mill however it is known that the mine never submitted its paperwork to BLM which caused BLM to close down the milling operation in the 1970s [1]. The Tyro Mine and Mill site then continued to operated illegally for approximately 20 years, beginning illegal operations in the early 1980s and was abandoned in 1999 [1]. Figure 1-3 below displays the old Tyro Mill with the labeling and locations of the old buildings and the tailings piles that were in place when the mill was in operation. There were also four tailing ponds that were located in the dry wash and supported by dam embankments which were also constructed of the tailings. Throughout the operation of Tyro Mill these dams and tailings piles were actively eroding. When the mill was abandoned, approximately 70,000 cubic yards of tailings between the four dry ponds were left and all of the buildings were demolished [1].

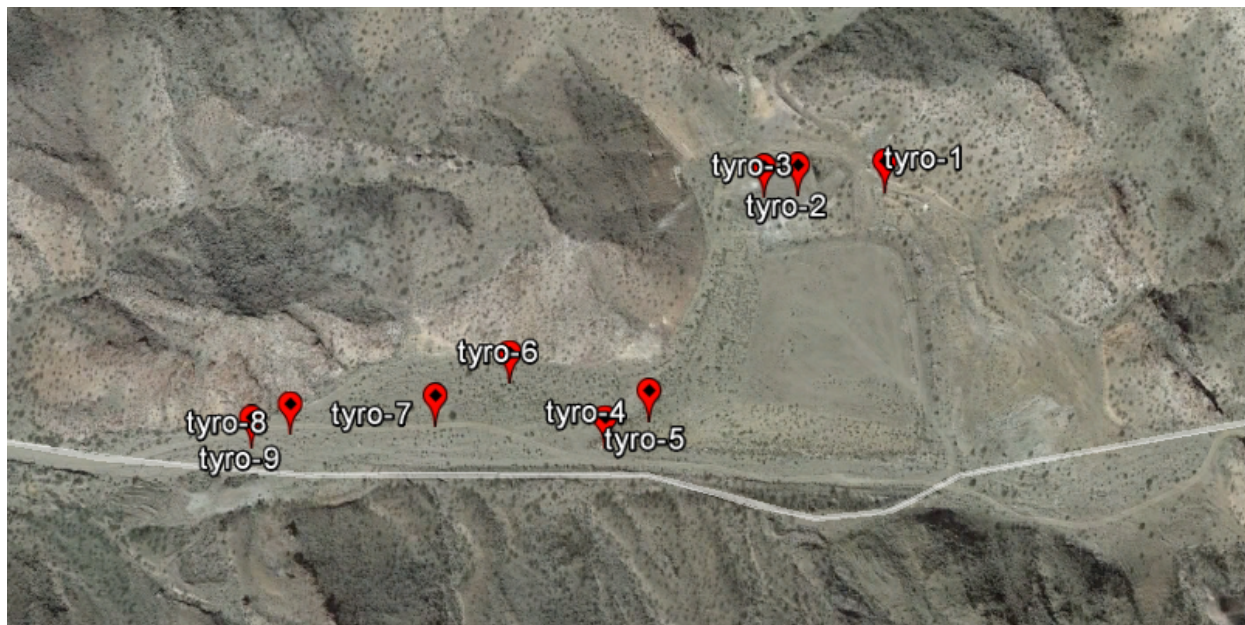
Figure 1-5. Nine Sampling Locations Conducted by the BLM in 2018 [3].

The sampling results from the April 2018 sampling event performed by BLM can be seen in Table 1-1. The red sections in Table 1-1 indicate a non-residential exceedance of the AZ Remediation Standards and yellow indicates a concentration between the Residential and Non-Residential Soil Remediation Standards [3]. The location of the nine soil samples collected during the sampling event can be seen in Figure 1-4 (note that no scale was provided for the figure).

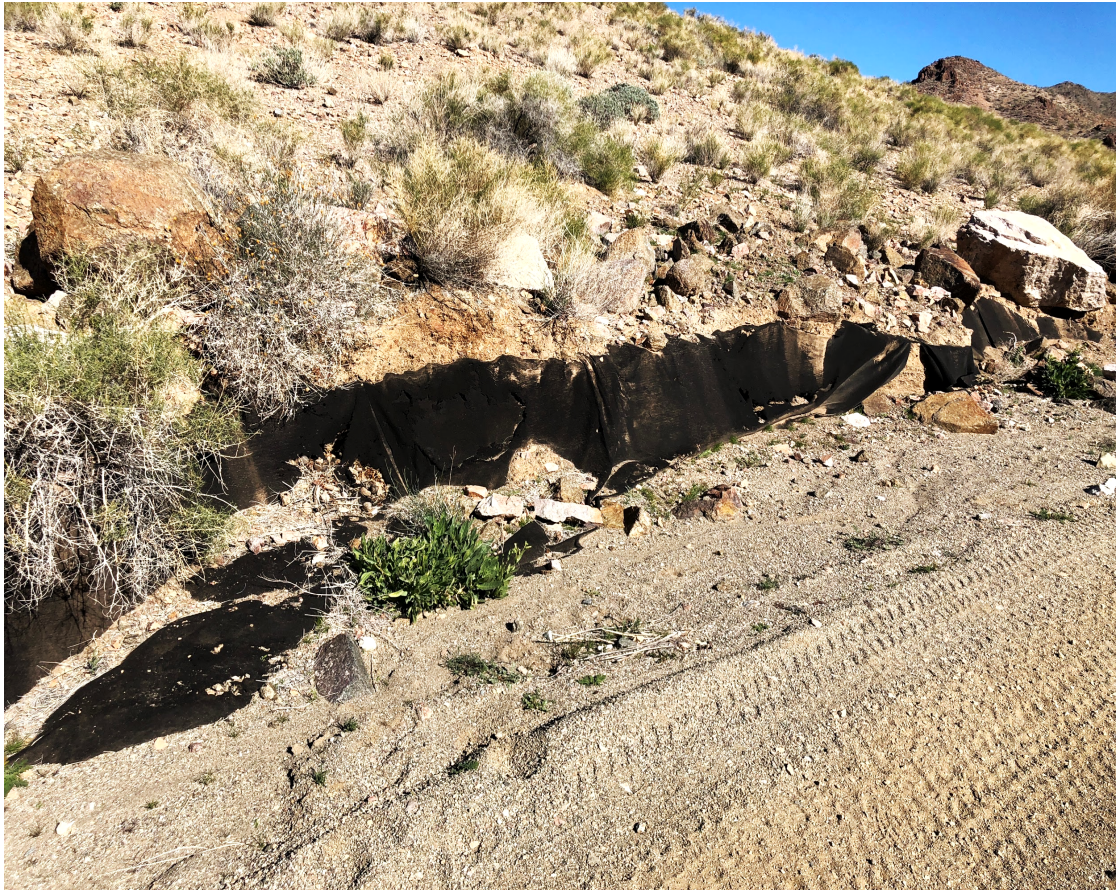
*Figure 3-1. Exposed Line Visible near Southern Edge of Repository.*

Over a 2 day period, January 25th and 26th of 2019, the Tyro Mill team and three interns from ACGM Engineering went to the site to collect soil samples. The weather on site for both days was clear skies with some cloud cover with temperatures in the mid 60 degrees Fahrenheit with slight to no wind. Upon arrival at the site, the ACGM Engineering team discovered that the outer

liner of the repository has been exposed due to erosion. The liner on the southern edge of the repository near the road on the base was visible, pictures of the exposed liner can be viewed below in Figure 3-1 and in Appendix B.

ACGM Engineering identified that erosion is present at the southern edge of the repository cap during the two-day sampling trip. Continuation of the erosion may increase the risk of contamination spreading towards the main access road. The native flora and fauna survey indicate that the identified species may be at risk due to the following COCs: lead, zinc, manganese, vanadium, and cadmium. ACGM engineering recommends that BLM post signs around the repository to restrict target shooting in the area as a preventative measure for additional contamination.

BLM may need to conduct further remediation if the repository liner around the perimeter of the repository were to fail. Five Year reviews may need to be performed in order to monitor health and ecological risk at the site.

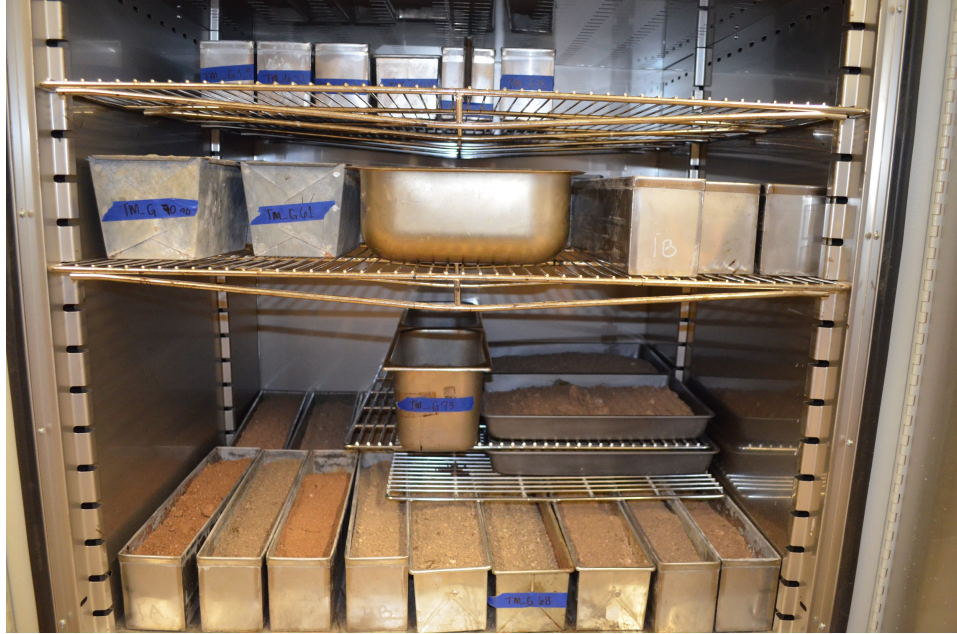
*Figure 4-1. Samples Drying in the Materials Oven.*

Drying of the soil samples was completed using ASTM 2216 Standard Test Methods for Laboratory Determination of Water (Moisture) Content of Soil and Rock by Mass. The drying of the samples was completed in the Materials Lab within the Engineering Building at Northern Arizona University (NAU).

PPE was worn by the team while working in the lab and with the soils and all containers were clearly marked to identify the samples. While the samples were drying in the oven a sign was also posted to warn others of the potential toxicity of the samples. Pictures of the drying process can be viewed in Appendix C.

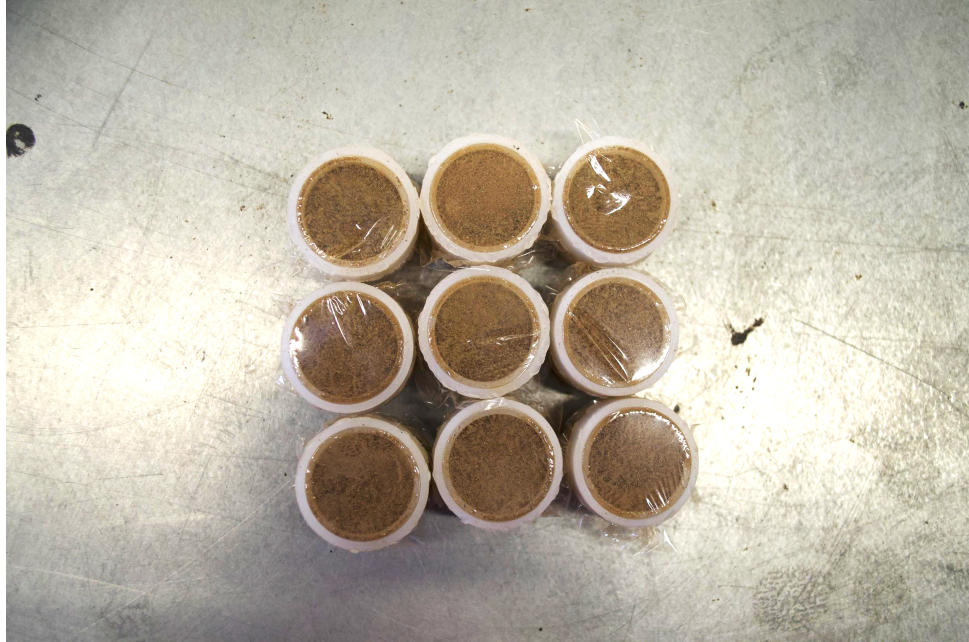
*Figure 4-3. Soil Samples Prepared for XRF Analysis Divided into subsamples.*

X-Ray Fluorescence (XRF) analysis was completed following EPA Method 6200: Field Portable X-Ray Fluorescence Spectrometry for the Determination of Elemental Concentrations for Soil and Sediment. This method was developed to provide a preliminary identification of elements present in a soil sample to be used in conjunction with additional confirmatory testing. Based on the method, each sample that has passed through the No.40 sieve was placed into a one gallon Ziploc bag and nine, approximately 1 gram, subsamples were taken using sample cups as seen in Figure 4-3. The XRF analysis of the samples was completed in the Materials Lab within the Engineering Building at NAU.

The subsamples were then placed one at a time into the XRF mobile test stand and analyzed with the handheld Thermo Scientific Nikon XL3t GOLDD+ XRF device provided by the BLM. Each sample was shot for a minimum of 90 seconds and the XRF device was calibrated at the beginning and end of each lab session using a provided soil sample from the manufacture with known contaminant levels. If the error in the calibration readings was lower than 20 percent, the XRF was determined to be calibrated and to provide accurate readings.

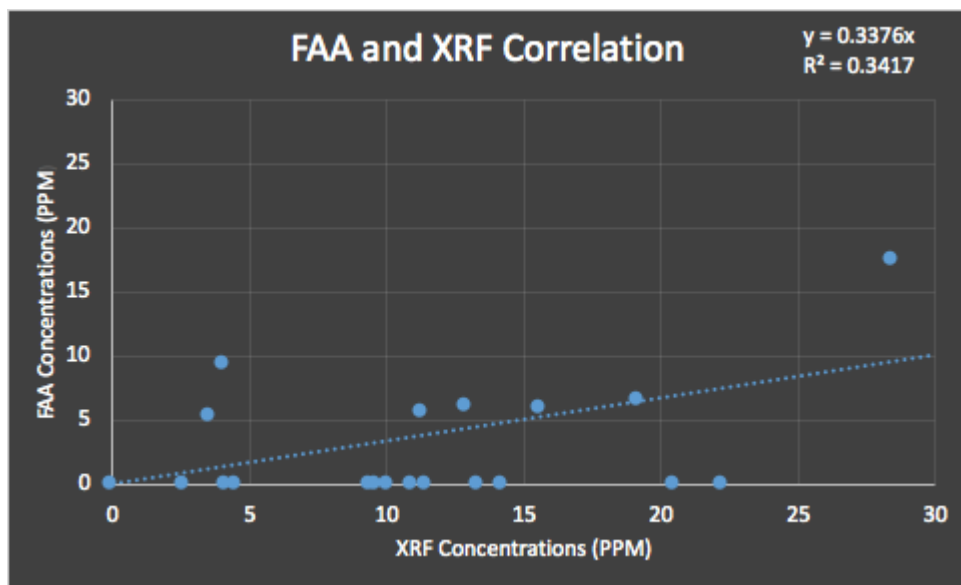
Figure 5-1. XRF and FAA Correlation [6].

The 20 samples chosen represent a range of the XFR results obtained, from high to low concentrations. The data is then plotted as shown in Figure 5-1 in order to find the correction factor to correct the XRF Arsenic results obtained. Figure 5-1 below displays the graphical correlation between the FAA results and the XRF results. The correlation provided an R<sup>2</sup> value of 0.328 and an R value of 0.57.

$$\text{Corrected Value} = 0.3376 * \text{XRF value}$$

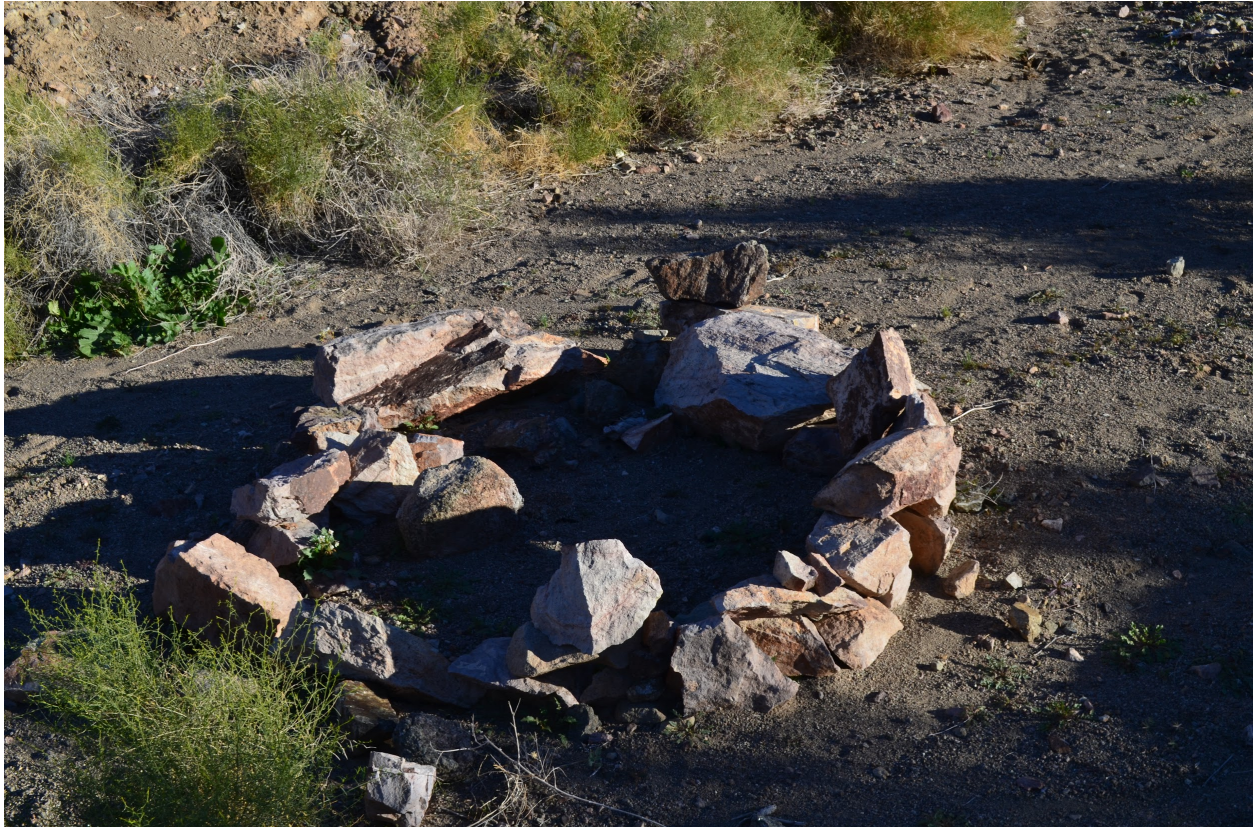
*Figure 5-2. Fire Pit on Site Near TM\_G57 Sample.*

The corrected XRF values showed TM\_G43 and TM\_G78 have exceedances over the Non-Residential AZ Remediation standards for arsenic. Cadmium and Silver concentrations showed one exceedance for each over the Non-Residential AZ Remediation Standard for TM\_G57. The location of TM\_G57 was near a fire pit with indications of locals camping in the specific area. Pictures of the all sampling locations can be seen in Appendix B.

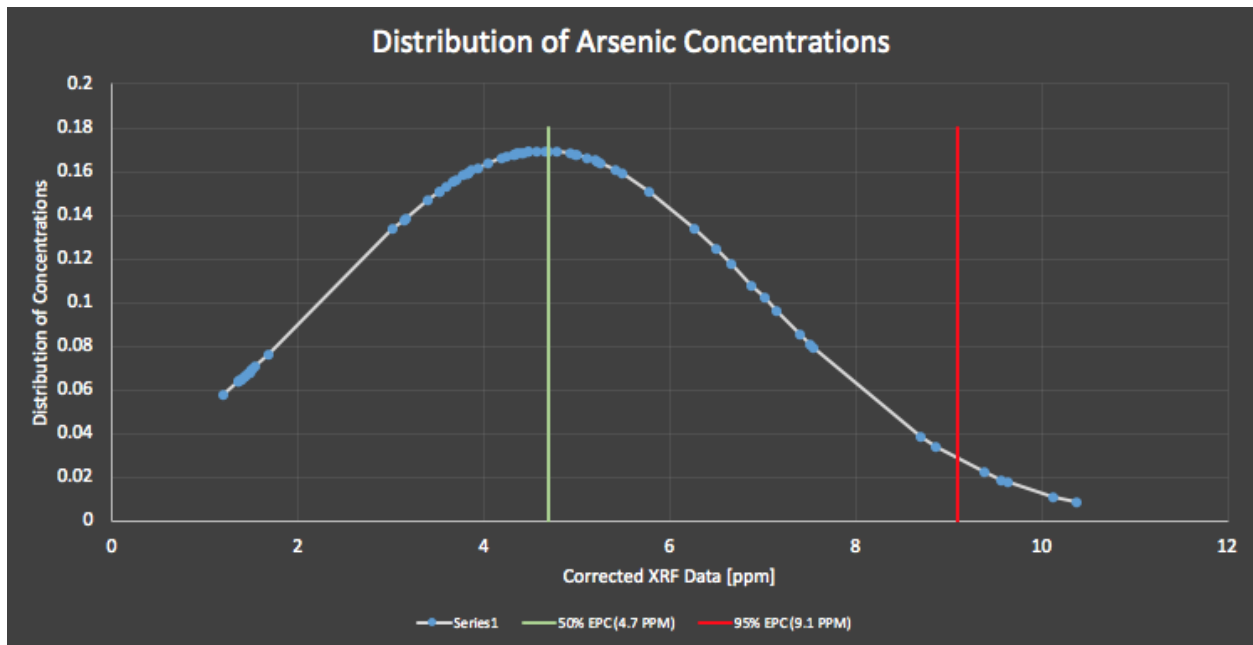
Figure 5-4. Distribution of Arsenic Concentrations [6].

Sample TM\_G3 was designated as a background sample by the guidance of the TA in the field. For determination of the EPCs the background and hotspot values were omitted as they are biased samples. Using the corrected XRF values for arsenic the average concentration of Arsenic was determined to be 4.7 ppm and the standard deviation was 2.35. The relation between corrected XRF data and distribution of concentrations showed a normal distribution. Figure 5-4 below displays the distribution graph of the arsenic concentrations in ppm.

Using the normal distribution ACGM Engineering was able to determine the estimated permissible concentrations at a 50% and 95% confidence interval. The 50% EPC is the mean arsenic concentration and the 95% EPC is two standard deviations above the mean arsenic concentration. The EPC values can be viewed in Table 5-5 below.

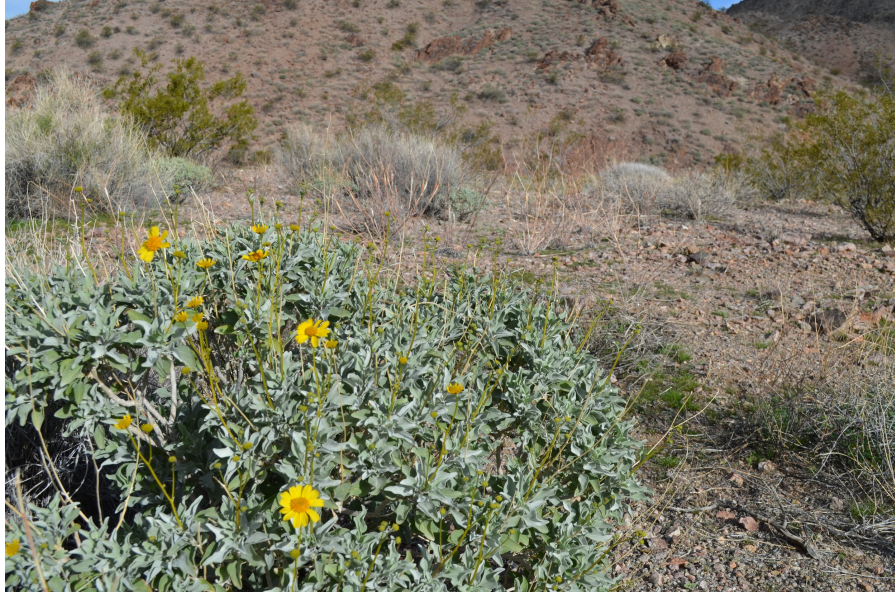
*Figure 6-1. Desert Marigold Located on Site.*

It is noted that ACGM Engineering only visibly seen desert marigolds, fire barrel cactus, Fickeisen plains cactus, and fecal matter that could indicate wild burros. The remaining species listed are based on research of known species that are present within the region of the Tyro Mill site [9].
