OLD TOWN FRAME COMPANY SITE REDESIGN

Submitted by Mitchell Tulk, Matt Rollins, Ryan Wolff, Saud al Saadoon

MAY 7, 2019

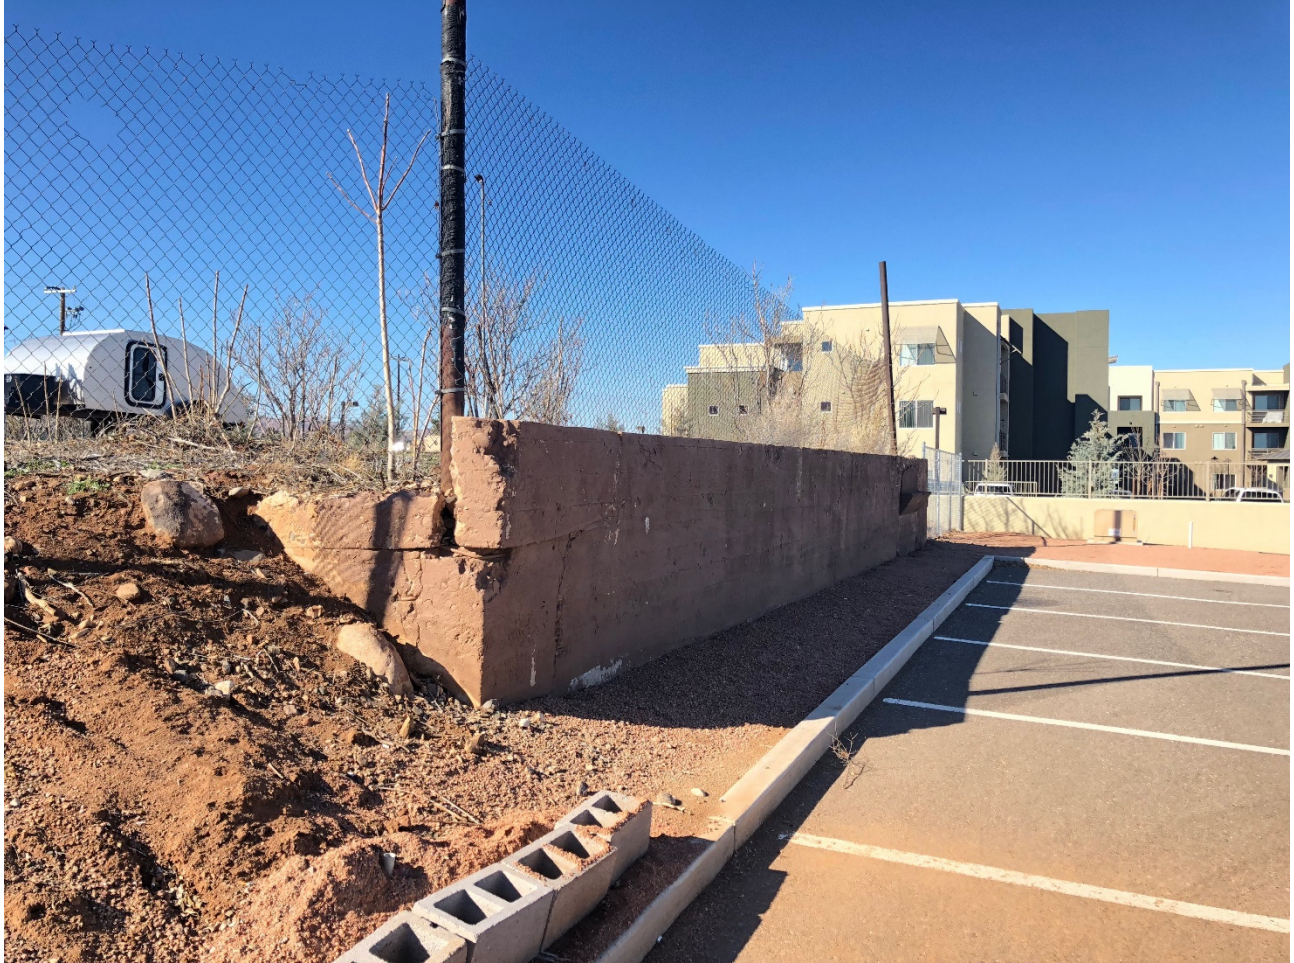
Figure 2. Existing Retaining Wall

Prior to requesting this project, the client was unaware of the property boundaries. As a result, it was unknown whether the one-hundred-year-old retaining wall in the northeast corner of the lot was on the client's property. After completion of the site survey, it was determined that the retaining wall is on the property. Figure 2 below displays the existing retaining wall.

Due to the complexity and lack of time, a full redesign of the retaining wall was excluded from the scope. During due diligence and land surveying, the team determined the retaining wall was on the client's property. The team also determined the retaining wall is over 100 years old and therefore a historical site according to City of Cottonwood. The property owner cannot touch the retaining wall as it belongs to the city.

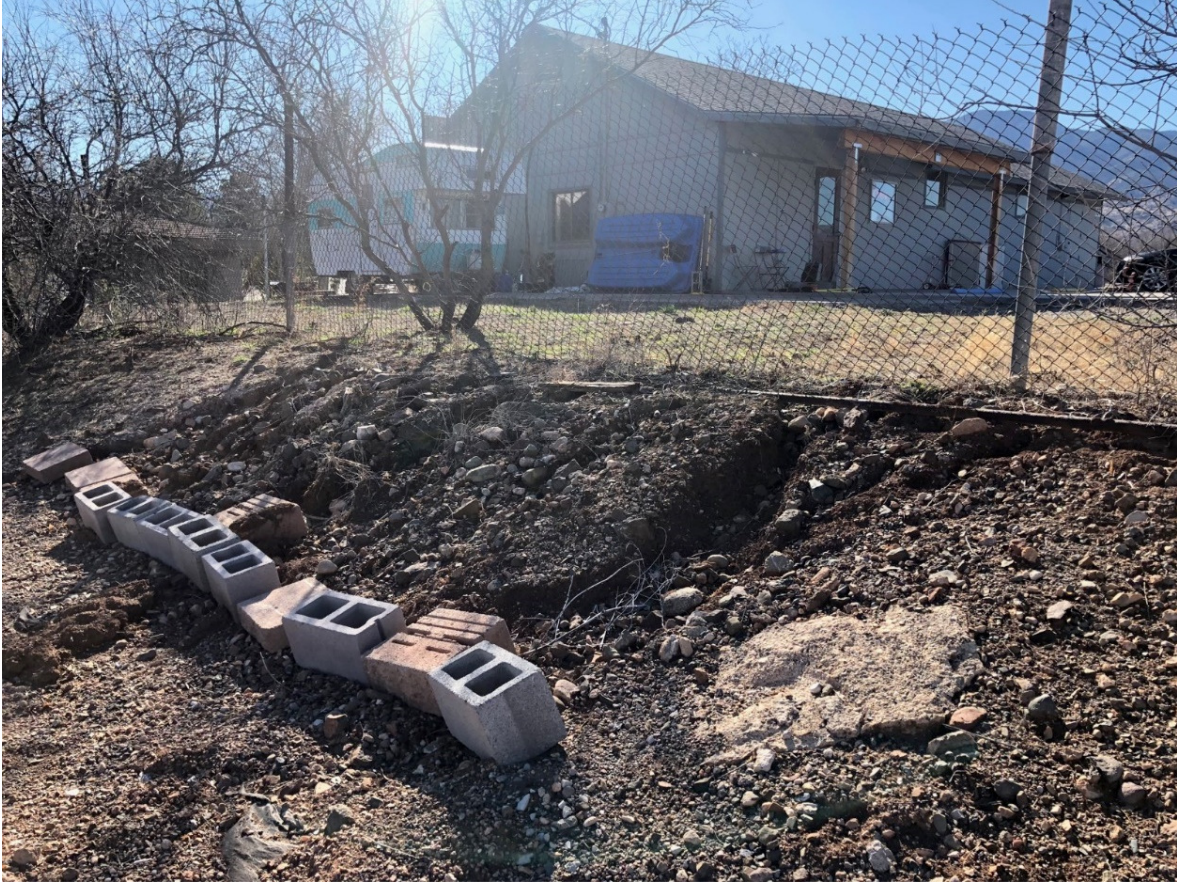
Figure 3. Erosion Occurring on Site

The current condition of the site is unpaved on the northern half which currently creates runoff during heavy rains. The runoff flows into the adjacent parking lot. The adjacent parking lot property owner wants this to stop. Following the first site visit in October 2018, the engineering team confirmed these preexisting conditions, and noted extreme soil erosion taking place on the eastern edge of the property. Figure 3 displays the erosion occurring on the site.

Environmental impacts, primarily soil erosion, were noted on the eastern boundary. Because of the magnitude of a complete drainage design, the drainage requirements serve as a limitation. To account for this the engineering team has completed accurate drainage calculations and identified the plausible location for a detention basin and outlet. This is limited because it is mandated that any drainage design does not change the historical drainage patterns onto a neighboring property.

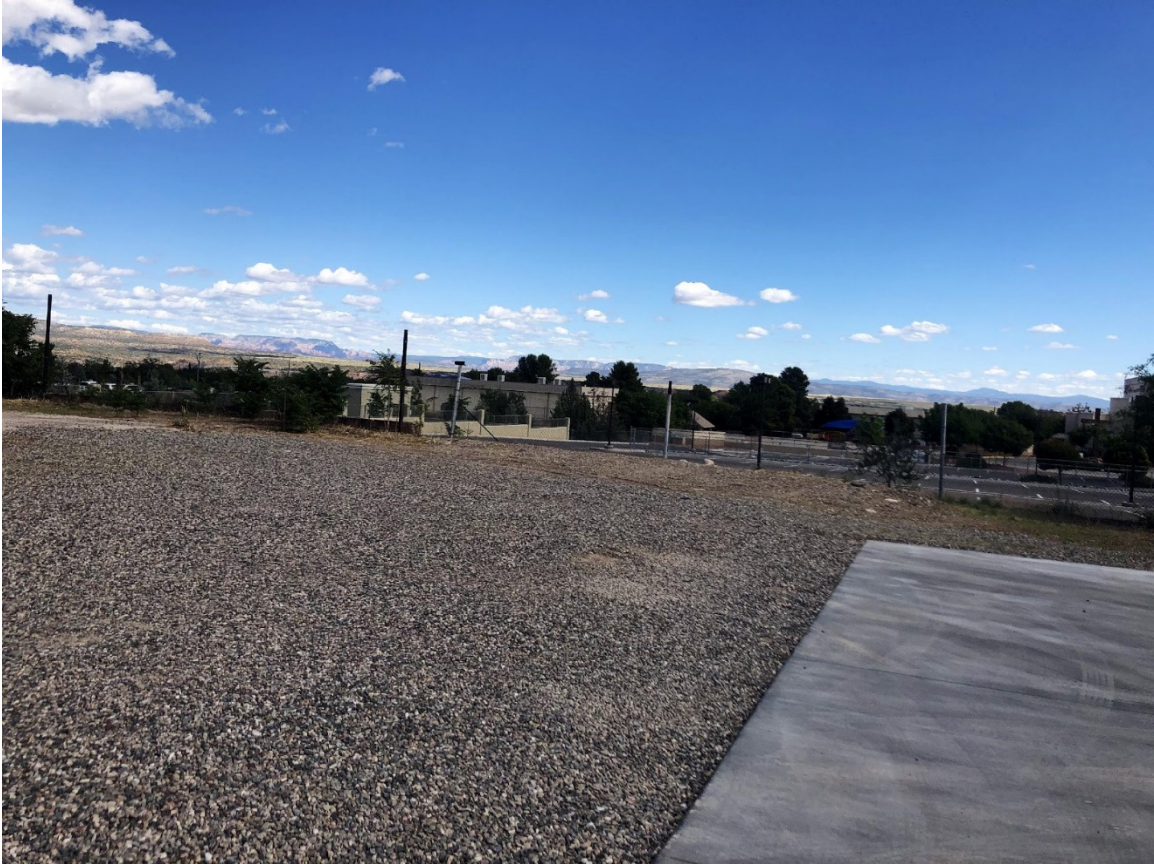
Figure 4. Existing Parking on Site

The design was primarily focused on the parking lot of the site seen in figure 4 below. The client would like to extend the current limited parking (4 spaces) into more of a "traditional" parking lot. The lot is also almost entirely dirt; the unpaved parking areas tend to experience both ponding and soil erosion. The client has requested that the dirt lot be redesigned to better drain during rainfall and that the team make recommendations to the retaining wall. A full set of construction plans has been provided for the site redesign.

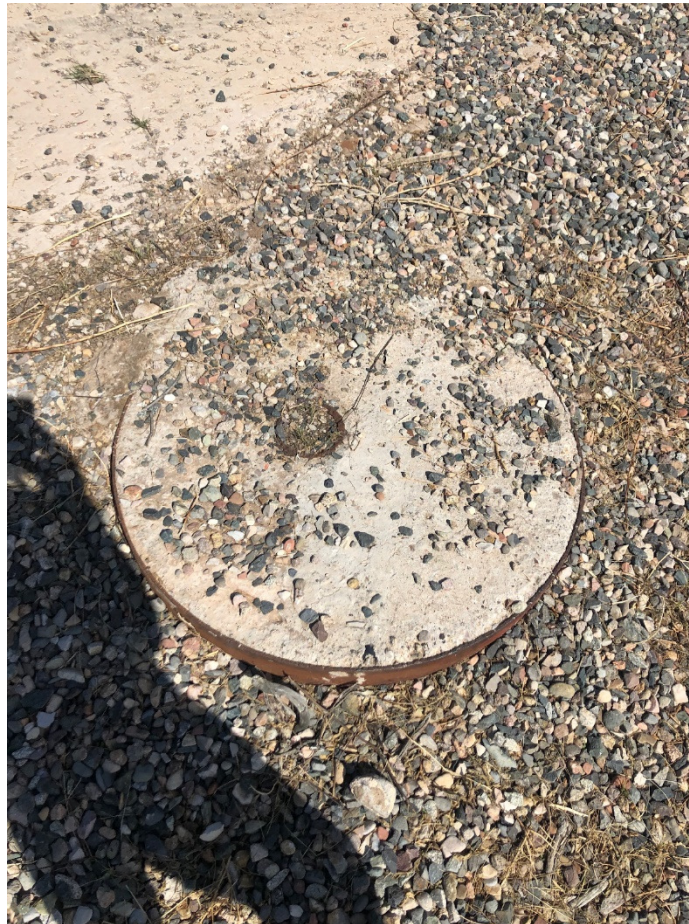
Figure 4. Sealed Well

The goal of the field investigation, which took place on February 2, 2019, was to identify other project challenges and collect soil samples. Challenges noted during the investigation included a sealed well near center of property which appears to cause drainage flow problems (figure 5), a crack concrete slab on the northern line with unknown corners (figure 6), and an aged fence which made staking the official property line difficult.

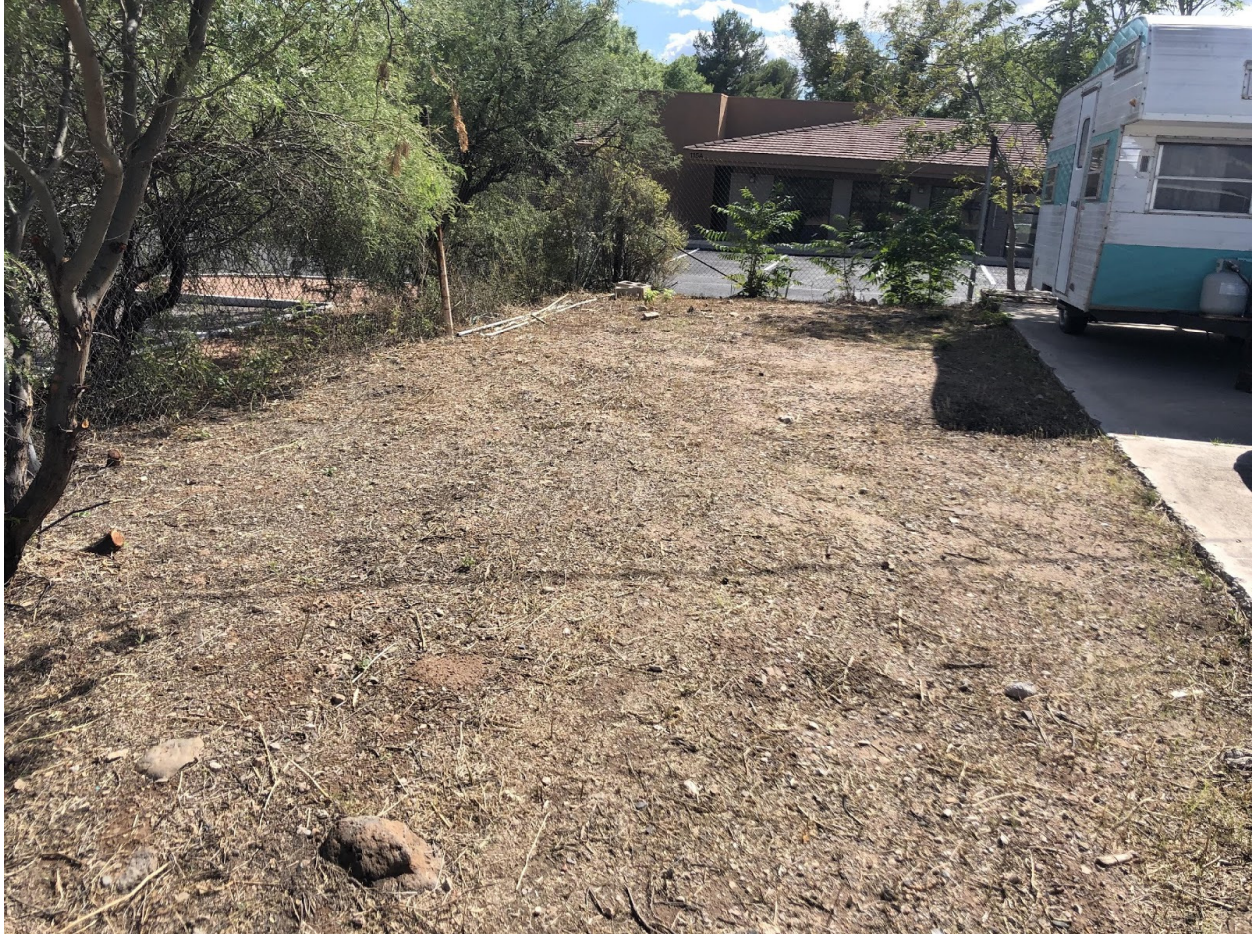
Figure 6. Existing Soil on Site

The goal of soil sampling was to gather a diverse collection of soil from the site to be used for geotechnical testing. Initial visual observations of the soil are shown in figure 7 below. The soil appeared to be homogenous throughout the site. Samples were taken at the center of the property, northern line by the retaining wall, and at the southern line by the building pad.

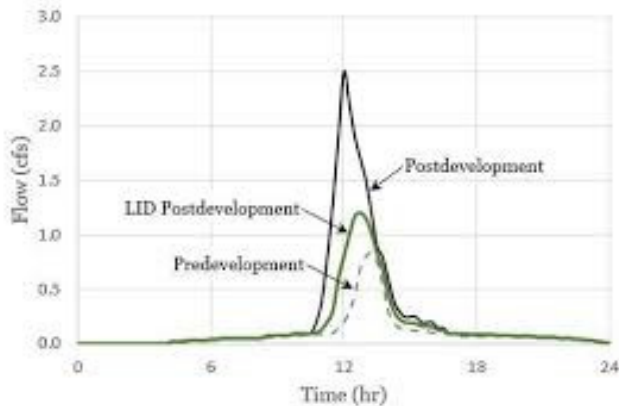
Figure 10. LID Basin Example

The figure below is an image from ADOT that shows the effects of an LID basin on a developed site. The LID basin will hold enough water (per dimensions on design sheets) to negate the increased flow due to the increase in impervious area.
