NAU Civil & Environmental Engineering Department - Pets Return Home - Abigail Autieri, Ryann  
DuBose, Allyson Fedor, Crockett Saline

# Pets Return Home Site Design

Ruff Engineering

Final Report

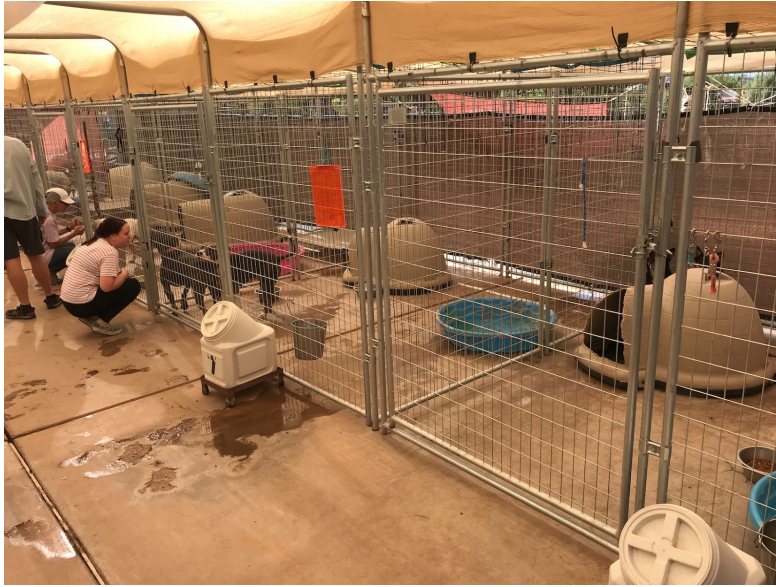
Figure 1-4 : South Kennels Facing SE.

The site was a 4.01 acre developed residential lot on the east side of a dirt cul-de-sac on Peyton Place. This lot is surrounded by developed and undeveloped residential lots. The site shown in the map consists of multiple structures; including a residential structure with barns and kennels along the north and eastern property borders. The kennel space consists of 10 kennels with 10 feet by 10 feet spaces for the dogs seen below in Figure 1-4. The residential structure has the north and east sides of the structure underground with the deepest on the north east corner approximately five feet deep, having walkout entrances/exits on those sides.

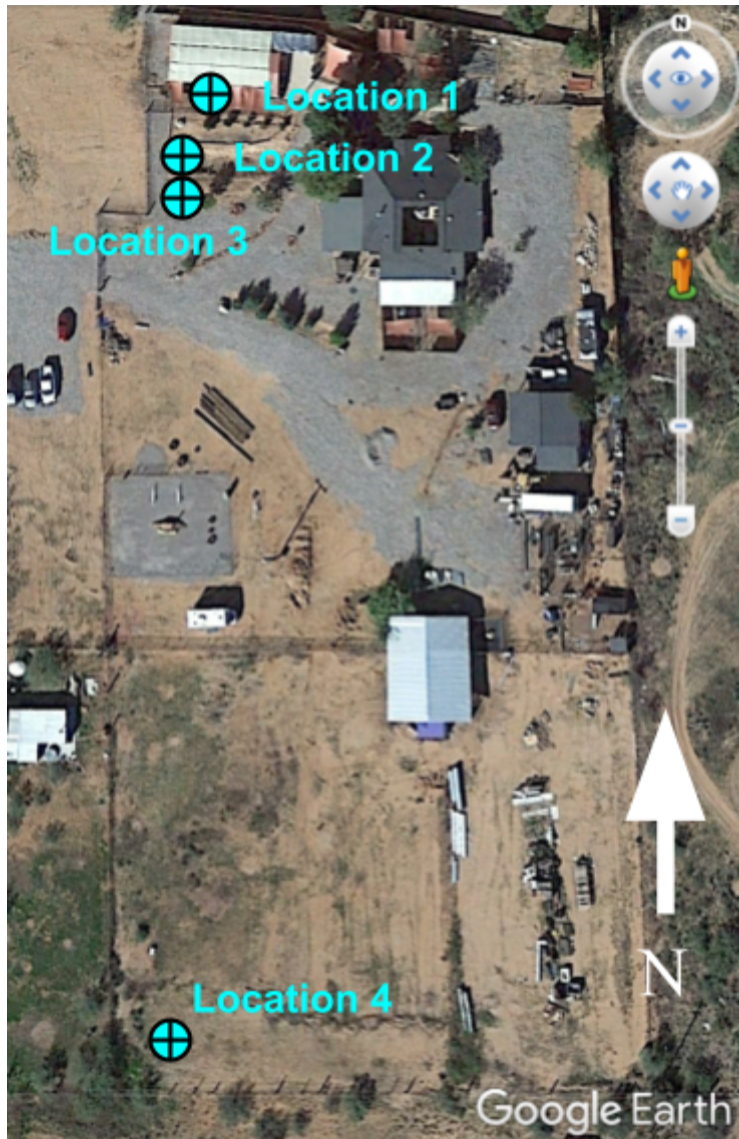
Figure 3-1: Test Pit Diagram

The geotechnical investigation was performed on January 31 and February 1, 2020. Prior to the investigation, four test pit locations were designated and Arizona 811 was called to ensure that no public utilities were within the vicinity of the locations. The test pits were excavated in accordance with the Sampling and Analysis Plan (see Appendix A). Four locations were excavated, one hand excavated and the other three were excavated with a backhoe (Case 580 with 18-inch bucket). The excavations ranged from about 2 feet to 4 feet below existing site grades at the approximate location shown in Figure 3-1 and the typical test pit characteristics can

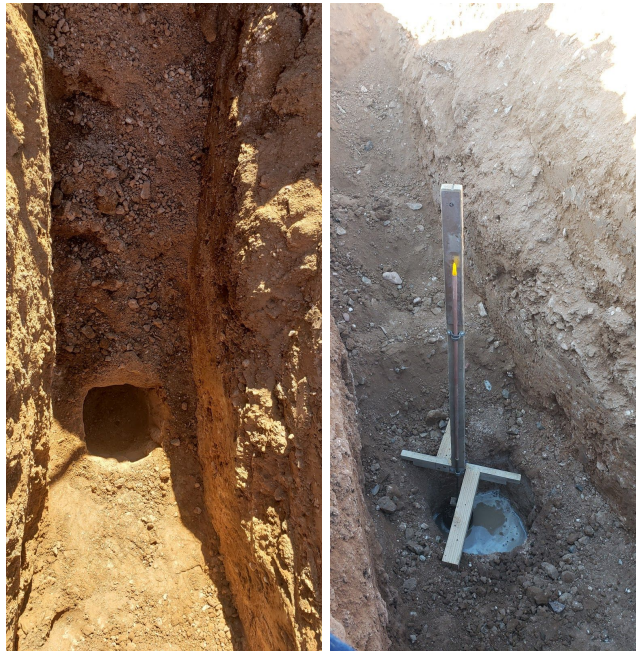
Figure 3-2: Typical test pit after excavation (right) and a test pit with ongoing infiltration test (left).

be seen in Figure 3-2. Logs of the test pits are presented in Appendix B. Subsoils encountered during excavation were examined visually and sampled at selected depth intervals. In addition, three field infiltration tests were performed in proposed sanitary leach fields and stormwater retention basin. Ring samples and large grab samples were taken at each location. Samples were labeled according to the job, test pit location, and depth that the sample was obtained. For example of a sample label, PRH 1(0-2), PRH would have indicated the job (Pets Return Home), location 1, and the depths of 0 to 2 foot depth.

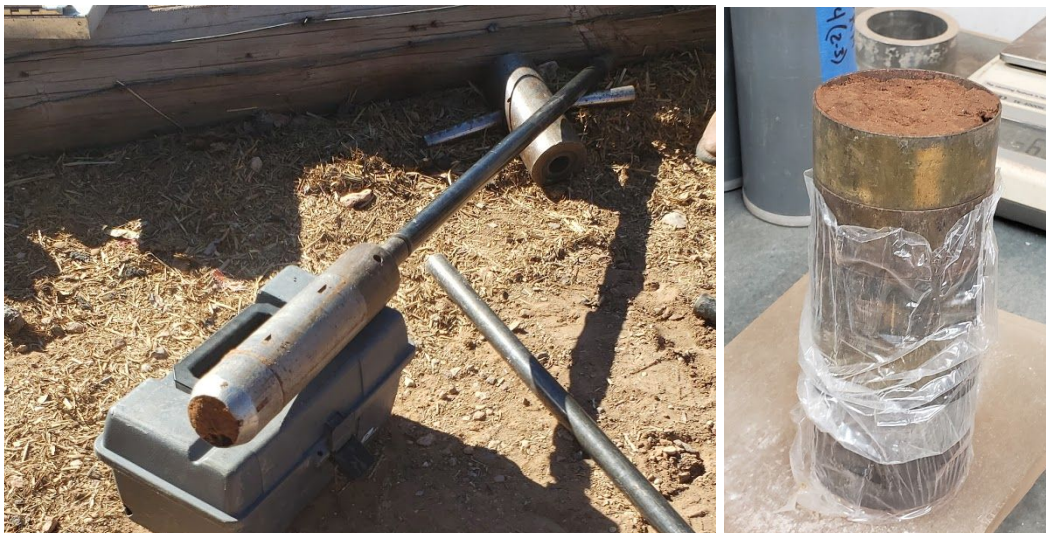
Figure 3-3: Collected sample in hand operated device (right) and sample in rings at lab (left).

Ring samples were taken by a hand operated device that drives a sampler that consists of multiple rings. Figure 3-3 shows the device and typical ring. The rings were constructed out of brass and with dimensions of 1-inch high and an inner diameter of 2.42 inches. After the sampler had been driven into native soil, the bottom six rings were collected as a single cylinder, placed in a plastic bag, and then placed in a protective plastic sleeve with lid and labeled. This protected this type of sample so that in-site characteristics of the soil can be determined in the lab. These ring samples determined the moisture, density, and consolidation/compaction of the existing soils in place.

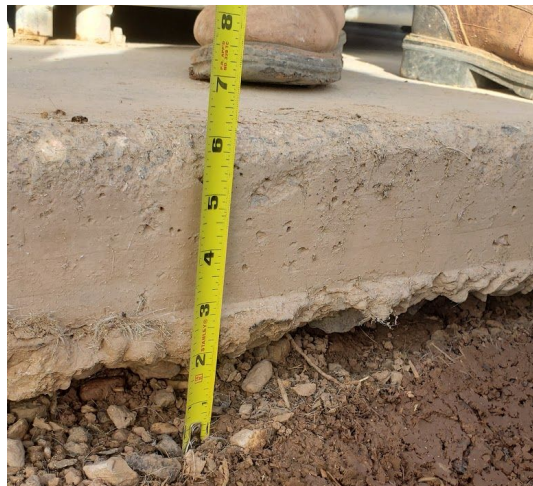
Figure 3-4: Measurement of the existing slab.

Test pit of Location 1 was chosen due to its close proximity to the proposed expansion of the concrete slab that was planned to be used for kennel space and was hand excavated. It was located along the center of the south side of the existing kennel space. During the hand excavation, the existing concrete slab was observed (see Figure 3-4) and consisted of a simple 4 to 5 inch thick slab-on-grade (no foundation). The samples taken at this location consisted of two ring samples (one after another) at the base of existing concrete slab, and a grab sample.

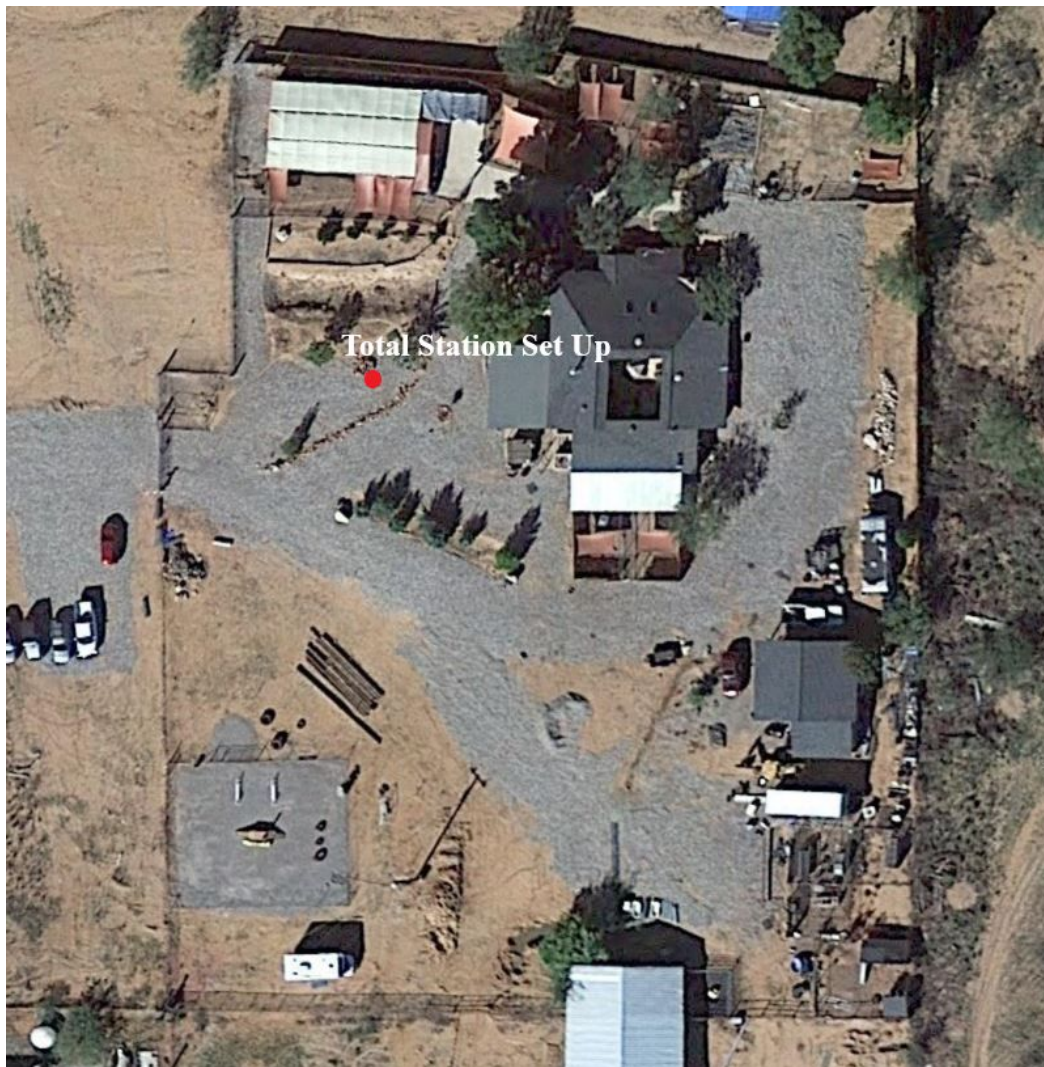
Figure 3-5 : Total Station Set Up Location

The survey was performed on February 8, 2020. The starting point of the survey was decided prior to heading into the field and an assumed northing, easting, and elevation for that point was determined. All other point elevations were based on the assumed point. The location of the total station setup can be seen in Figure 3-5. The total-station set-up point was marked using rebar with painted white top.

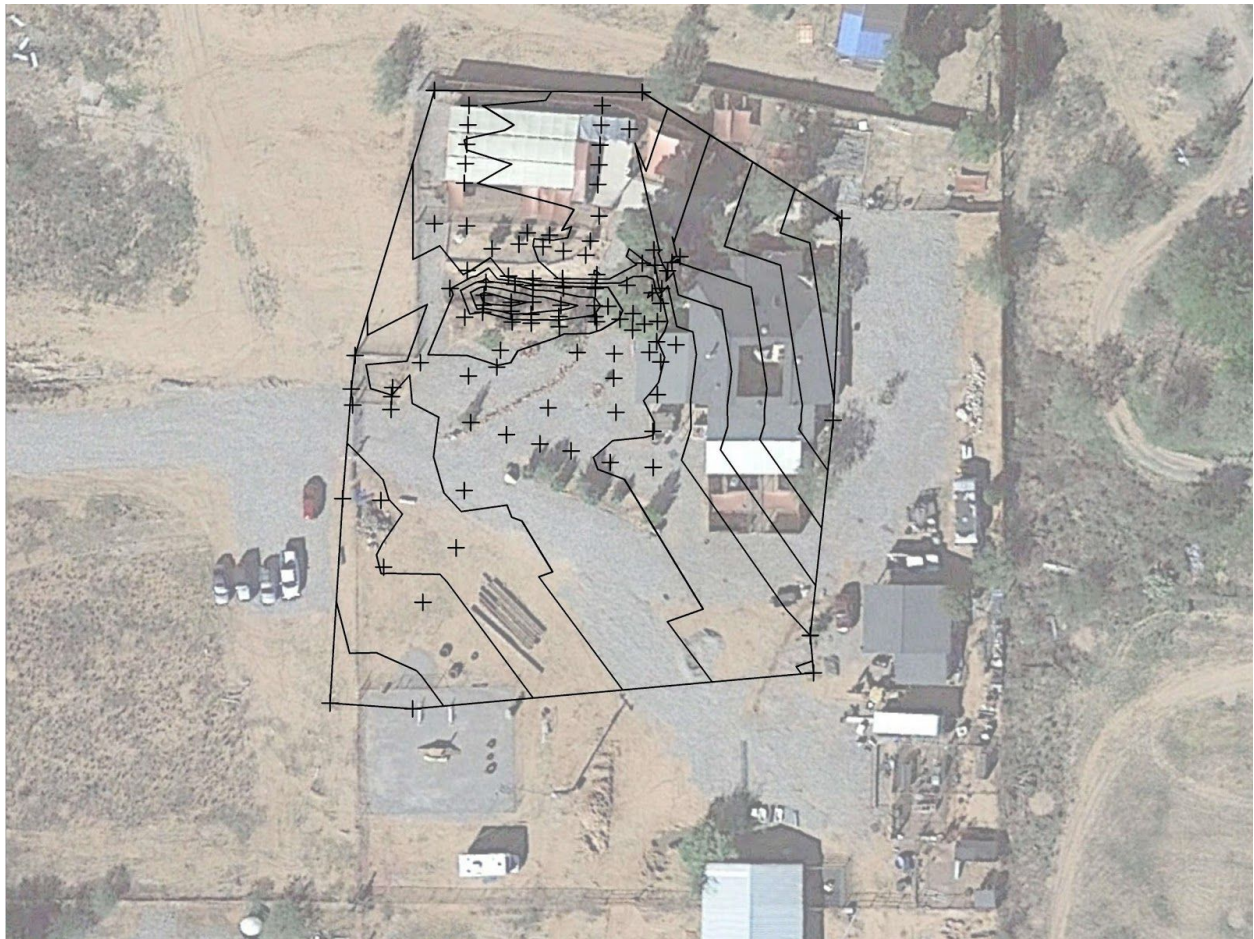
Figure 3-6 : Surface with Photo Reference

Using the data collected during the survey, a topographic map was made of the site. The topographic map with a reference photo of the site behind it can be seen in Figure 3-6. The topographic map can be seen in Figure 3-7. There were 94 points taken in the field in the form of point, northing, easting, elevation, and description. There were 16 points added to the surface using Google Earth for a total of 110 points. These points were deemed sufficient due to the dogs being under duress during surveying. The csv point file contains 94 points and was used to create the surface and can be seen in Appendix C.

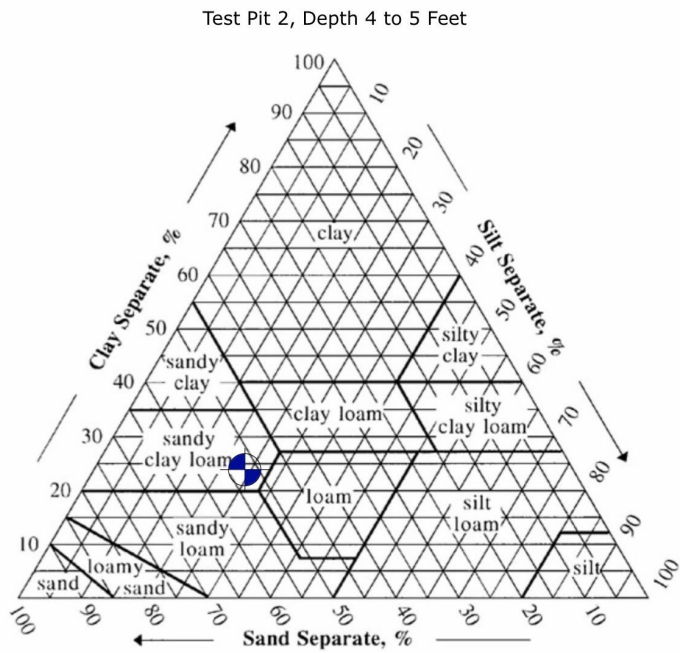
Figure 4-4: USDA soil texture chart for Test Pit 2 at a depth of 4 to 5 feet.

Figures 4-4, 4-5, and 4-6 depict the USDA soil texture chart at the depth of 4 to 5 feet in Test Pits 2, 3, and 4. The USDA soil texture chart results show that the soil at Test Pits 2, 3, and 4 is Sandy Clay Loam.

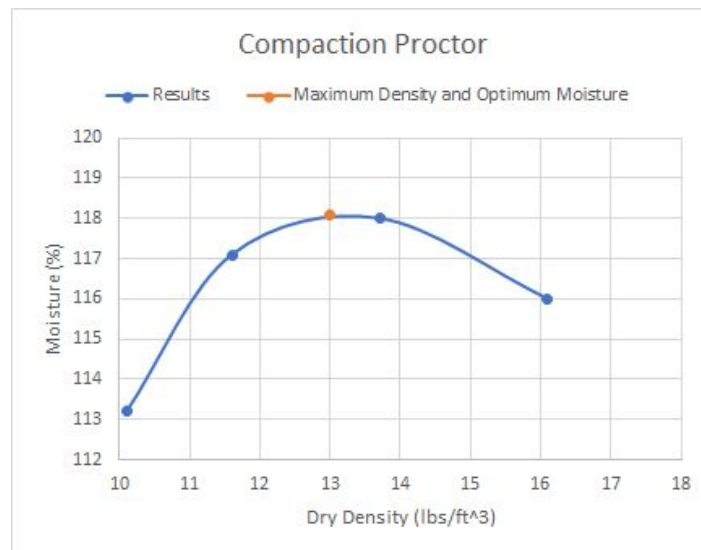
Figure 4-10: Results of the compaction proctor test.

Compaction proctor tests were performed on the bulk sample collected from Location 1 and performed in accordance with ASTM D698-12e2 [11]. Samples from Location 1 were the only ones used because Location 1 is where the concrete pad will be. The soil compaction is only needed for a structurally sound concrete pad. Results of the test can be seen in Figure 4-10. A maximum density of 118.1 lbs/ft<sup>3</sup> and optimum moisture content of 13.0% was determined. If no additional soil is used to produce grade under proposed kennel this data can be used to compare field density to determine rate of compaction and moisture content compliance.

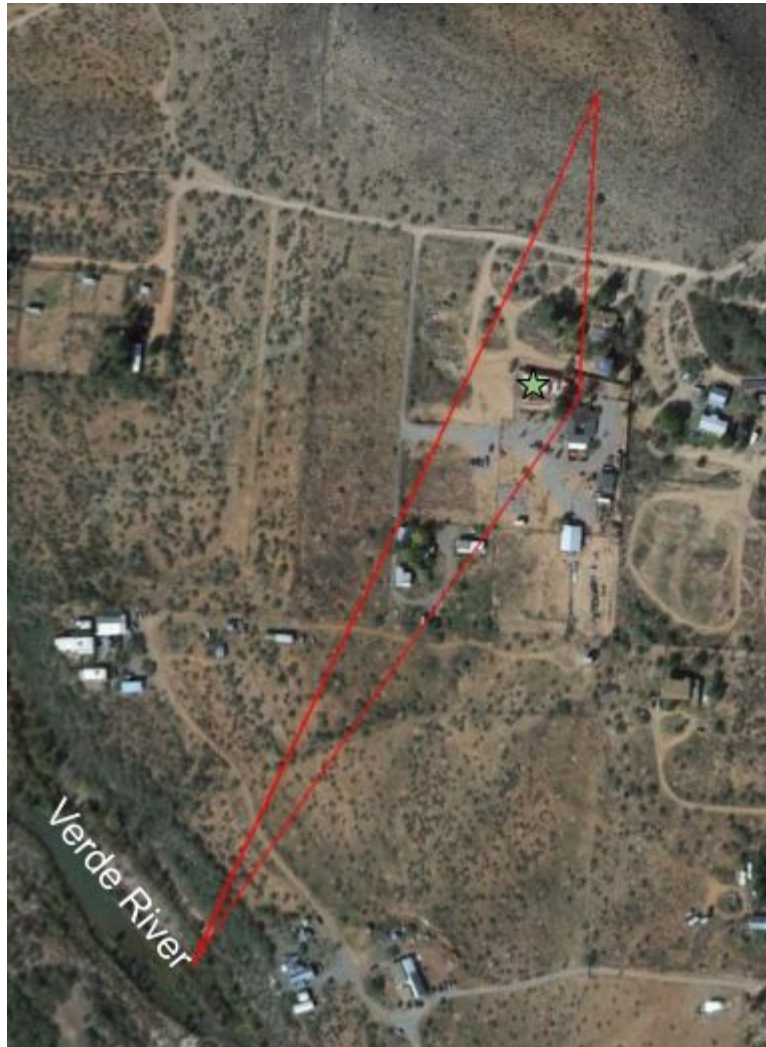
Figure 5-2: Drainage Area

The “sub-basin” used to analyze the hydrology of the site was the drainage area determined using the topography of the area. Figure 5-2 below shows the drainage area used to analyze the hydrology of the site. The drainage area is outlined in red and the kennel space is marked by a green star.

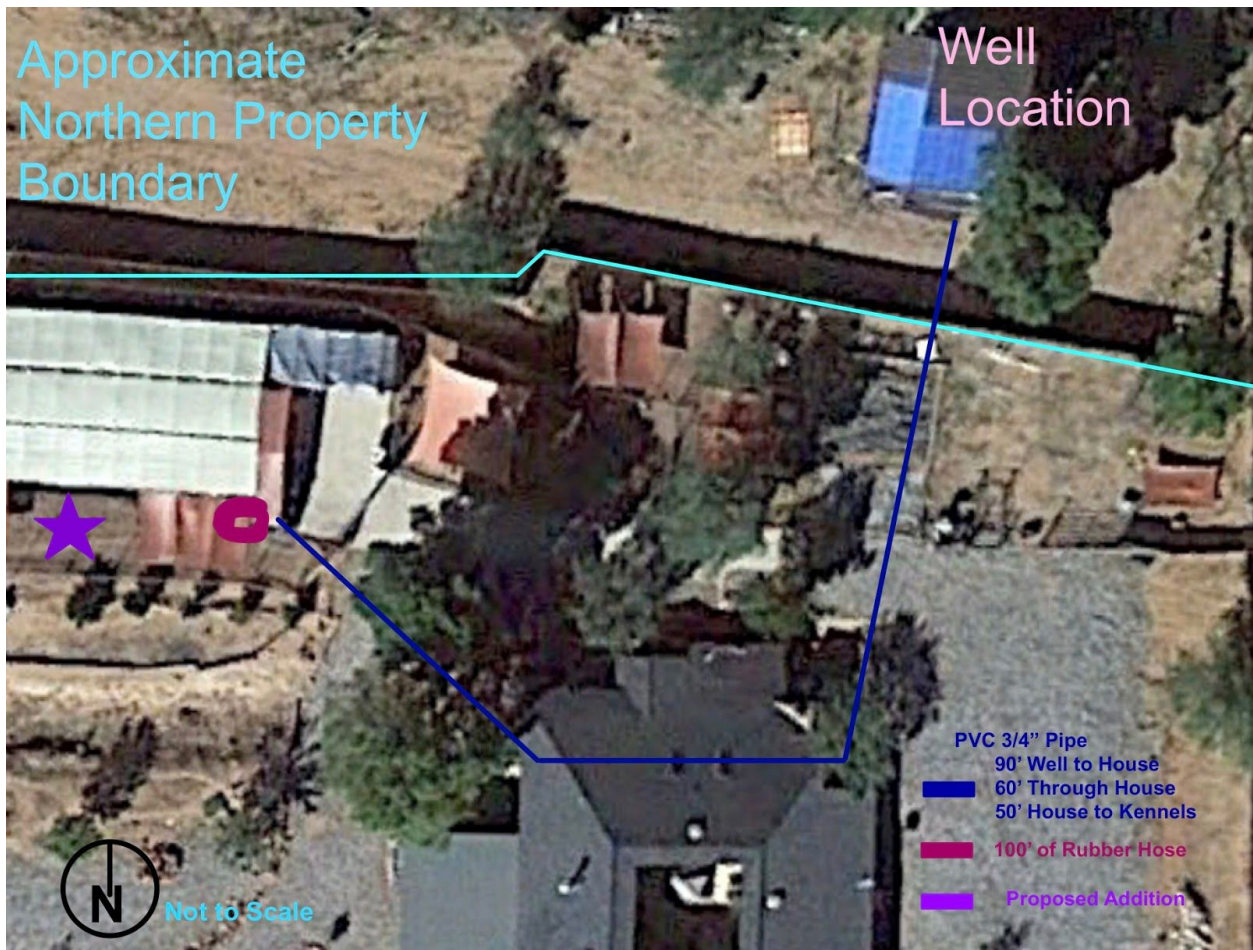
Figure 6-1: Existing well location in respect to the site location and pipe system. Star represents the general location of the project location. Figure is not to scale.

Bernoulli's Equation (see Equation 6-1) was utilized to determine the volume of flow utilized to sanitize the kennel space. The client uses a well pump system north-east of the existing slab (see Figure 6-1) to supply water to his hose to wash the kennel space. The client informed us that the pump supplying pressure was of 60 psi.

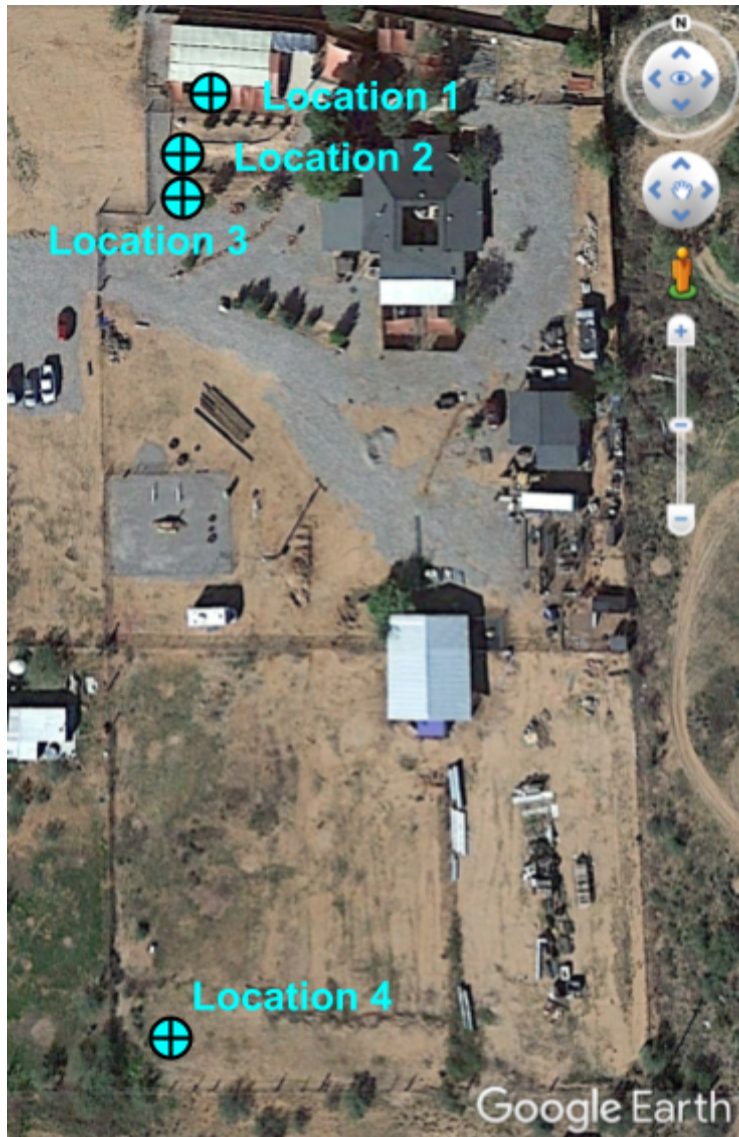
Figure 1: Test Locations

There are four proposed test locations. These test locations can move as needed by the client's needs or request, location of utilities, and the discretion of the field engineer. For proposed test locations see in Figure 4.1 below, marked by the circles with crosses.
