Geotechnical Data

Pets Return Home Project

Ruff Engineering

**Northern Arizona University
Flagstaff, Arizona**

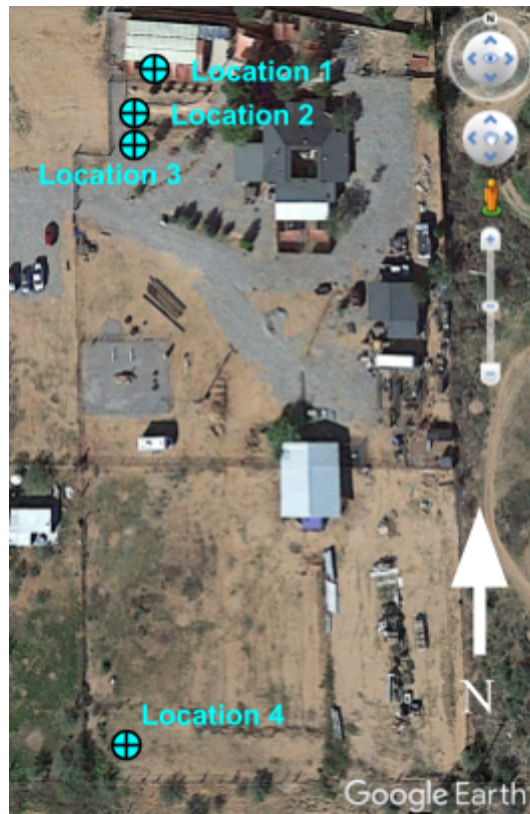
Figure 1: Test Pit Diagram

The geotechnical investigation was performed on January 31 and February 1, 2020. Prior to the investigation, four test pit locations were designated and Arizona 811 was called to ensure that no public utilities were within the vicinity of the locations. The test pits were excavated in accordance with the Sampling and Analysis Plan (see Page 19). Four locations were excavated, one hand excavated and the other three were excavated with a backhoe (Case 580 with 18-inch bucket). The excavations ranged from about 2 feet to 4 feet below existing site grades at the approximate location shown on Figure 1 and the typical test pit characteristics can be seen in Figure 2. Logs of the test pits are presented on Page 25. Subsoils encountered during excavation were examined visually and sampled at selected depth intervals. In addition, three field infiltration tests were performed in proposed sanitary leach fields and stormwater retention basin. Ring samples and large grab samples were taken at each location. Samples were labeled according to the job, test pit location, and depth that the sample was obtained. For example of a sample label, PRH 1(0-2), PRH would have indicated the job (Pets Return Home), location 1, and the depths of 0 to 2 foot depth.

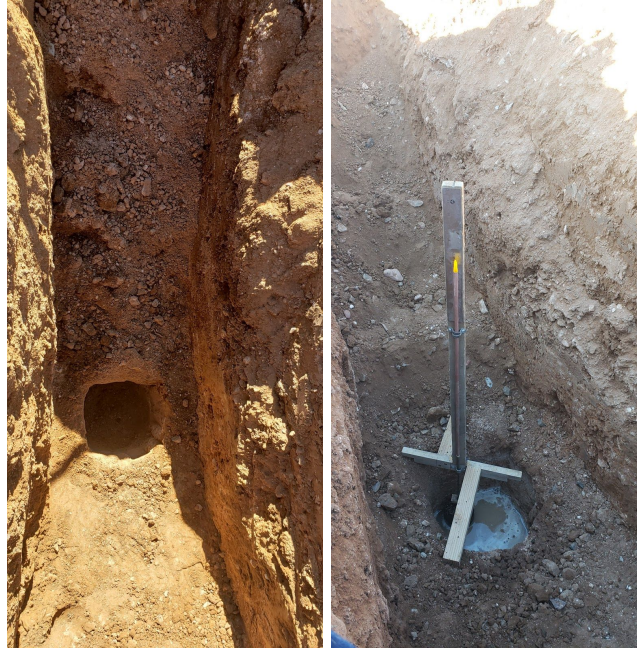
Figure 2: Typical test pit after excavation (right) and a test pit with ongoing infiltration test (left).

A field log was prepared for each test pit by the field engineer during the excavations. These logs contained visual classification of the materials encountered during the excavation as well as interpolation of the subsurface conditions between samples. Final logs, included starting on Page 25, represented our interpretation of the field logs and included modifications based on laboratory observations and laboratory tests of the field samples. These logs, with the results of the infiltration tests, can be found starting on Page 25. Infiltration tests were performed at Locations 2, 3, and 4, at the base of excavation with the presoak on January 31st, and the final test on February 1st.

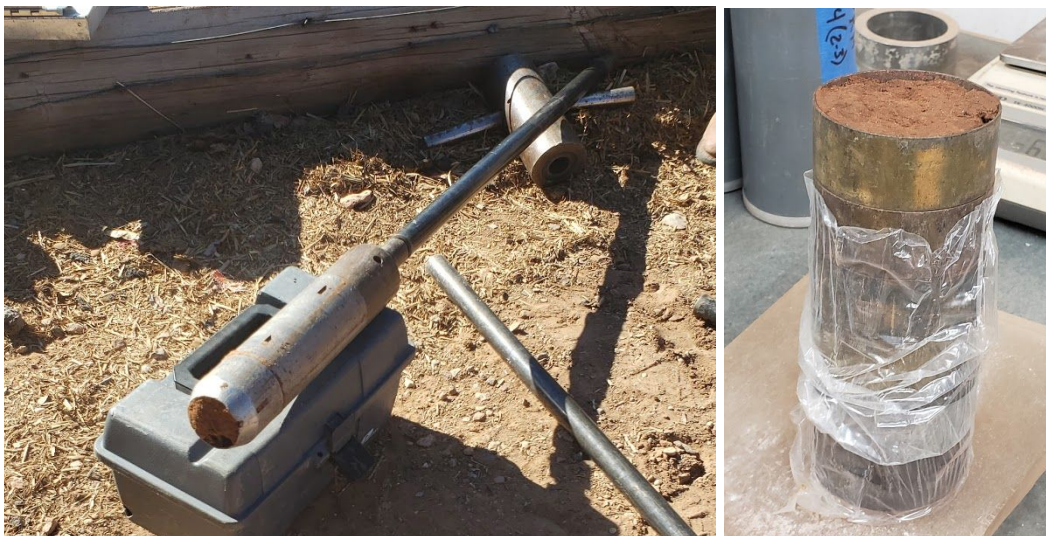
Ring samples were taken by a hand operated device that drives a sampler that consists of multiple rings. Figure 3 shows the device and typical ring. The rings were constructed out of brass and with dimensions of 1-inch high and an inner diameter of 2.42 inches. After the sampler had been driven into native soil, the bottom six rings were collected as a single cylinder, placed in a plastic bag, and then placed in a protective plastic sleeve with lid and labeled. This protected this type of sample so that in-site characteristics of the soil can be determined in the lab. These ring samples determined the moisture, density, and consolidation/compaction of the existing soils in place.

Figure 3: Collected sample in hand operated device (right) and sample in rings at lab (left).

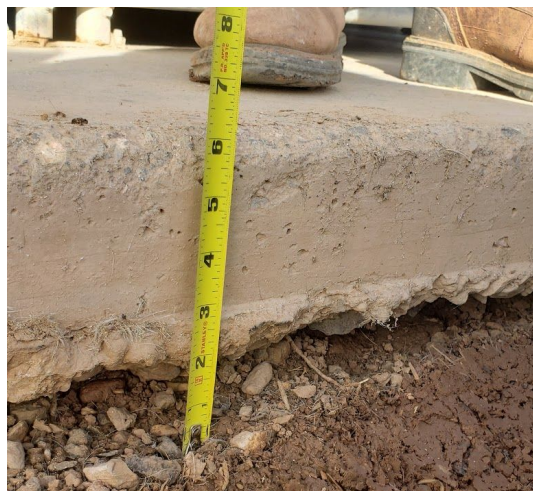
Figure 4: Measurement of the existing slab.

Test pit of Location 1 was chosen due to its close proximity to the proposed expansion of the concrete slab that was planned to be used for kennel space and was hand excavated. It was located along the center of the south side of the existing kennel space. During the hand excavation, the existing concrete slab was observed (see Figure 3-4) and consisted of a simple 4 to 5 inch thick slab-on-grade (no foundation). The samples taken at this location consisted of two ring samples (one after another) at the base of existing concrete slab, and a grab sample.

Test pit logs indicated the observed soil classification and characteristic was Clay Sand; trace to some gravel; brown, loose, moist to wet, and might be a subbase fill. Due to the kennels being washed daily, these soils generally stay moist to wet. Excavation stopped at 2 feet.

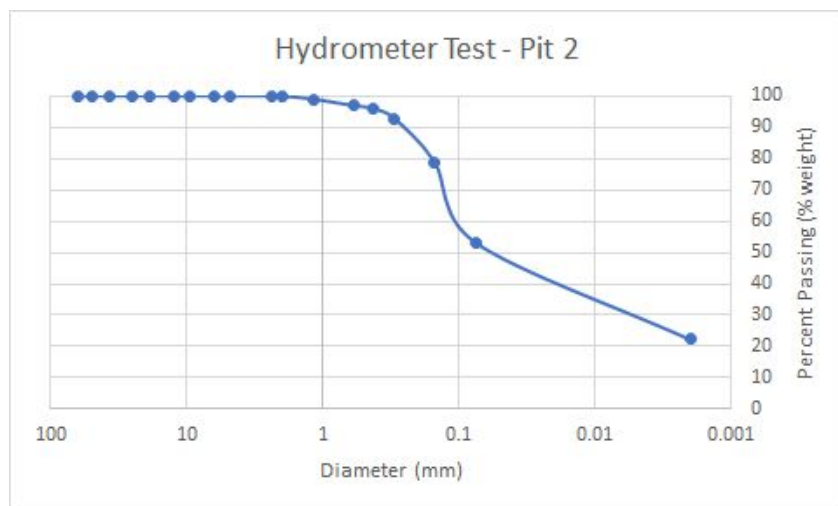
The hydrometer test was done in accordance with ASTM D7928-17 [9]. Results of the hydrometer tests performed at Test Pits 2, 3, and 4 are depicted graphically below in Figures 5, 6, and 7. The results of the hydrometer tests were used to determine the USDA soil classifications of the three test pits.

Figure 5: Results of hydrometer test at Test Pit 2.

Table 2 below shows the percentages of sand, silt, and clay for each of the test pits. These percentages were used for the USDA triangles to determine soil classification.

Test Pit	% Sand	% Silt	% Clay
2	55	25	20
3	55	15	30
4	65	15	20

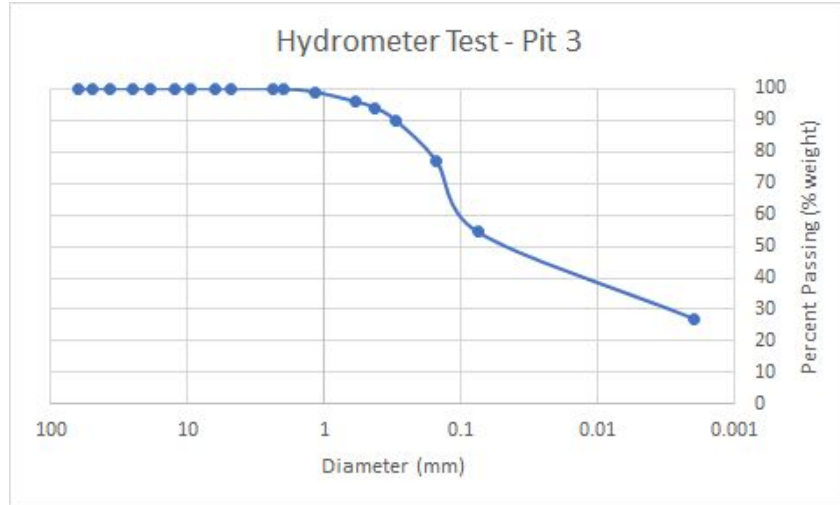
Figure 6: Results of hydrometer test at Test Pit 3.

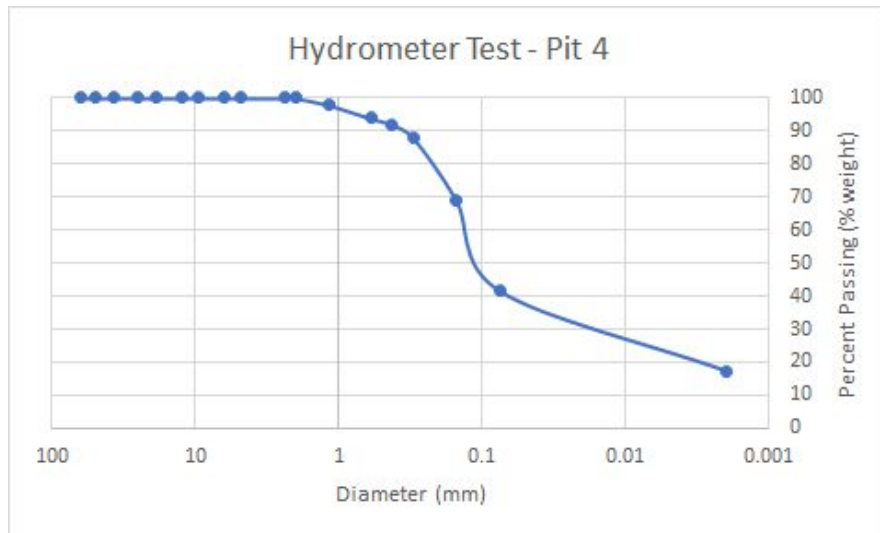
Figure 7: Results of hydrometer test at Test Pit 4.

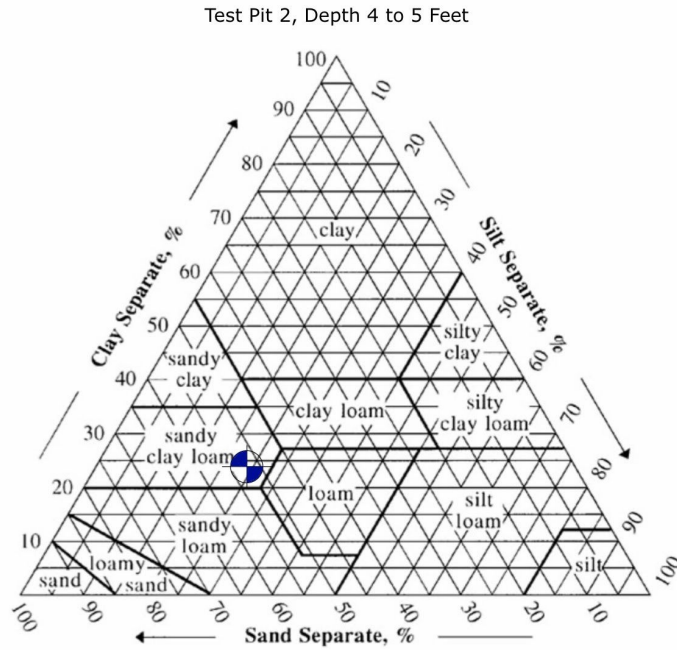
Figures 8, 9, and 10 depict the USDA soil texture chart at the depth of 4 to 5 feet in Test Pits 2, 3, and 4. The USDA soil texture chart results show that the soil at Test Pits 2, 3, and 4 is Sandy Clay Loam.

Figure 8: USDA soil texture chart for Test Pit 2 at a depth of 4 to 5 feet.

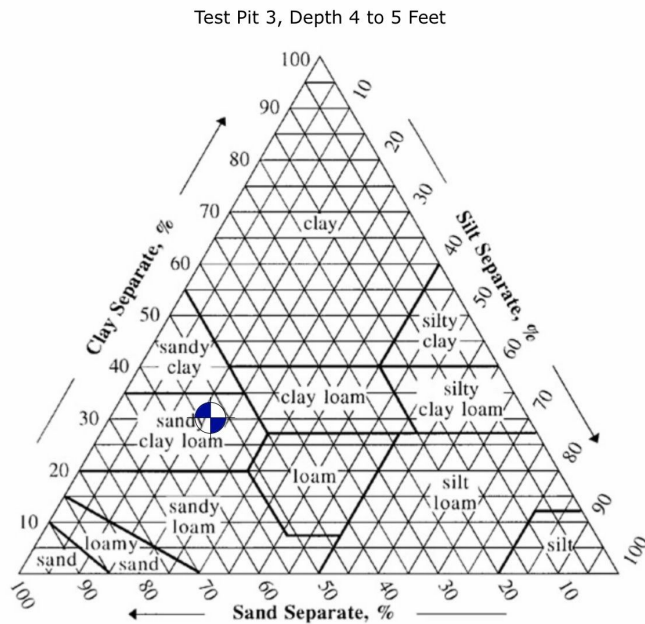
Figure 9: USDA soil texture chart for Test Pit 3 at a depth of 4 to 5 feet.

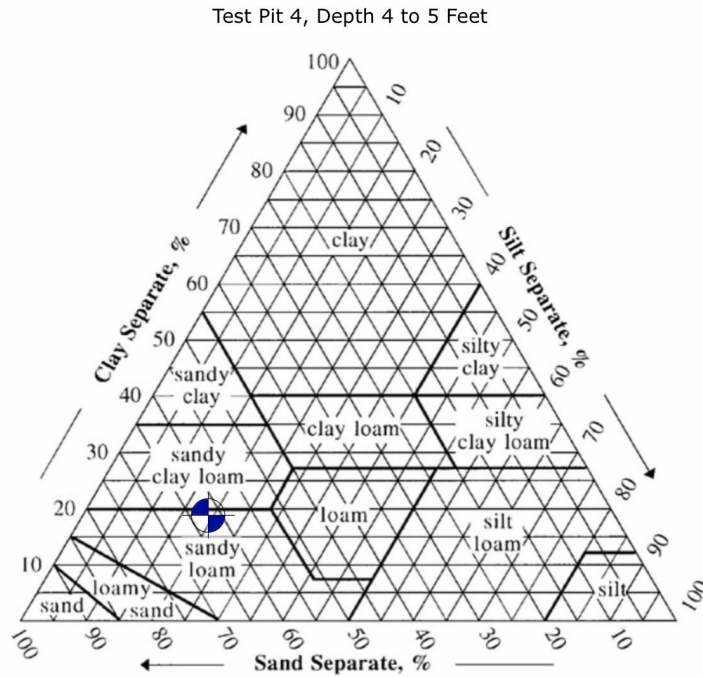
Figure 10: USDA soil texture chart for Test Pit 4 at a depth of 4 to 5 feet.

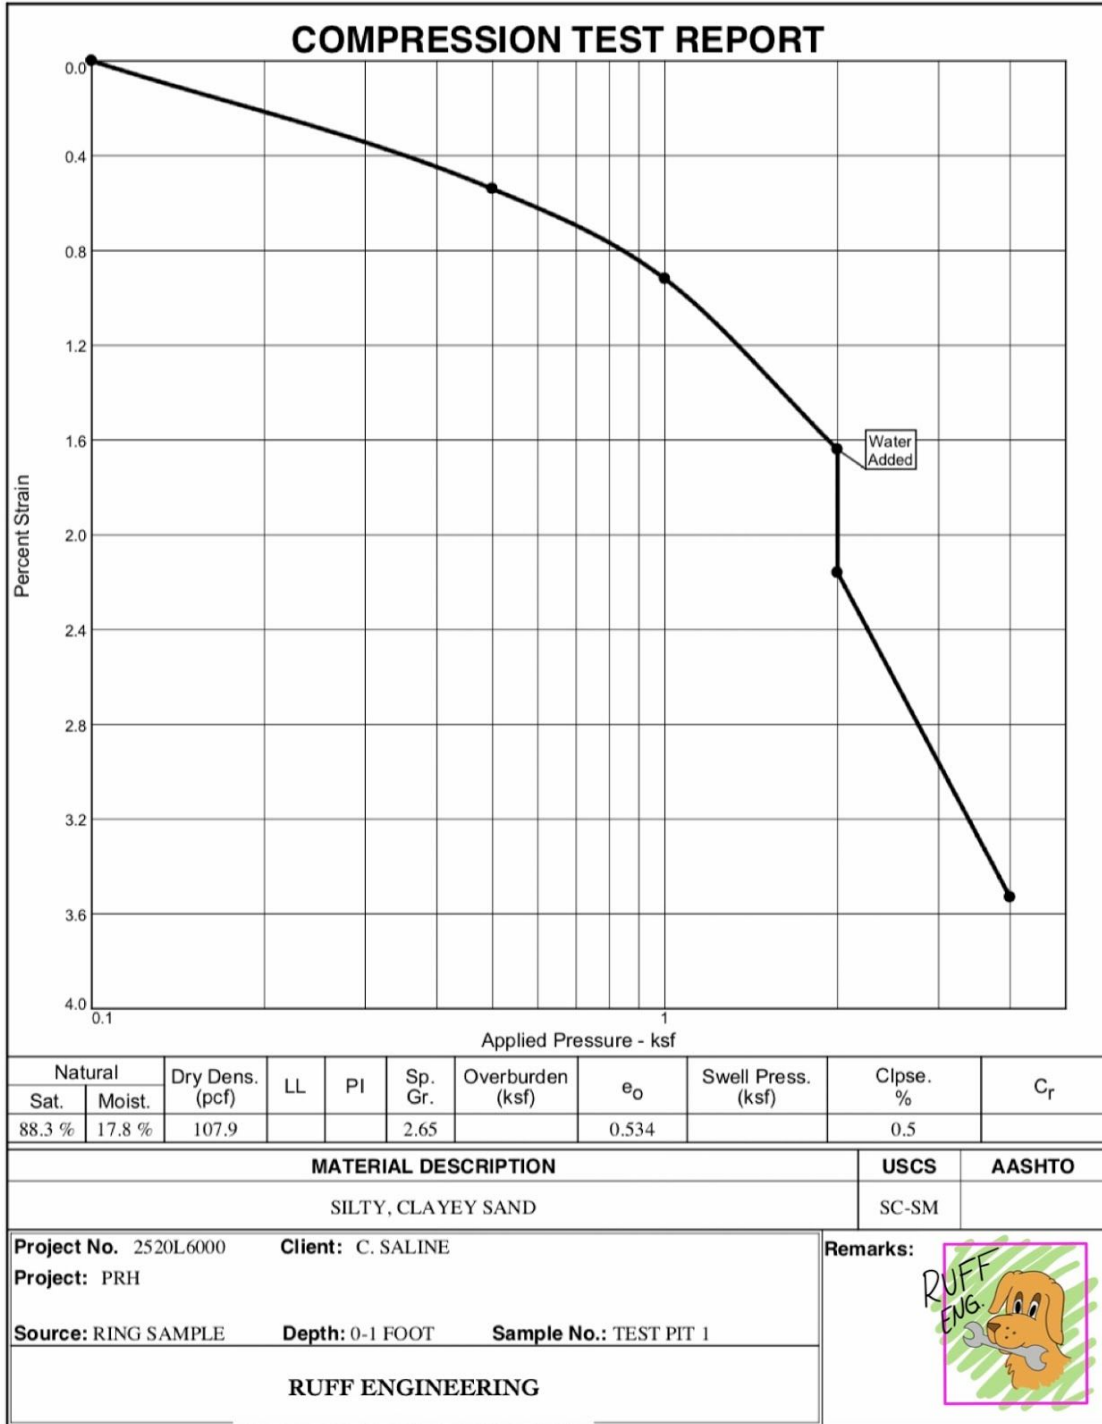
Figure 12: Location 1, 0-1 foot depth

The modified consolidation/compression test was done in accordance with modified ASTM D2435 [6] to determine how an in place soil will cope with different loads. Figures 12 and 13 show how the in-situ soil from the ring samples would handle different loads. The loads were added after the soil had stabilized from the previous load. The initial load is called the seating load and is 0.1 kpsf., and the following loads are 0.5 kpsf, 1.0 kpsf, 2.0 kpsf, saturation, and 4.0 kpsf.

The reason why this is considered a modification from a consolidation test is because the sample is not saturated from start to finish, but is saturated subsequent to loading of 2.0 kips per sq. ft. Due to the environment of Arizona soil conditions are not normally saturated but in a few cases, and to better understand how an in-situ soil supports loads with different conditions, hence the reason for the modification. This modification occurs after what would be considered the load required the soil to support a normal structure. Saturating the soil at the point sees what would happen if the footing were inundated with water and observing the hydro collapse for any potential issues.

The compaction of the surface soil can be compared to the Compaction Proctor results (see Section 4.1.7 below) and the upper sample had a compaction of 91.4 percent and the lower sample with 88.1 percent. These soils have been disturbed due to the freeze and thaw cycle, and the moisture content exacerbates this freeze and thaw condition. This condition produces gaps

between the particles in the soil causing the soil to collapse when loads are placed on them. This is why it is required to scarify and recompact the top 8” of soil under and extending 5 feet beyond the footprint of the proposed kennel. It is recommended that a large vibrating steel drum roller performs the compaction.

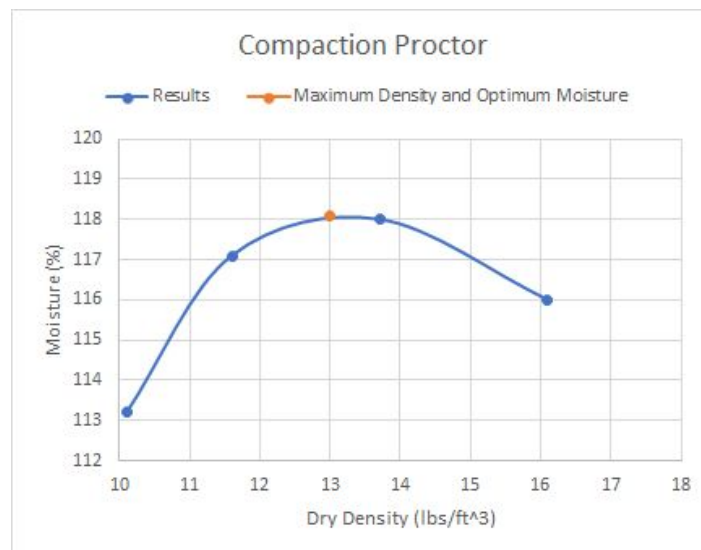
Compaction proctor tests were performed on the bulk sample collected from Location 1 and performed in accordance with ASTM D698-12e2 [8]. Samples from Location 1 were the only ones used because Location 1 is where the concrete pad will be. The soil compaction is only needed for a structurally sound concrete pad. Results of the test can be seen in Figure 14. A maximum density of 118.1 lbs/ft³ and optimum moisture content of 13.0% was determined. If no additional soil is used to produce grade under proposed kennel this data can be used to compare field density to determine rate of compaction and moisture content compliance.

Figure 14: Results of the compaction proctor test.

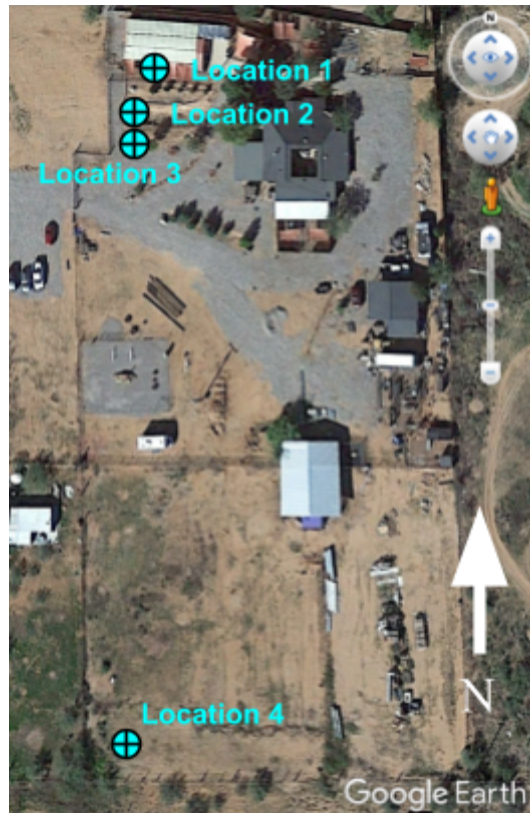
There are four proposed test locations. These test locations can move as needed by the client's needs or request, location of utilities, and the discretion of the field engineer. For proposed test locations see in Figure 4.1 below, marked by the circles with crosses.

Location 1: Adjacent To Existing Kennels

This location is to investigate the existing kennel pad. The investigation is needed to see the details of the previous construction of the slab/foundation, and to collect samples of existing fill and its condition. The test pit will be dug excavated by hand and should be no deeper than the depth of slab or footing of foundation. A bulk sample will be taken of every soil type and a ring sample will be taken at the base of slab or footing.
