# CANYON CITY MILL PA/SI FINAL REPORT

## CENE 486

Flag Environmental Solutions

March 21, 2023

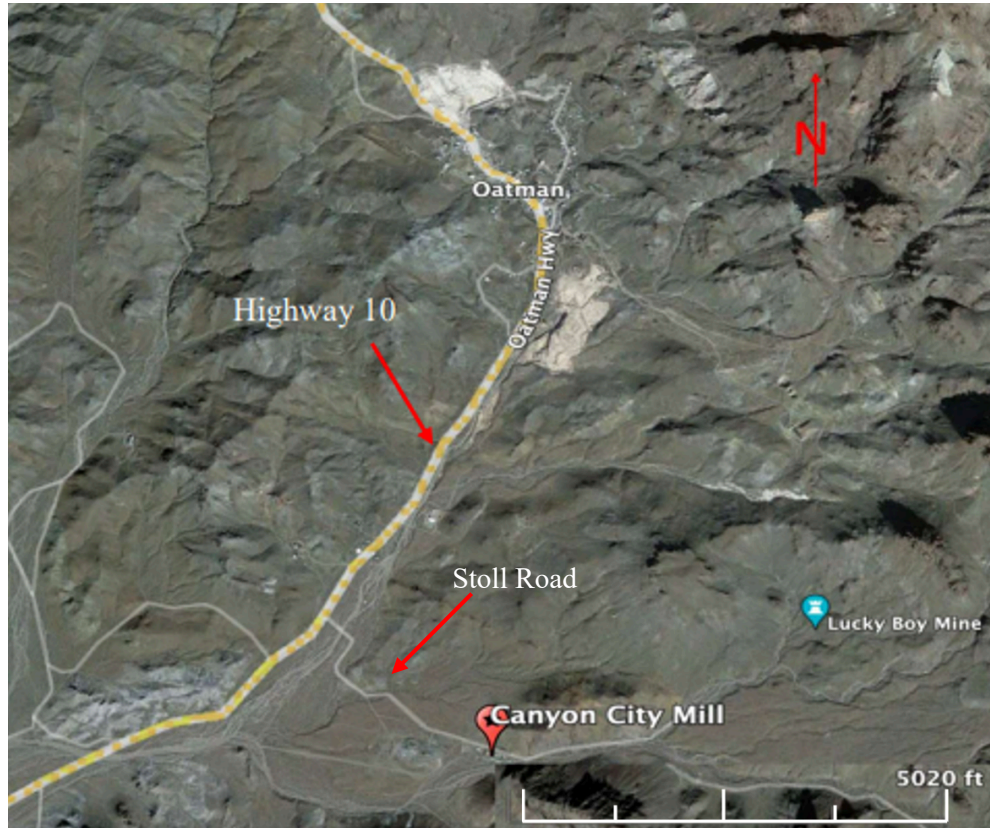
Figure 1.2: Site Location in Relation to Oatman

The site can be accessed from Flagstaff by traveling on I-40 westbound and exiting on State Route 10 (Oatman Highway). The Oatman Highway is followed for approximately 1.5 miles past the town of Oatman until Stoll Road is reached. Figure 1.2 below shows an aerial image of the site in relation to Oatman.

There are washes south of the site, which flow from northeast to west/southwest towards the Colorado River. The Colorado River is located approximately 14.5 miles downstream of the site [1]. Highway 10 is indicated by the yellow path in the top left corner of the image above. Stoll road can also be seen in the image above.

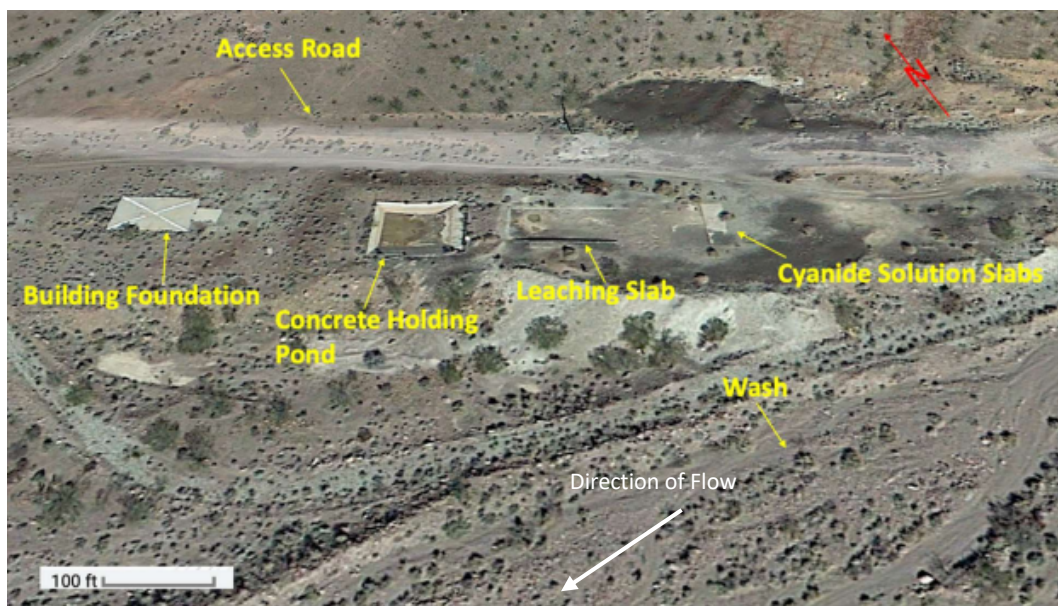
Figure 1.4: Current Site Condition [1]

In 1991, the three 30,000-gallon tanks holding the cyanide solution were dumped on the site. The Bureau of Land Management and the Arizona Department of Environmental Quality (ADEQ) Emergency Response Unit were contacted and informed of the spill. This prompted a site investigation in 1991, completed by ADEQ's Office of Waste and Water Quality Management [2]. The mill site has been abandoned since 1991 when extraction operations stopped after the cyanide solution spill. The operational equipment was subsequently removed from the site after operations ceased, leaving behind a concrete holding pond, multiple concrete slabs used for holding cyanide solutions and cyanide leaching, a building foundation, and debris. Figure 1.4 below shows the current site conditions as found from Google Earth aerial imagery. The access road runs to the north of the site, and a wash is present to the south of the site that runs in the southwest direction towards Oatman Highway.

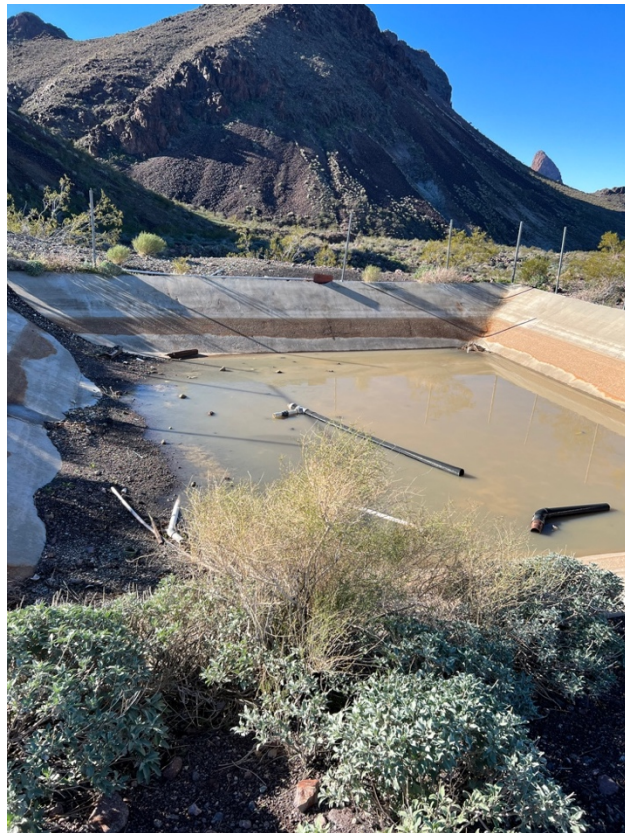
*Figure 3.1: Abandoned Sedimentation Pond (photo credit: Frankie Martinez)*

The border of DU1 was defined as the location where industrial activity occurred. DU1 includes all areas where cyanide leaching processes occurred, such as the concrete holding pond, concrete slabs where equipment was held, and the leach field. DU1 is a highly disturbed area with remaining PVC pipes, metal pipes, concrete, and trash from the original operation. Soil types in DU1 ranged drastically every few feet from red clay, gravel, black sand, and sandy clay. From the previous days of heavy rain, standing water was observed in the concrete basins at the site, and at the base of the spent ore piles as well. The standing water can be observed in Figures 3.1 and 3.2 below.

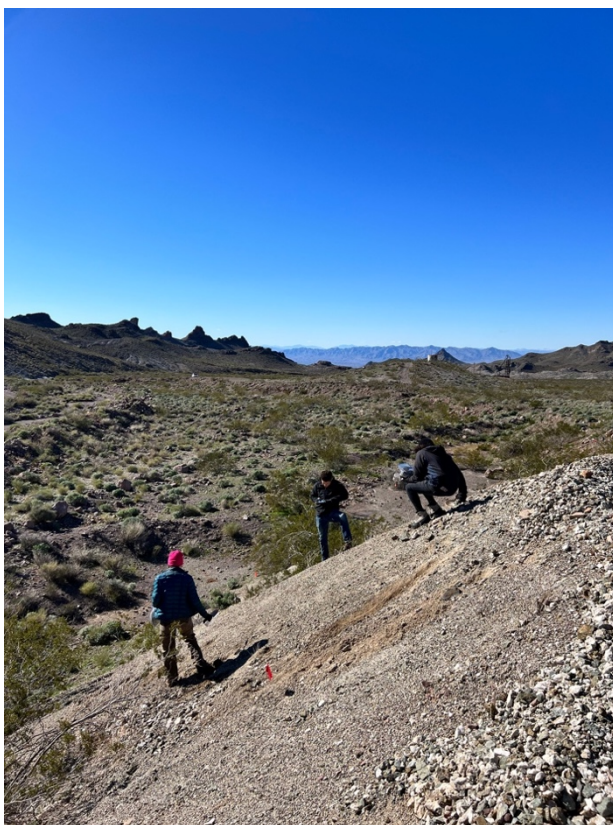
*Figure 3.3: Site Terrain (photo credit: Claire Griffiths)*

The steep nature of the spent ore piles can be observed in Figures 3.3 below. Steep slopes from waste piles border the south edge of DU1.

DU2 started at the access road and stretches down to the berm, built-up approximately 5' high adjacent to the wash in a likely attempt to prevent material from entering the wash. The area to the west of DU1 appeared to possibly have been bulldozed flat in the past. This area had a great number of shrubs and vegetation, and included steep slopes immediately south of DU1. Additionally, a minor wash has developed through the south edge of DU2, joining the main wash further downstream. Soils appeared to both sand and clay. Clay was found closer to the access road and sand was more towards the berm. The steep slopes made gridding the subsample areas difficult, which is why imperfections in the grids can be seen in Figures 3.5 below. The steep slopes are exemplified in Figure 3.3 above.

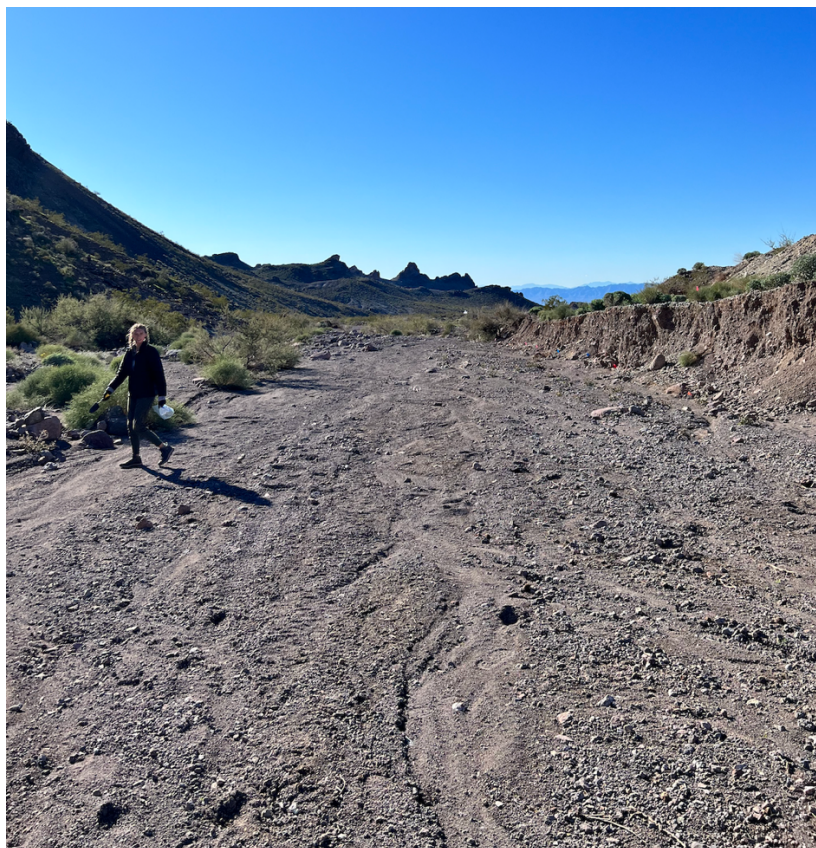
*Figure 3.4: Soil Type in the Wash*

DU3, the wash, started at the southeast point of DU1 at the bank of the wash and went approximately 500 feet downstream. Although the original sampling plan included traversing the wash from the site to substantially farther downstream, this DU was based upon the belief that a representative sample of the wash should be taken adjacent to the site and not further downstream, as no information was known regarding contamination of the wash. The wash is bordered by a mountain to the south and the berm to the north. The wash broke into smaller sections that rejoined downstream, typical of a western dry wash. The wash had some vegetation, particularly on the banks, but not a great amount. This area mainly consists of gravel and sand soil types, which is consistent with washes in this area. Figure 3.4 below exemplifies the soil type in the wash.

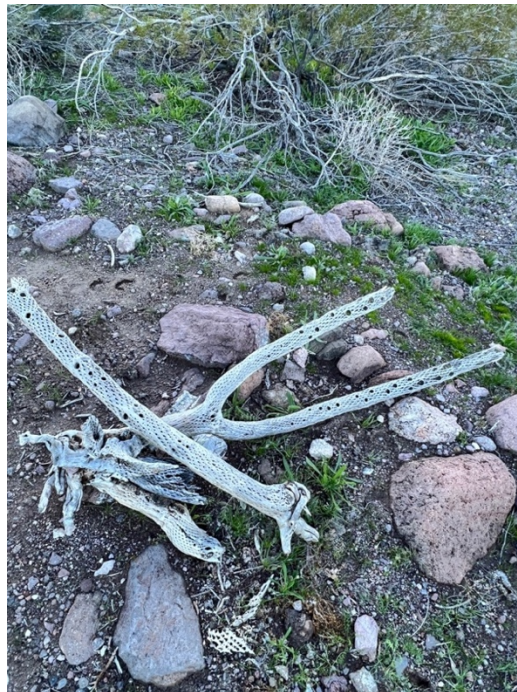
Figure 3.6: Cholla Cactus at Site (photo credit: Claire Griffiths)

During the site investigation, vegetation was observed lining the wash, roads, and all throughout DU2. The following vegetation was observed throughout the site: brittlebush, cholla cactus, barrel cactus, creosote bush, among other common desert vegetation not identified. An image of a decaying Cholla Cactus observed in DU2 is shown in Figure 3.6 below.

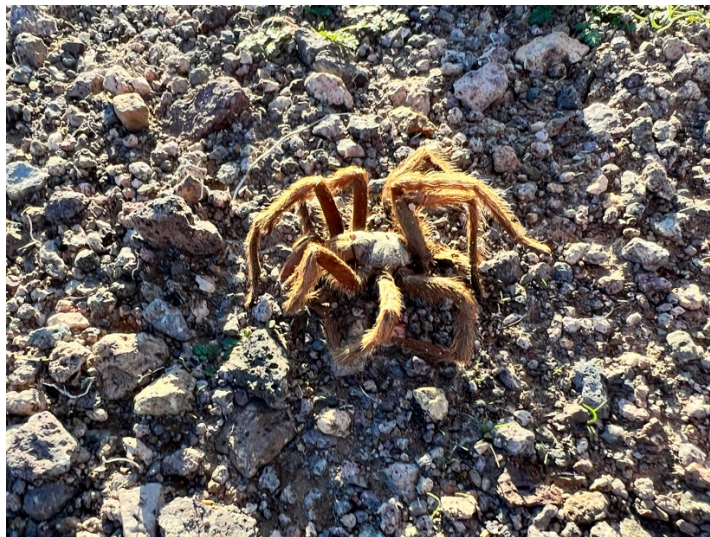
*Figure 3.8: Mojave Tarantula Molt Observed at Site (photo credit: Claire Griffiths)*

Jack rabbits, lizards, sparrows, crows, and other common birds were also observed during the site investigation. A Mojave tarantula molt was observed in DU2. It was apparent that DU2 experienced heightened biological activity due to the undisturbed and vegetated nature of the area when compared to DU1. An image of the tarantula molt is shown in Figure 3.8 below.

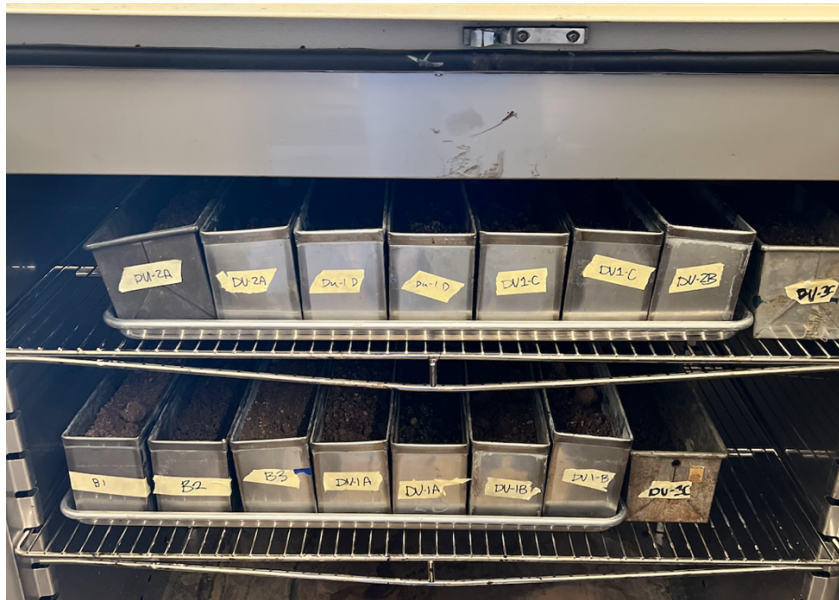
*Figure 4.1: Samples Drying in the Oven*

Each soil sample was dried according to ASTM Method D2216 for approximately 17 hours at 110 degrees Celsius. Samples were poured from the Ziplock bags into clean metal drying containers that were labeled to reflect the location of the samples. For example, the drying container containing sample A from DU1 was labeled DU1-A. All 17 samples were able to be dried in one batch overnight on February 2<sup>nd</sup>, 2023. After the samples were removed the next morning, they were inspected to ensure thorough dryness. An image of the samples in the drying oven is shown in Figure 4.1 below.

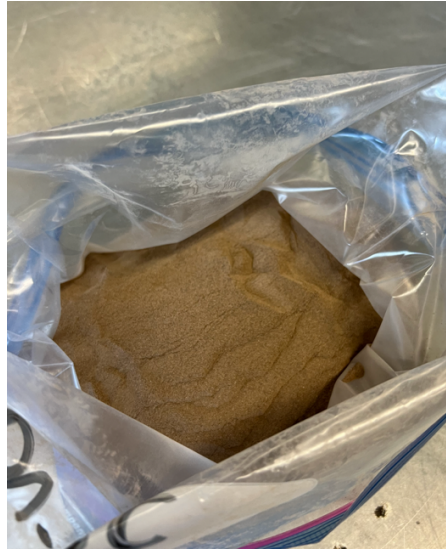
*Figure 4.2: Dried and Sieved Fine Sample Material (photo credit Evan Downs)*

After drying, the samples were broken up using rubber mallets to provide better homogeneity within the sample. Clay and silt-like materials in the samples were in large, hard clumps after drying, which were necessary to break down so that they would pass through the sieves as intended.

Samples were sieved using the 60-mesh sieve for 6 minutes each on the sieve shaker. #8-mesh and #30-mesh sieves were used on top of the 60-mesh sieve to aid in the sieving process. Due to the samples' size, it was necessary to sieve one half of each sample on the sieve shaker at a time,

to ensure that all fine materials were reaching the bottom pan of the sieve. After the samples were sieved, the fines were added to labeled Zip-lock freezer bags and stored in a bin. An image of the fine material collected from a sample is shown in Figure 4.2 below. The sieves and any other tools used (scoops, mallets, etc.) were cleaned between samples with compressed air.

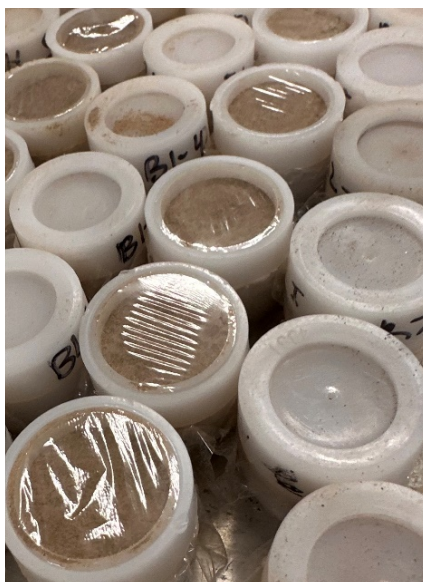
*Figure 4.3: Subsample Cups (photo credit Frankie Martinez)*

After prepping the samples, the team performed an XRF analysis. A Niton XL3t XRF was used. Each sample was subsampled nine times; subsamples were placed into the XRF testing cups. Cups were capped using a thin plastic film and the lid of the test cup. Since 9 subsamples were created from each sample, this resulted in a total of 153 subsamples. The subsamples are shown in Figure 4.3 below.

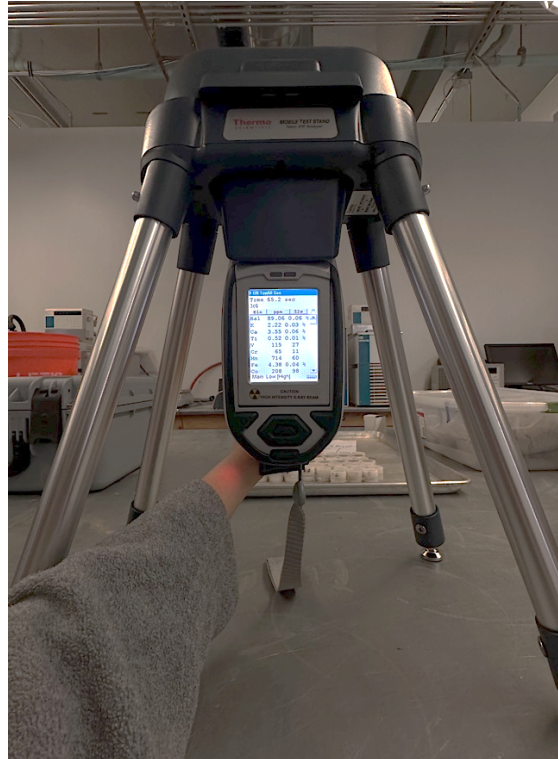
Figure 4.4: XRF Analysis (photo credit Frankie Martinez)

Each subsample was placed into the XRF test stand and were analyzed for 90 seconds. Figure 4.4 shows the XRF positioned in the test stand for analysis.

Raw XRF data are available in Appendix E. The maximum lead level detected was 376 ppm and the minimum lead level detected was 22 ppm. In the presence of high lead levels, XRF readings of arsenic can be inaccurate due to overlap in XRF frequency detection. EPA Method 6200 specifies that confirmatory analysis of arsenic levels is needed if the lead to arsenic ratio is greater than 10:1 [33]. The highest lead to arsenic ratio present at the site is 4.7:1. It was determined that the arsenic levels were accurate and confirmatory analysis was not needed.

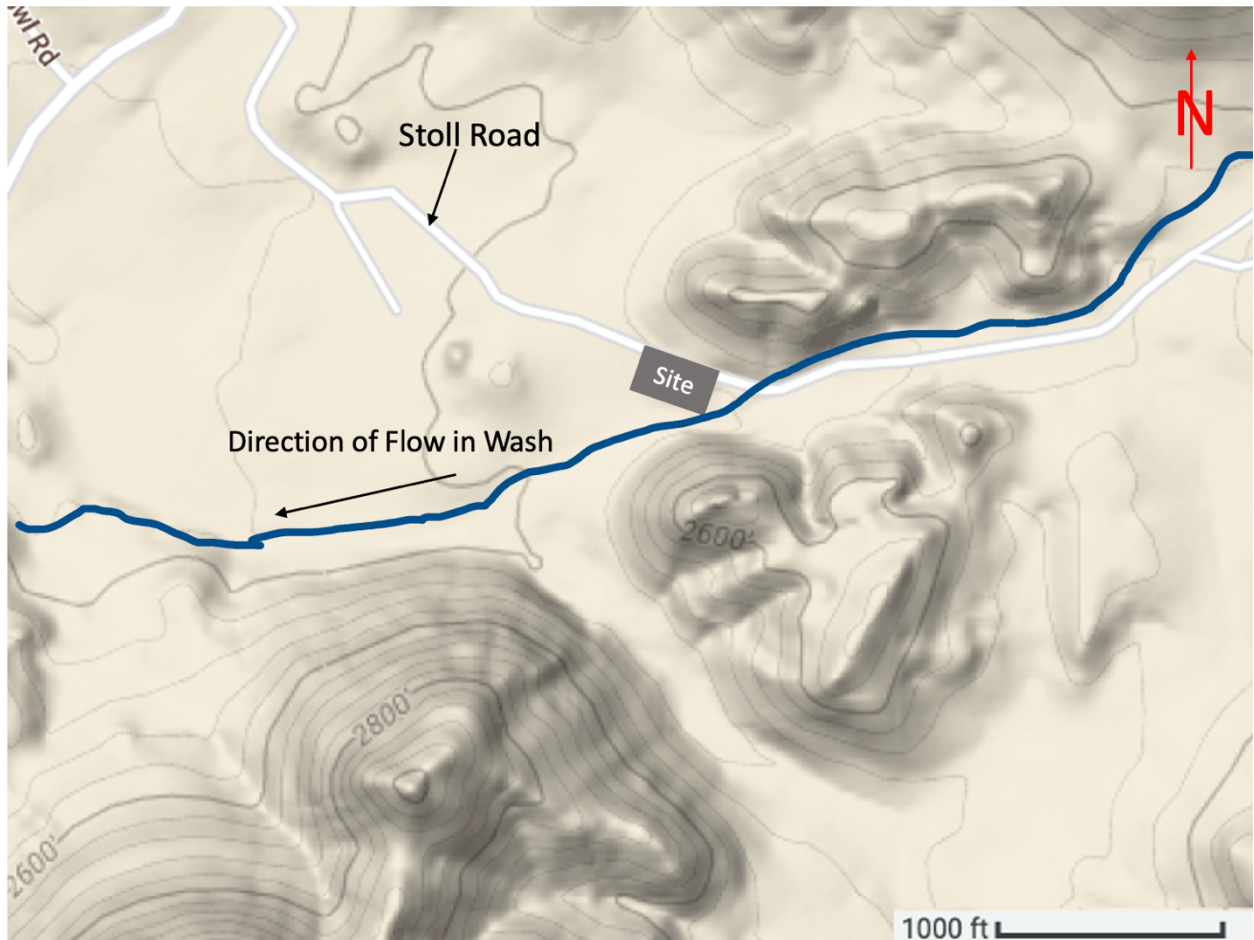
Figure 6.1: Site Topography

Figure 6.1 shows the topography surrounding Canyon City Mill. Mountainous terrain can be observed, and there are two hills to the north and south of the site at approximately 2600 feet in elevation. A wash immediately south of the site flows west to the Colorado River, as discussed in section 1.2.

The topography at the site shown in Figure 6.1 indicates that incoming runoff comes from the hill north of the site. The overland flow would flow through the site, then enter the wash to the south of the site. This presents the greatest risk for contaminant migration through erosion of contaminated soils via overland flow. At this time, the data do not show that contamination from the site has migrated into the wash, as DU3 soils did not contain elevated levels of arsenic or levels above background for the ecological COCs.
