Parabolic Trough-Solar Tracking and Energy Extraction

Final Report
Document

*Submitted towards partial fulfillment of the requirements for
Mechanical Engineering Design II – Spring 2015*

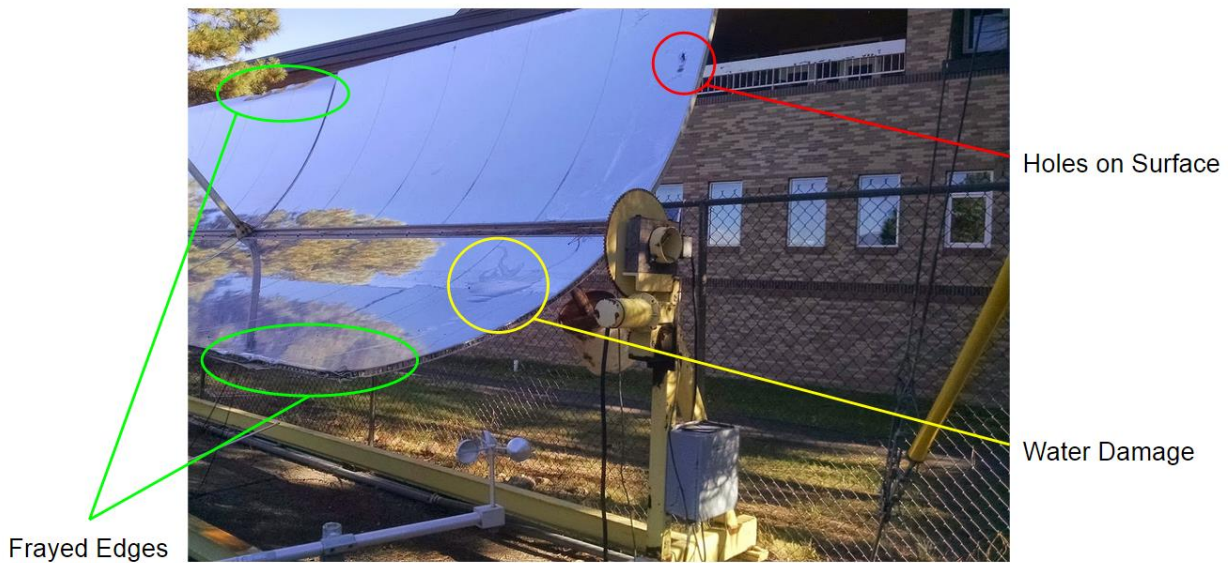
Figure 1 - Parabolic Initial Condition

In this section the team will discuss the initial conditions of the parabolic trough. The first topic covered is the condition of the tires. The pre-existing tires on the trough were flat and weather damaged. The team tried to restore the tires and inflate all four tires. Cracks from years of sun and weather damage prevented the air to stay in the tire. The next topic is the chain. On further inspection we did not find a chain on the gears located on the trough. Due to a nonexistent chain, the parabolic trough could move about freely. The gearbox, with years without operation, has not been maintained. Over 15 years of sitting, the oil has drained from the upper level of the gearbox and into the lower level. The oil left in the lower gearbox was black and gritty. The gasket keeping the oil from leaking has failed. Most of the oil dripped down the

frame below the gearbox. The pre-existing motor was inoperable. Upon further inspection, water came into contact with some internal parts and caused it to rust. The edge and the surface of the trough had significant damage. The edge lost some of its trimming so water and other debris made its way into the honeycomb material in the parabolic surface. The initial trim was made of plastic, and most of the trim was brittle from the sun and weather. Some edges were frayed from rotating freely and hitting the fence. The surface of the parabolic trough had some puncture holes due to various weather and external forces. From the frayed edges and holes, water made its way in between the plastic film and the reflective material of the trough. The control box also had water damage, along with a vast array of outdated electrical components. The gasket around the door failed, resulting in water and debris making its way into the control box. There was significant damage to the wires and other electrical components. The chord for the power source was left sitting on top of the control box causing the weather and sun to damage it. Other wires on the trough were also left hanging.

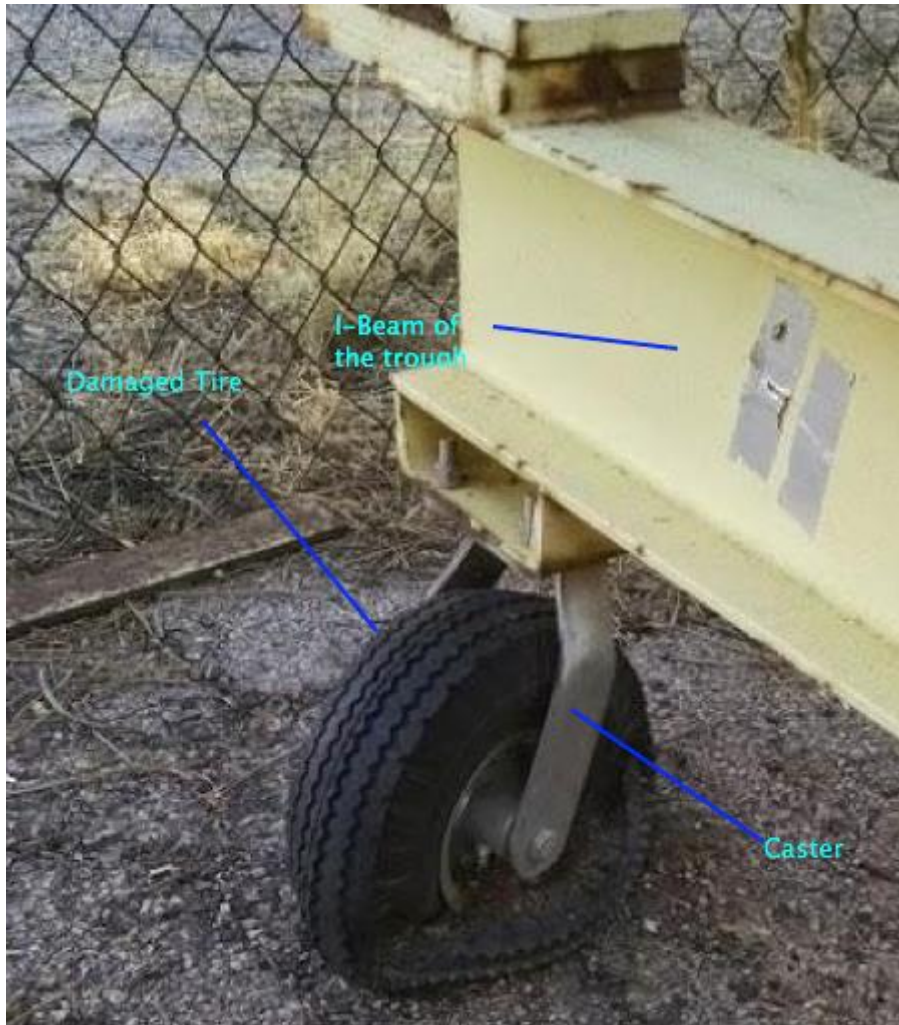
Figure 2 - Damaged tires

At the beginning of the semester, the parabolic trough's four tires, one shown in Figure 2, were all damaged and needed to be replaced.

The tires were replaced with Marathon 4.10/3.50-4 tires, which cost \$14.50 per tire plus shipping. After the tires were purchased, the team started the process of installing the new tires on the trough.

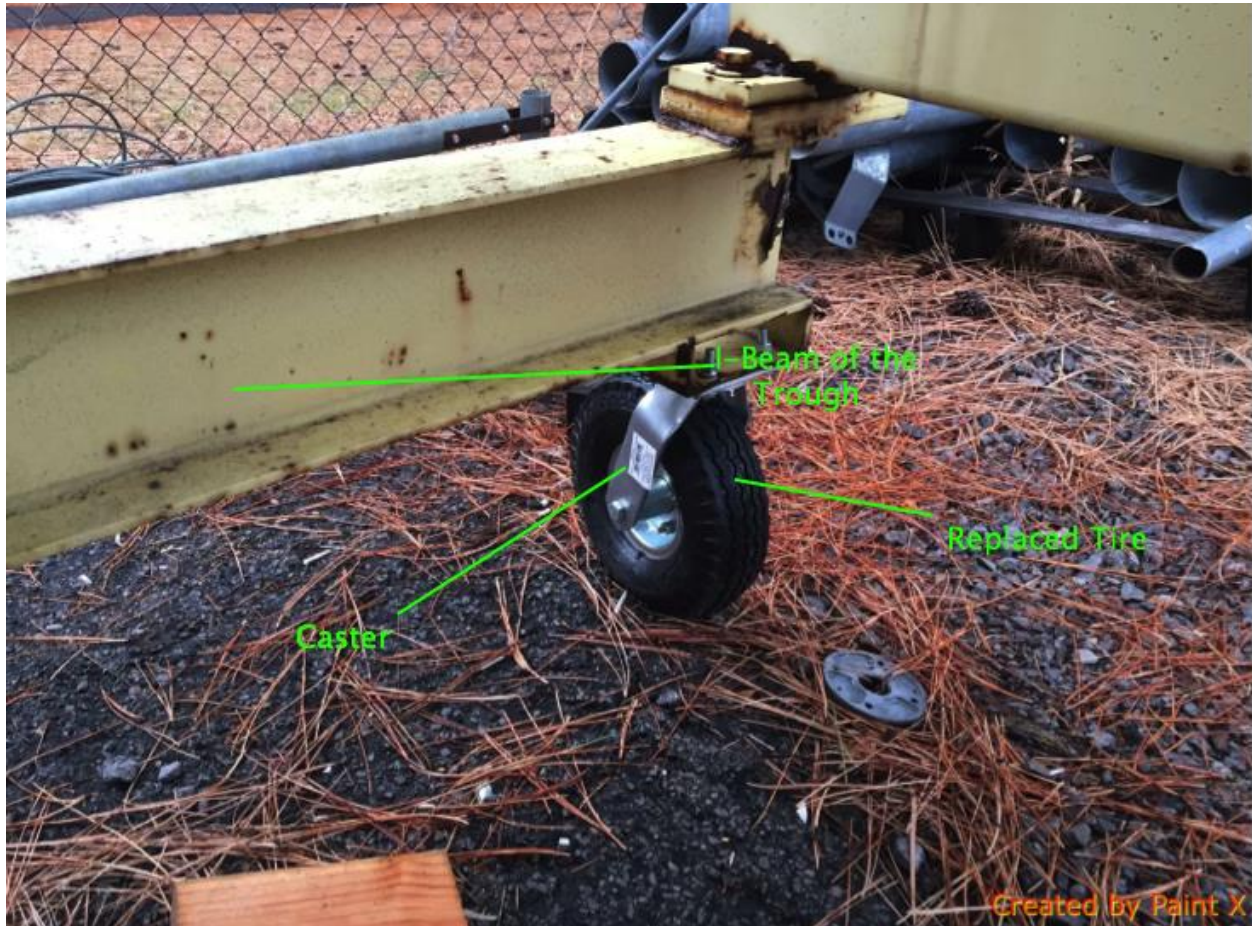
Figure 3 - Replaced Caster with the tire

During installation of the new tires, one of the four casters broke, which then generated three solutions to this problem. The first option was to replace all the casters with new casters that are only sold with tires and not separately. The total cost was \$65.99 for each combination of caster and tire with a subtotal of \$263.96 if the Marathon tires were returned. The second option was to weld the broken caster using the NAU machine shop. Although this option would have no cost, the durability of the caster would be unknown and may fail again with the load of the parabolic trough. The third option was to replace only one caster that would come in

combination with a new tire and keep one of the purchased Marathon tires as a spare at a cost of \$65.99. One caster and tire combination was purchased as it was the best solution at a reasonable cost. The purchased caster and tire combination is displayed in Figure 3.

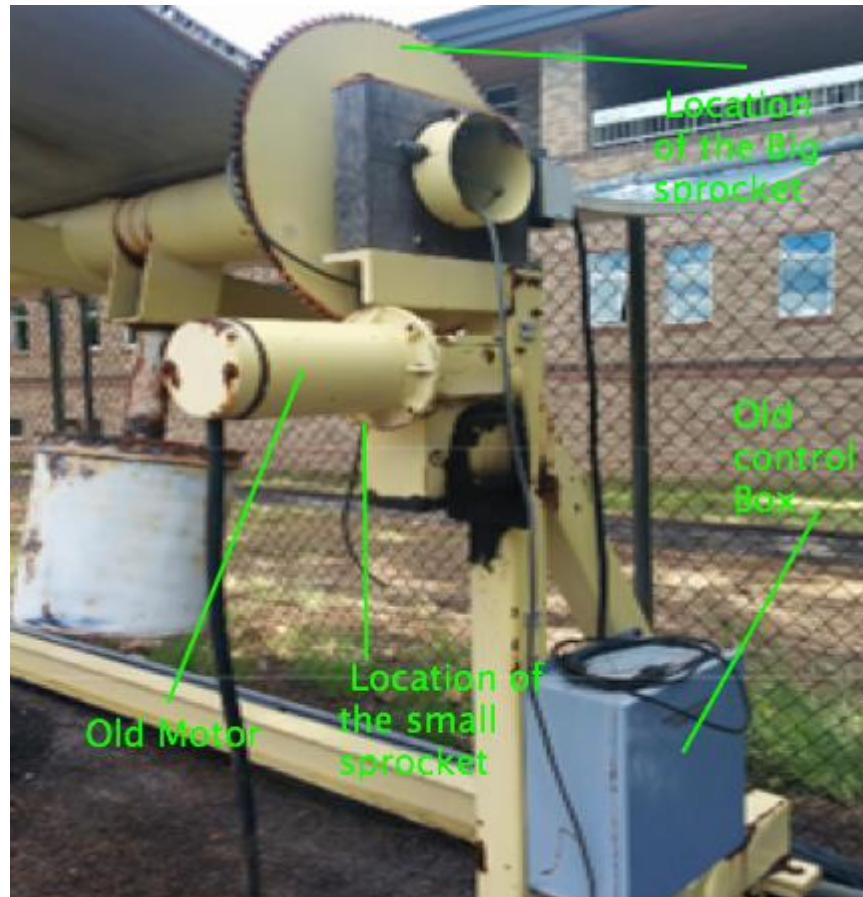
Figure 4 - Big Sprocket with missing chain

When researching chains, the specifications needed were the length, pitch, and roller width. We measured the length using a tape measure around the large sprocket, seen in Figure 4, and small sprocket (not pictured). The measured distance found was 75 inches or 6.25 ft. From McMaster-Carr, the chain lengths are rounded up to the nearest foot. Therefore, the chain length required was 7 feet. Also measured was the pitch and roller width needed. The values measured are $\frac{5}{8}$ in pitch and $\frac{3}{8}$ in roller width. With these values, an ideal chain was found on McMaster-Carr's website. The chain purchased is a standard steel ANSI 50 roller chain and links, with a

pitch of $\frac{5}{8}$ in and roller width of $\frac{3}{8}$ in. This chain has a working load limit at 561 lbs. and costs \$5.98 per foot that had a total of \$41.86 before shipping.

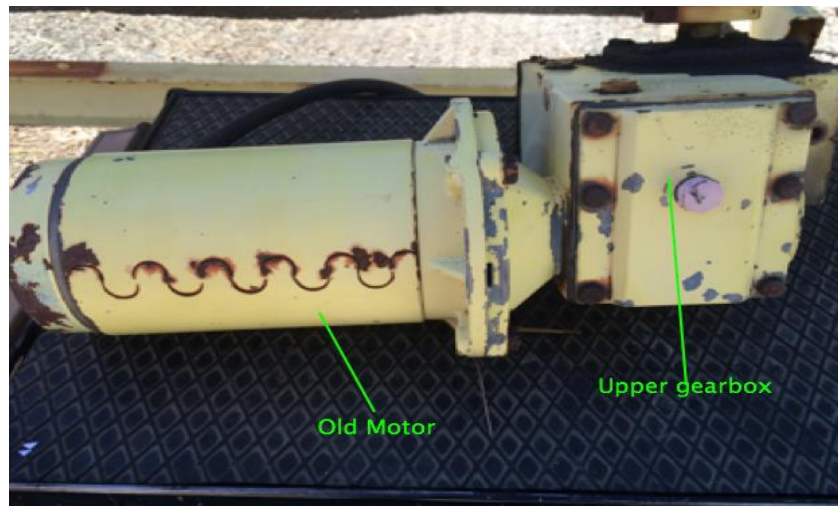
Figure 5 - Motor connected to the upper level gearbox

One of the tasks to complete was to check the interior of the gearbox and determine the condition of the parts by removing the rust and oil from the assembly. The process was started by disassembling the gearbox, which contains an upper level gearbox and lower level gearbox. The upper level gearbox is connected to the motor which can be seen in Figure 5. The motor shaft and the worm gear are secured together by a rectangular key. After disassembling the cover plate lubricating oil was found that turned from a golden color to black. Since the system had not been operated or maintained for over 15 years, there was minimal amount of oil left in the upper level gearbox. Most of the lubricating oil drained down to the lower level of the gearbox. The interior surface and the worm gear holding the horizontal shaft showed some rust.

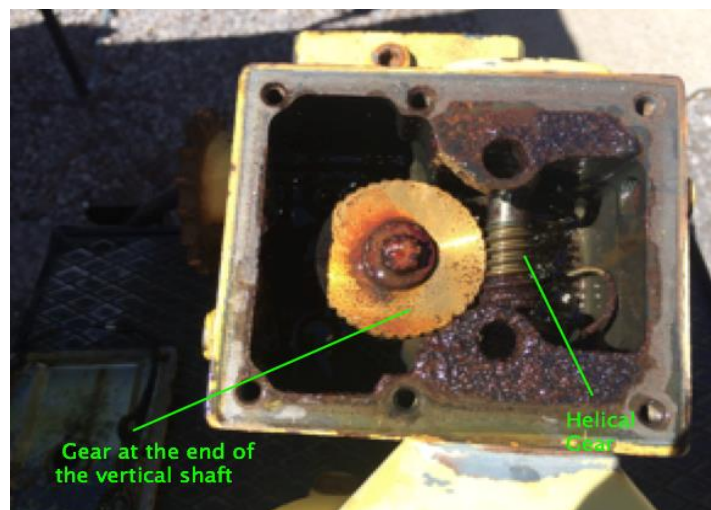
Figure 6 - Upper gearbox with the cover off

Figure 6 shows the helical gear secured by a bolt and a washer has some rust and will be replaced. The helical gear had minimal rust but can be cleaned by a wire brush. However, the shaft was able to rotate, but we still to decide if it can work efficiently in the near future.

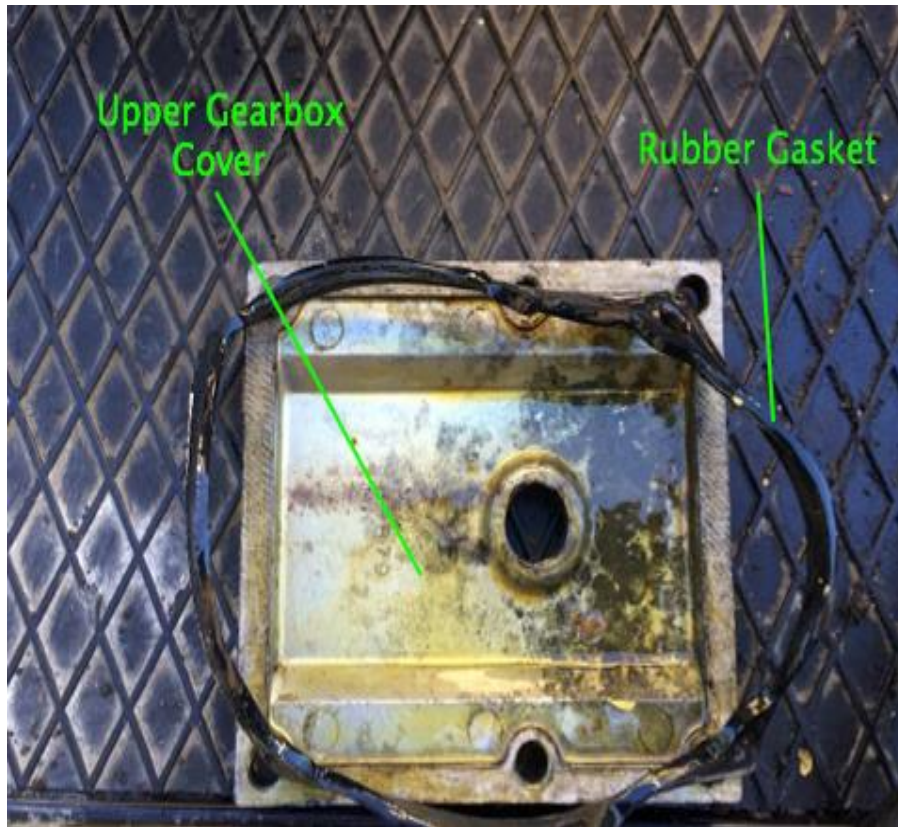
Figure 7: Upper gearbox cover

The rubber gasket has stretched and deteriorated from the weather of Flagstaff. The gasket will need to be replaced before the system can function properly. The defective gasket was the cause of the rusted parts in the upper level gearbox which is pictured in Figure 7. Moisture and condensation found its way through the gasket and the addition of minimal

lubrication oil, resulted in rust. All hardware has also been replaced. The drain plug located on the upper level gearbox is in working condition.

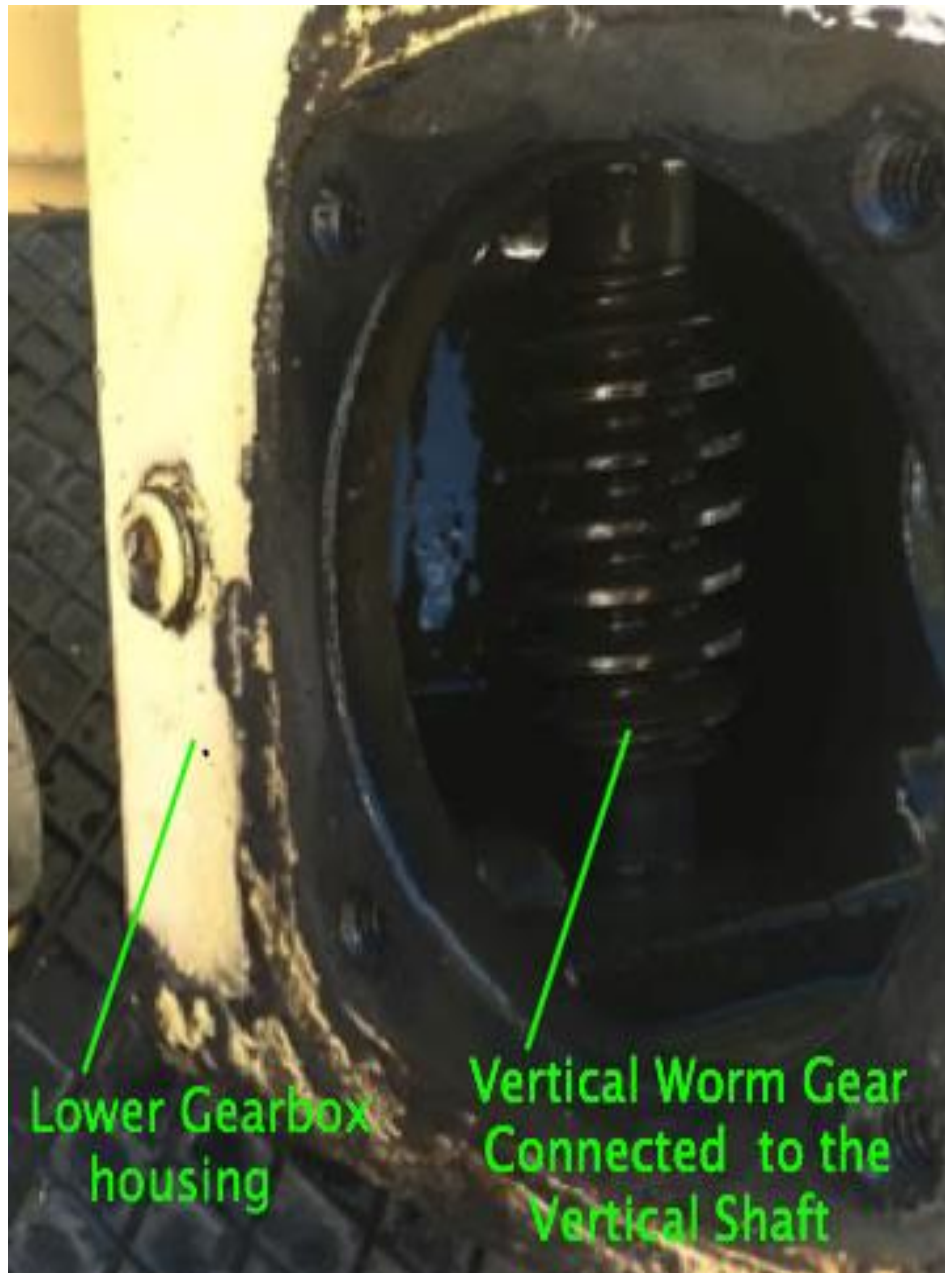
Figure 8 -Vertical worm gear connecting the upper level to the lower level gearbox

After disassembling the side cover mounted to the gearbox to observe the interior of it, it was found that it contains a vertical worm gear connected to the vertical shaft that rotates a helical gear in the same shaft located at the upper gearbox. The worm gear is connected perpendicularly to another helical gear located in the horizontal shaft that rotates the outer small sprocket. The vertical gear coming down has a roller ball bearing attached to it. As seen in Figure 8. The bearing sits between the upper level gearbox and the lower level gearbox to reduce friction and secure the vertical shaft. The roller ball bearing and the vertical shaft are in good condition. This is due to the lubricating oil protecting the parts from condensation and moisture.

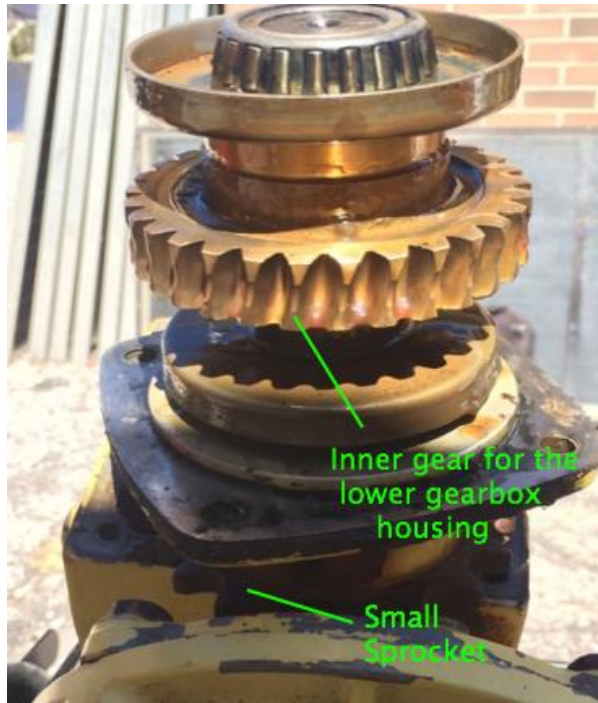
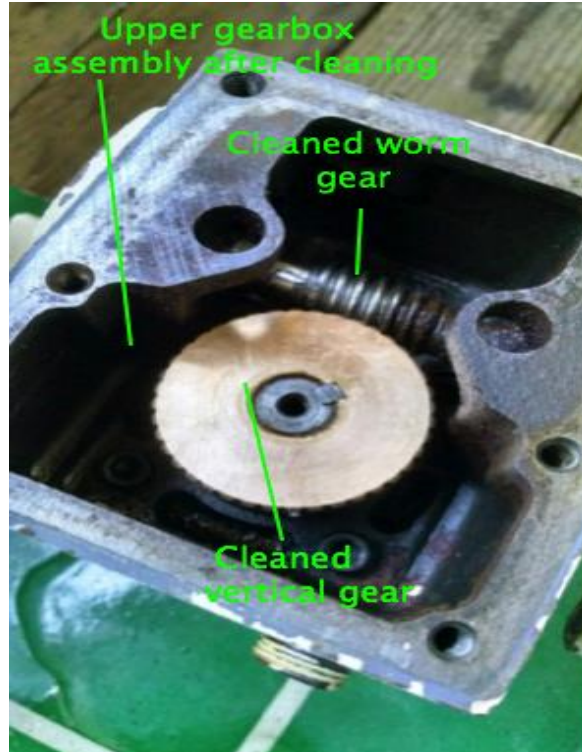
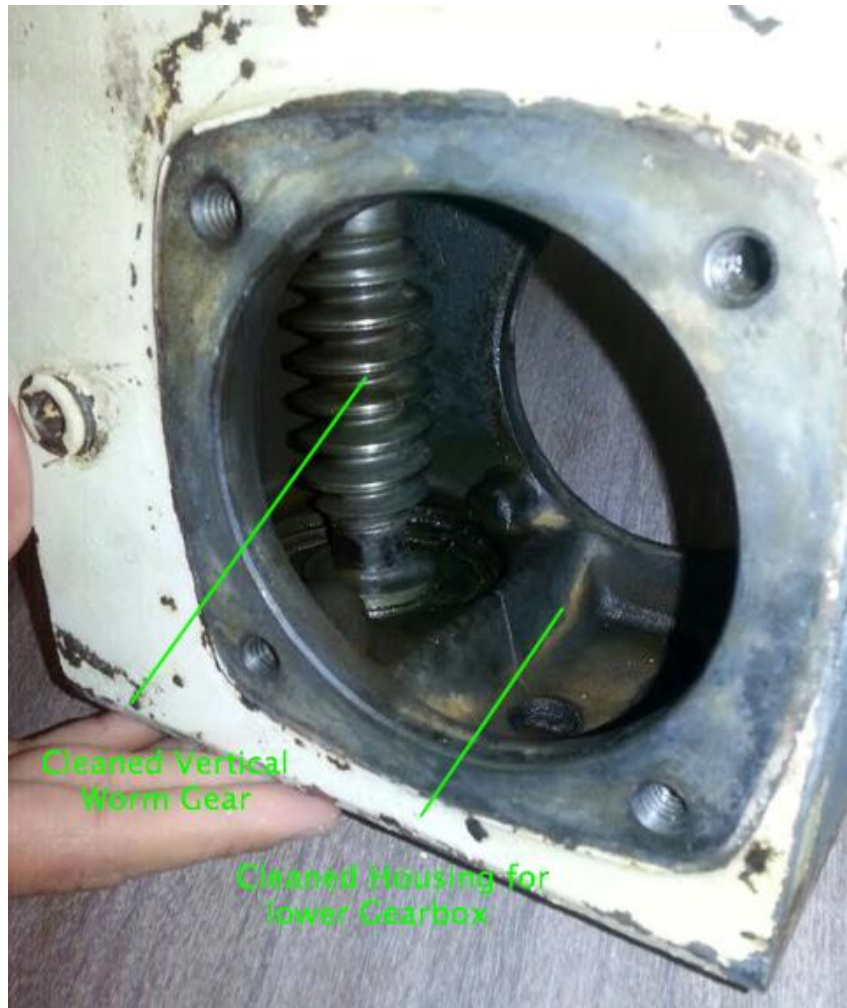
Figure 9 - Sprocket and shaft assembly

Figure 10 -Post-cleaning upper gearbox

Figure 11 -Post-cleaning lower gearbox

The gearbox was taken to Coconino Auto Suppliers to get it professionally cleaned. The total cost for the cleaning was \$35, and the material for a new gasket is also sold there for \$8 a sheet. The upper and lower gearbox was cleaned up well with the exception of a small bit of rust on the worm gear located in the upper gearbox. Figures 9, 10 and 11 show the gearbox after it was professionally cleaned. The gearbox will be used for the tracking system of the parabolic trough.

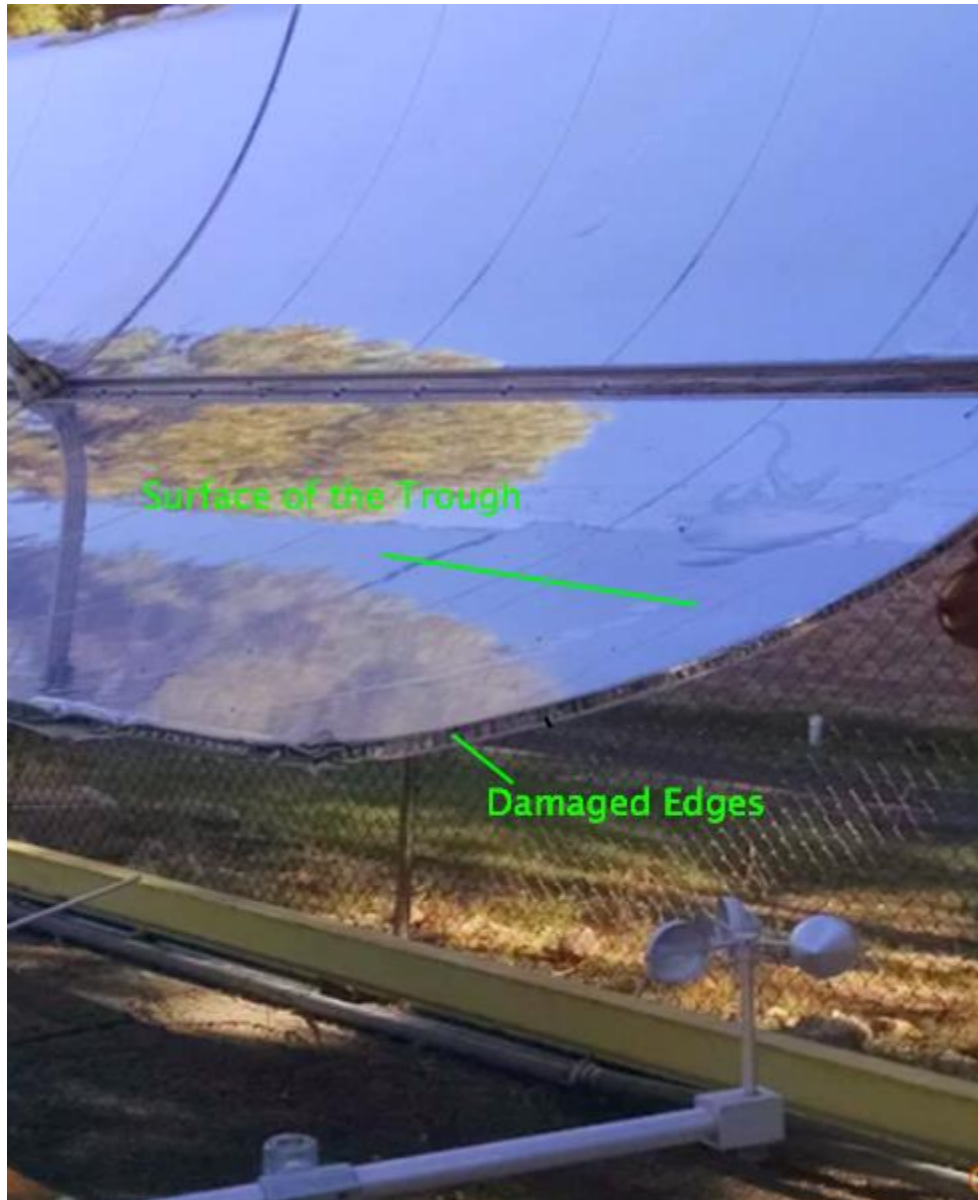
Figure 12 - Initial condition of edges

Due to the trough sitting outside in the environment for so long, the trim around the edges has almost completely broken off. Plastic trim was previously used when the parabolic trough was built, but after over 15 years it has become brittle and aesthetically displeasing. Most of the trim had already broken off, so new trim would be needed in order to seal the edges and also help make the trough look better. Figure 12 shows the previous conditions of the edges when the trough began to be worked on. After measuring the perimeter of the trough, it was decided that 80 feet of trim with a 1 inch channel gap would be needed to enclose all edges.

In order to determine what kind of trim to use, a material that has a long lifespan was desired. Although plastic was previously used, metal became the new material of choice because of the longer lifespan it has over plastic, it was found to be less expensive, and it could also hold down the areas of the edge that were bent, shown in Figure 13. Aluminum specifically was chosen because it is cheap and easy to work with. From Metals Depot, 8 ft. sections of 1 ¼" length legs, 1 ¼" base width, and ⅛" thickness, giving us the 1" gap needed, were found and were ready to be shipped. Once the material was chosen, ten 8ft sections were ordered to ensure

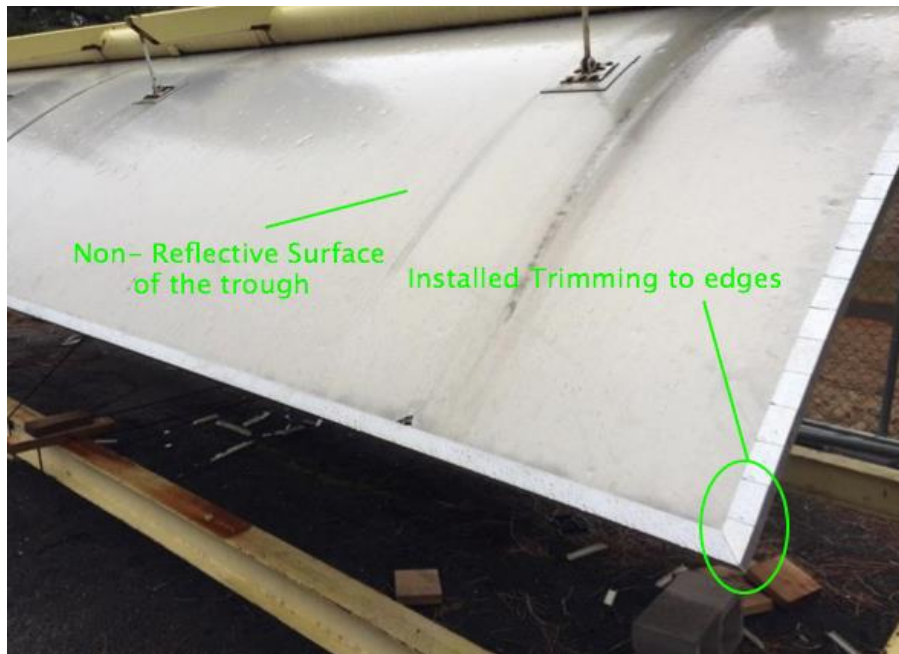
Figure 14- Installed trim on flat and curved edge

For the curved edges, a way to install the trim had to be decided since bending the 8ft lengths of aluminum was not possible given the resources available. In order to overcome this, 2 inch sections were cut and installed individually in order to ensure that there would be no gaps in the trim due to the curve. Figure 14 shows how these small segments look on the trough, showing that there are no gaps.

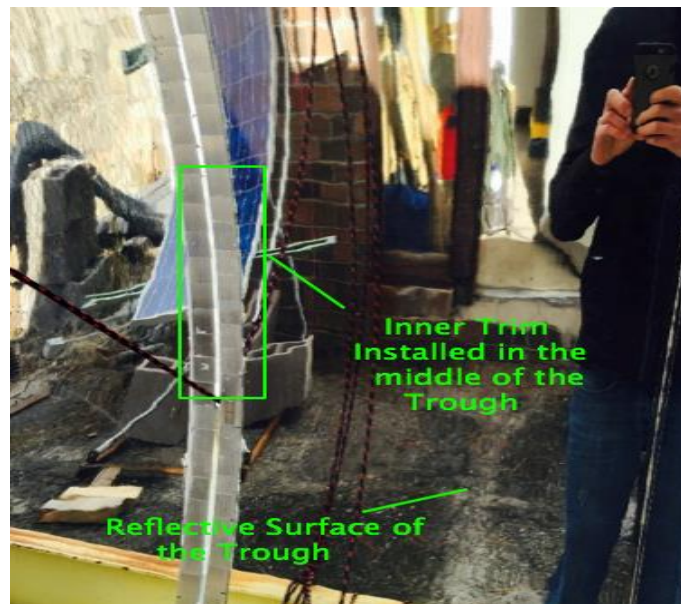
Figure 15- Inner trim installed

Another concern about the installation of the aluminum trim was that there is a small gap in the center of the trough perpendicular to its axis of rotation, (0.5" on one side, 2" on the other) which does not allow room for sliding the trim on. To overcome this, there were several options to choose from. One way to apply the trim would be to cut the aluminum in half along its length, then apply each half to each side of the trough, and seal the cut with the adhesive. Another option would be to just lay a material across the gap, such as Mylar, and leave the edge open, but it will still be protected from rain and snow since the trough will always be in its upright position. The only problem with this is that because Mylar is so thin, a puncture in the material would be easy due to the size of the gap. Placing a stronger material underneath for support would solve this problem, but application may be inefficient and alter the reflective surface towards the parabola's focal point. The third option is to remove one or two of the supports in order to slightly bend the trough and slide the aluminum onto the edge. Because the materials of the trough are already flexible, this option could be simple if the supports are easy to remove, but could be very difficult due to the condition of the corrosion wearing down the supports and possibly losing the supports entirely. Our team chose the third option in order to install the trim along the inner sides of the trough as well as shorten the legs of the aluminum trim. Figure 15 shows the trim on the inner side of the curved edge installed.

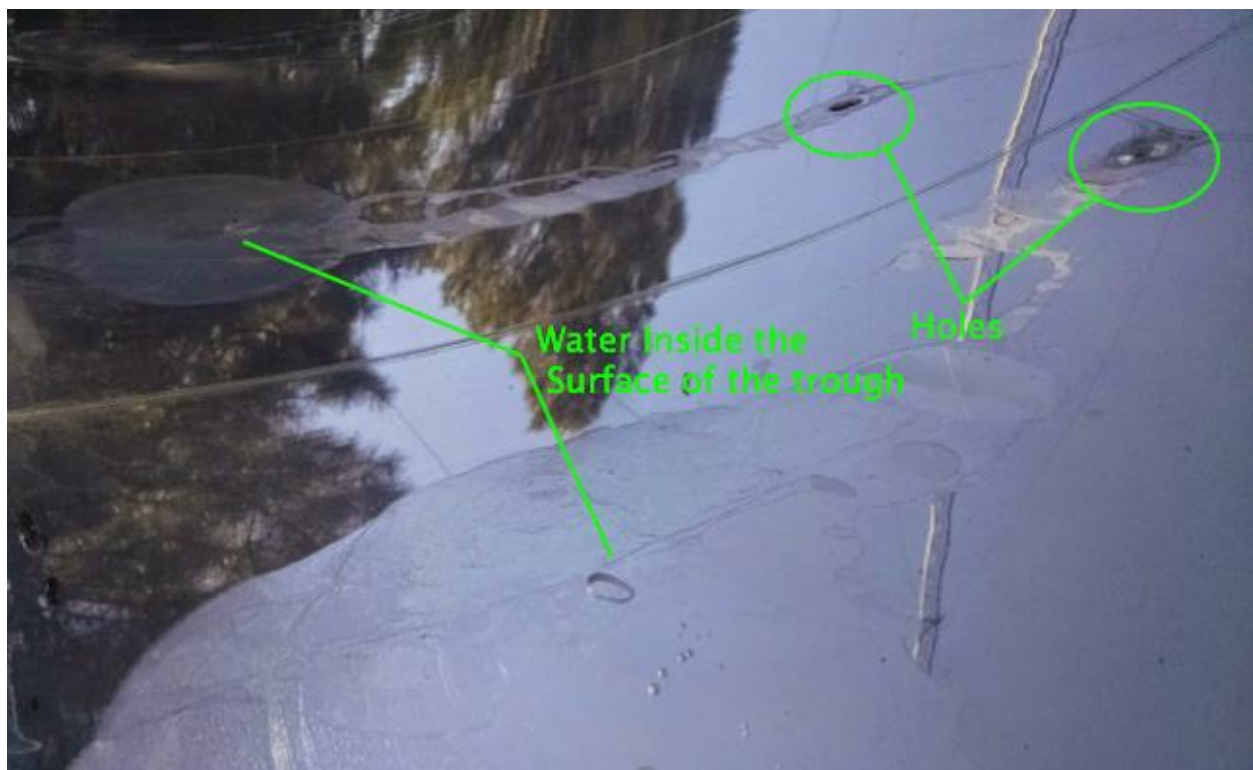
Figure 16 - Holes and water damage in surface

Due to the holes and water damage on the parabolic surface, shown in Figure 16, the reflectivity is hindered and will not be at peak efficiency in this current condition. In order to retain an entire reflective surface, something that could be applied to the surface and still be as reflective as what is on there currently was needed.

For this application, Mylar was chosen due to its low cost, flexibility, and most importantly its reflectivity. Another benefit of this material is that it can be used to cover the trim that will be hanging over the reflective surface. This will help maximize the solar energy that

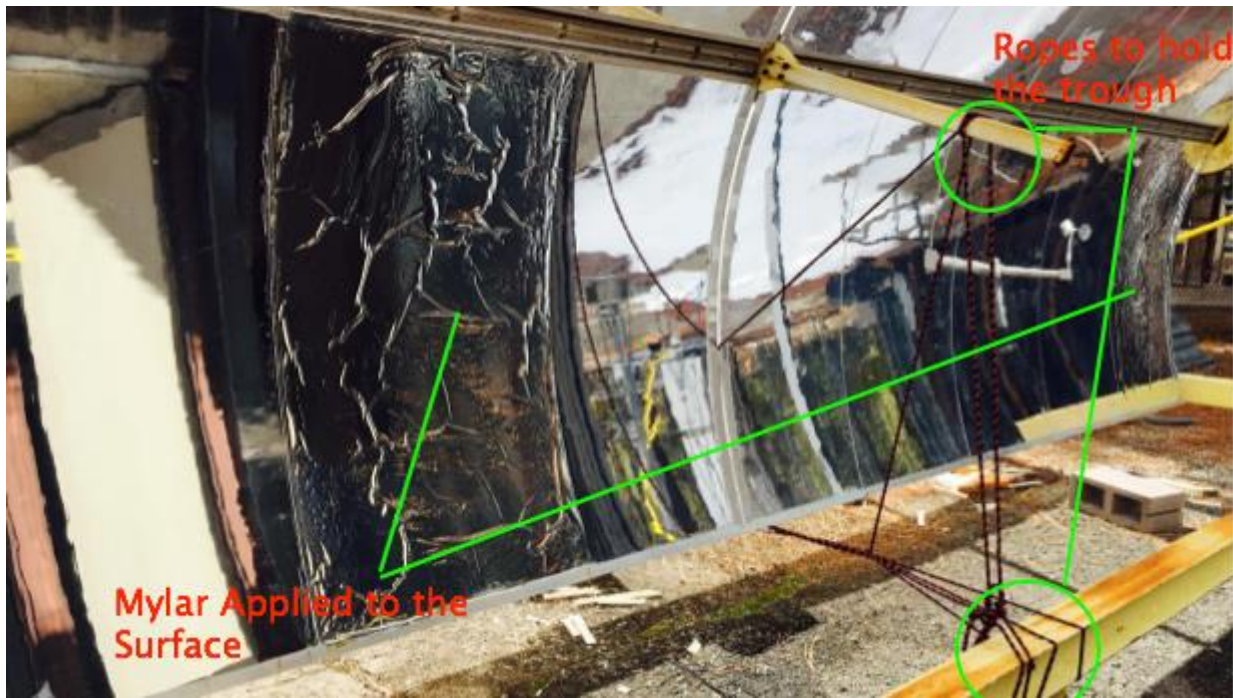
Figure 17- Mylar applied to parabolic surface

After we successfully finished installing the trim to the edges of the trough, we started to apply Mylar to the surfaces to cover the holes in the surface. We finished applying Mylar to the damaged surface, so the trough will once again be able to rest in its upright position and the complete surface can be reflective. Figure 17 shows the application of the Mylar on the reflective surface.

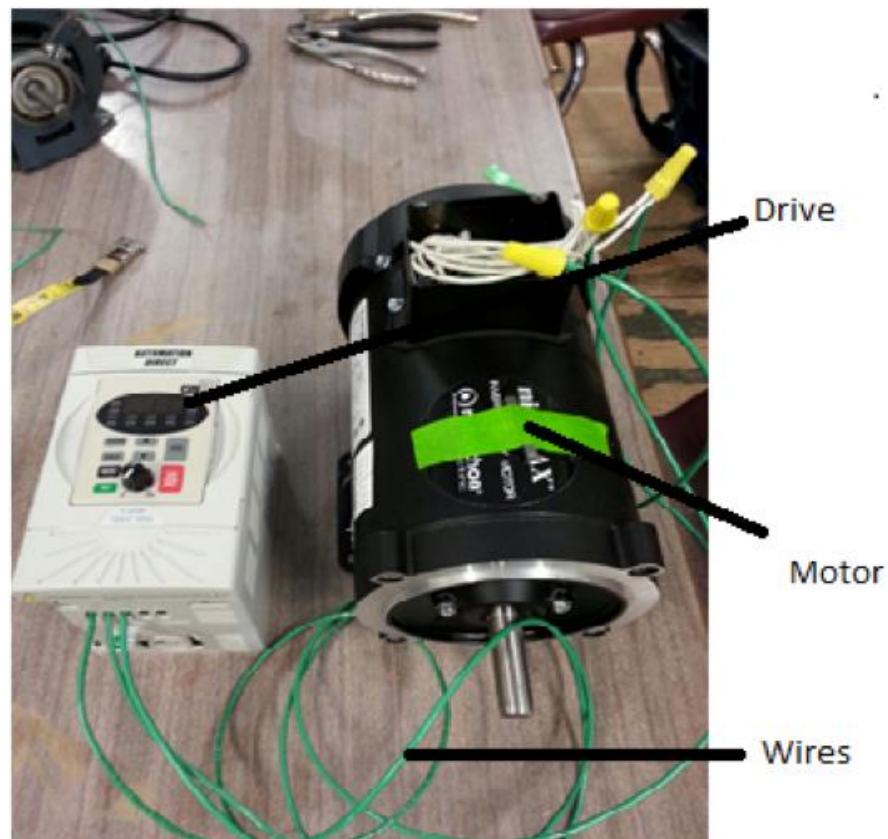
Figure 18 - Motor and drive connected

Once the new drive arrived, the team went straight to connecting the two and testing motor function. The drive needed to be programmed to meet the specifications of the motor, which was a simple process and connections were made quickly. Shown in Figure 18 is the motor and drive wired together.

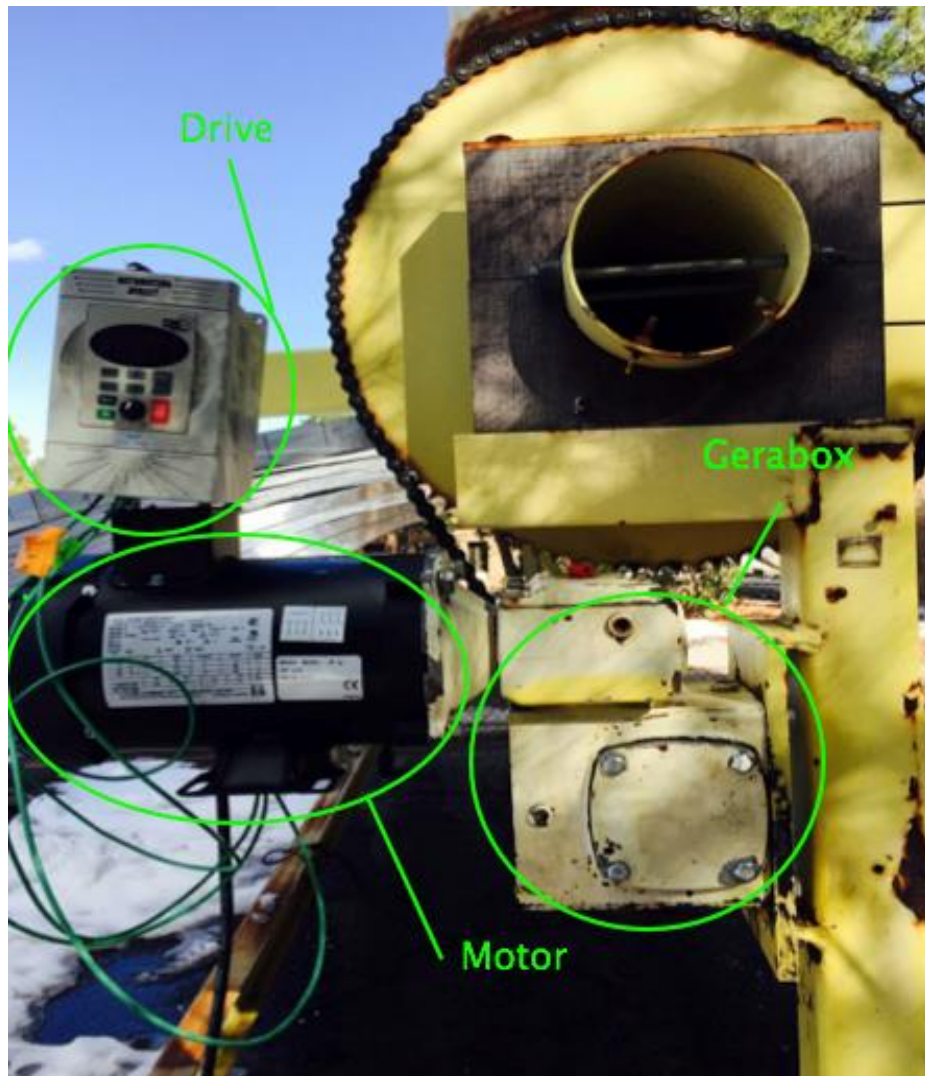
Figure 19 - Motor and drive connected to trough

Running the motor was then possible at this point. The motor was mounted to the frame of the trough and ran smoothly based on the parameters set. Once we knew the motor would run the way we wanted it to, all tracking components could be installed on the trough. The gear box, chain, motor, and drive were all installed and tested to make sure the entire trough would turn. Figures 19 and 20 show the basics of the tracking system installed together. The trough turned just the way we wanted it to, and the next step in the tracking system is to program the PLC so the motor will run based on a timer throughout the day to reflect the most sunlight.

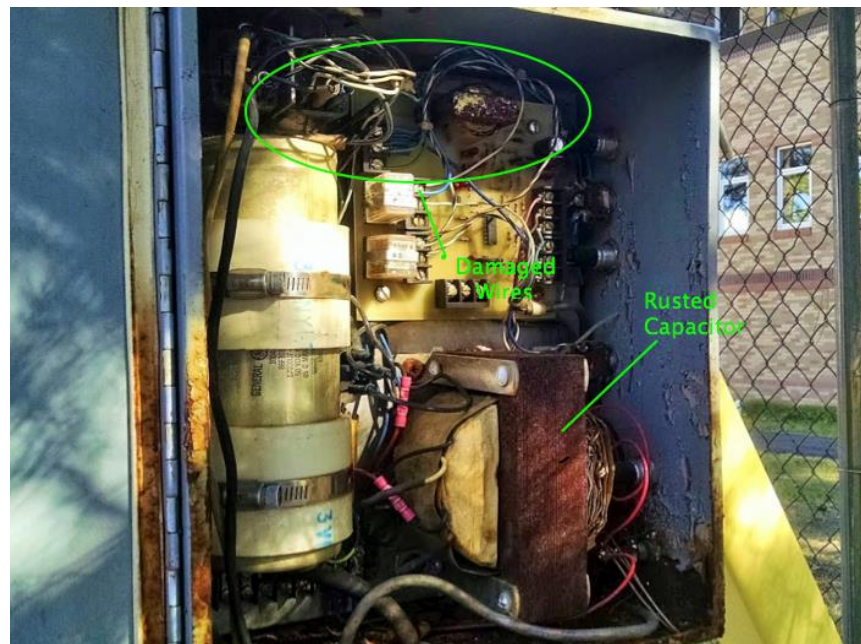
Figure 21-Previous control box

To protect the drive, PLC, and power inverter from the elements, a control box needed to be purchased. Because of the poor and outdated conditions of the previous control box, shown in Figure 21, a new control box for the new tracking components was needed.

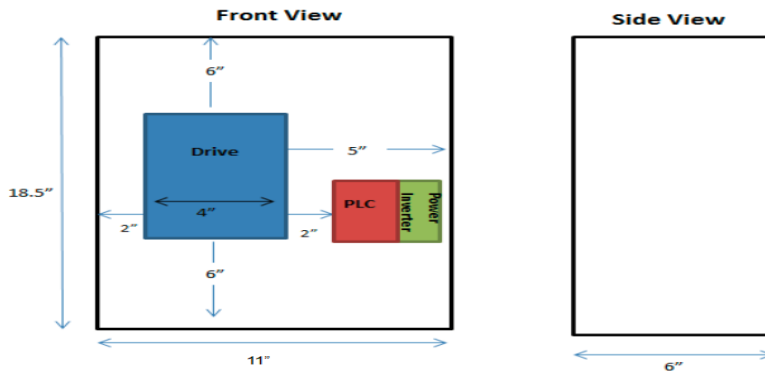
Figure 22 - Schematics of control box

Shown in Figure 22 is a schematic of each component and clearances required for each to determine the dimensions of the control box needed.

Based on these dimensions, a 20" X 12" X 8" will suit the need for all components necessary to run the tracking system. Shown in Figure 23, the mounted control box along with the installed components is shown.

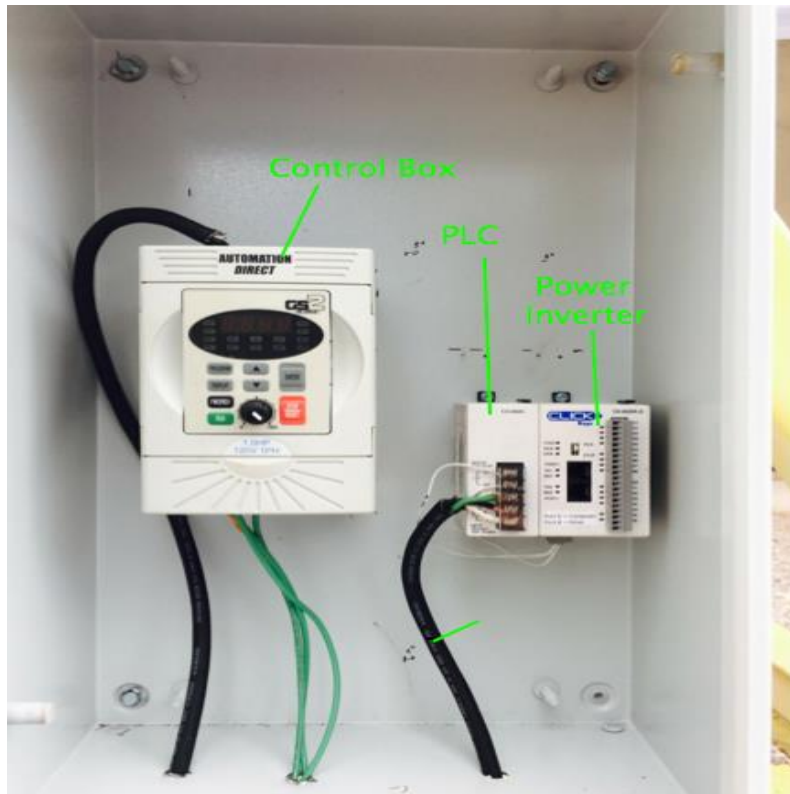
Figure 23 - Control box and components

Above the PLC and inverter there is room for extra components if desired for future uses.

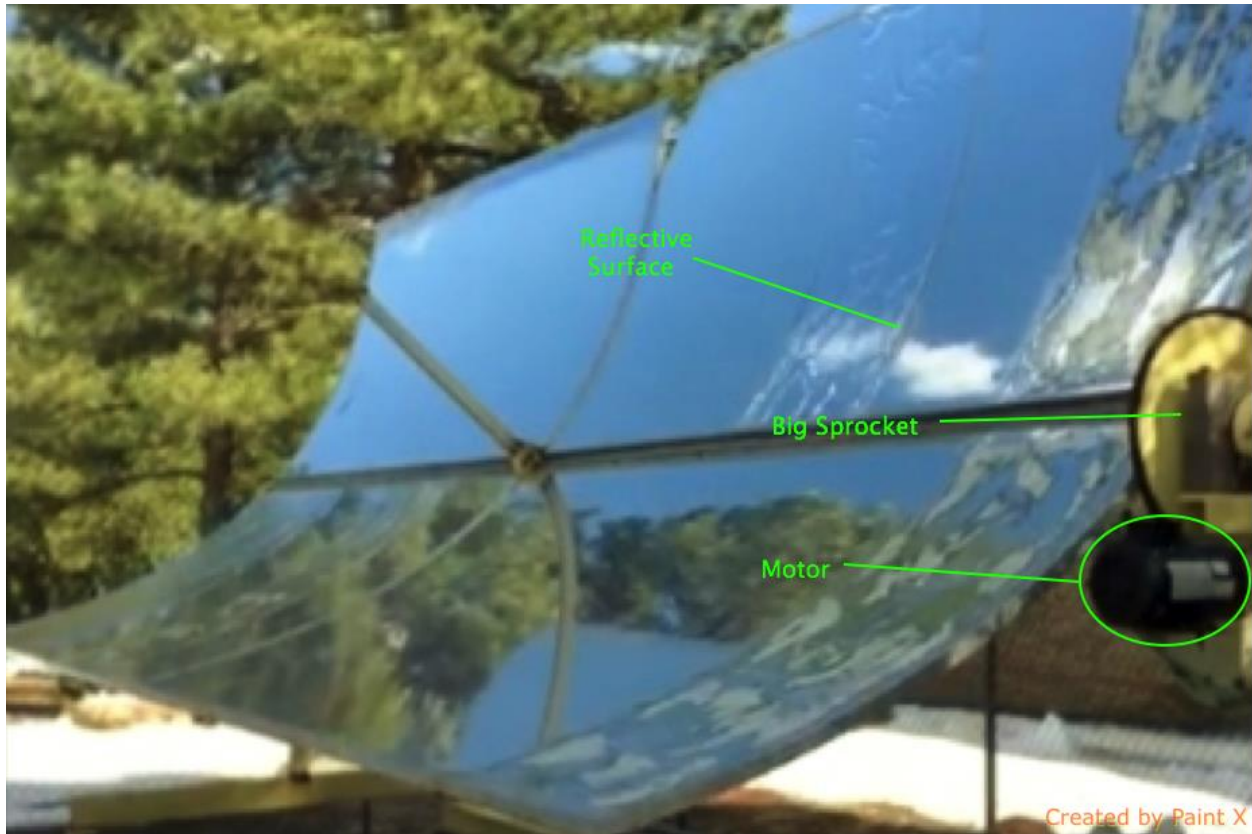
Figure 24- Initial Parabolic Trough

On the old system, there was not an energy extraction system installed. Figure 24 shows the old system with no existing method to extract energy.

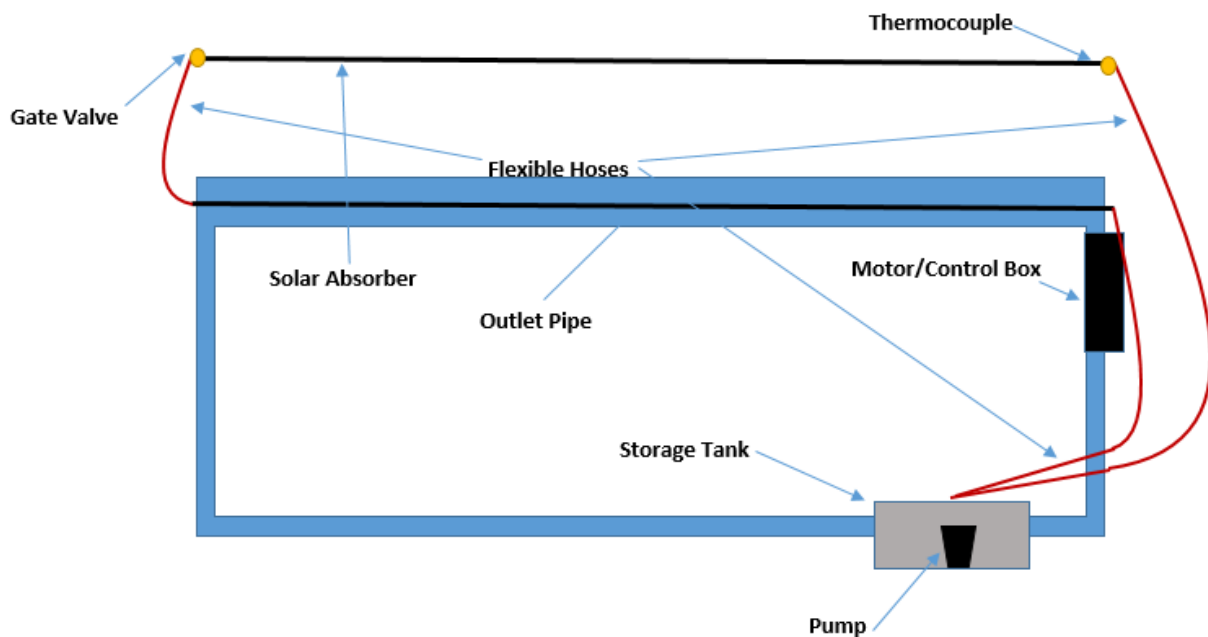
Figure 25- Extraction Design

Figure 25 below shows the schematic for the energy extraction system. The placement of the solar storage is mounted on the frame underneath the entire trough. The tank is 15 inches in height with a clearance of two inches from the ground. The outlet piping is inside the hollow steel section that is the length of the trough. Flexible hoses are attached to each end of the pipes in order to accommodate for when the parabolic trough rotates. The solar absorber is mounted on each side of the trough and at an existing hollow steel section located in the middle of the surface. The adjustable gate valve and K-type thermocouple are attached at the 90 degree elbows of the solar absorber.

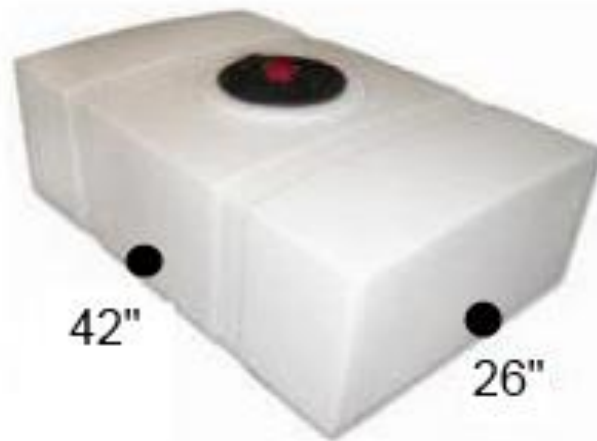
Figure 26- 55 Gallon Water Tank (Plasticwatertanks.com)

There are three main components for the process of energy storage: the submersible pump, the water tank, and the frame that the water tank rests on. The water pump was purchased at a local hardware store that runs at a maximum of 750 gallons per hour (GPH) that submerges into the water tank. It is a Little Giant water pump with one inch diameter output and 1/6 HP power. The water tank is a 55 gallon rectangular tank from the Plastic Water Tanks Company. The specifications are 42"x26"x16" with an eight inch fitting on the top with a drain on the short side of the tank. The eight inch fitting made it possible to insert a five inch diameter pump and two one inch diameter hoses. Figure 26 displays the 55 gallon water tank and Figure 27 shows the submersible water pump used in the system.
