Parabolic Trough-Solar Tracking and Energy Extraction

Final Report
Document

*Submitted towards partial fulfillment of the requirements for
Mechanical Engineering Design II – Spring 2015*

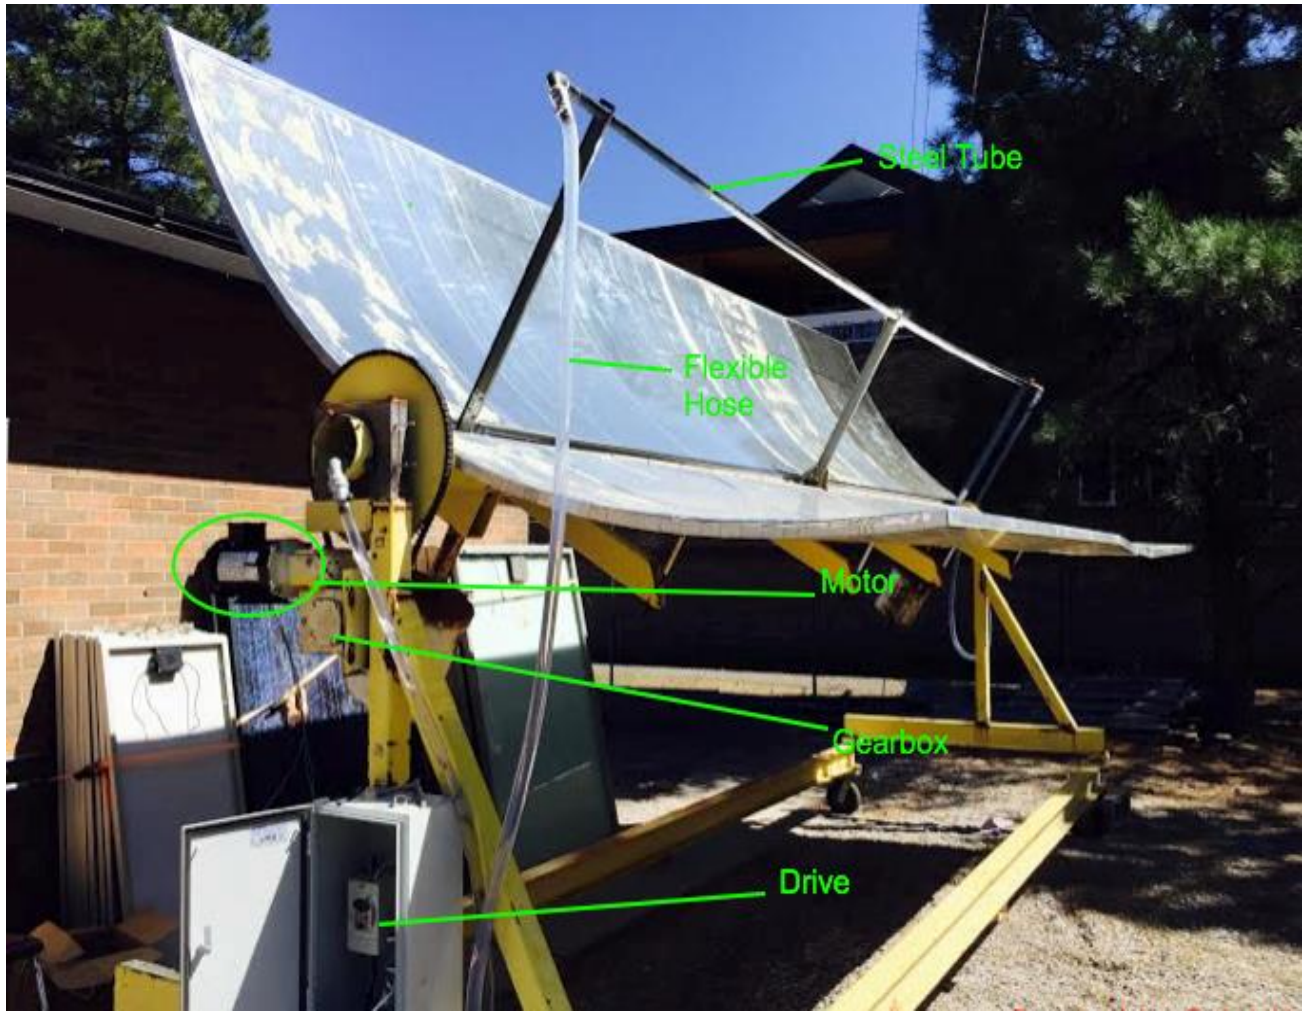
Figure 28- Final Solar Energy System

The final system consisted of repairs, replacements parts, and installation of the energy extraction system. The initial system had no apparent way to collect or store the solar energy. Also, there was no documentation on any precious tracking system, specifications of the parts, and if any extraction system existed. The repairs were mainly on the reflective surface and gearbox maintenance. The replacement parts consisted of the control box components, motor, wheels, and chain. The installation of the extraction system required modifying the trough with mounts and pipes. Figure 28 shows the entire new system that rotates with the sun and extracts the maximum solar energy.

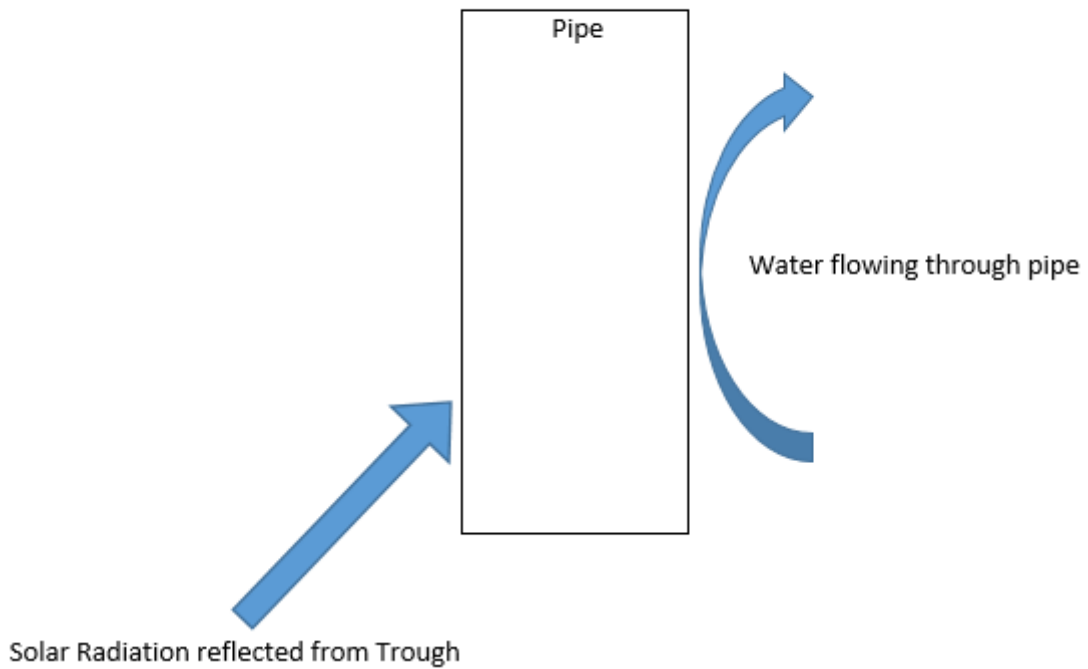
Figure 29- Heat transfer of system

In the solar energy extraction, the black solar absorber pipe is heated through radiation reflected from the panels and conducted through the absorber pipe and finally heat transfer through convection to the water flowing through the pipe as shown in Figure 29. Within 10 minutes of the trough tracking the sun, the absorber reached a temperature of 350° Fahrenheit. Our team conducted two different tests for our system for 15 gallons of water, which consisted of a constant flow rate at different times of a clear, sunny sky day with a high of 63° Fahrenheit, and a constant change of temperature at different flow rates was also tested.

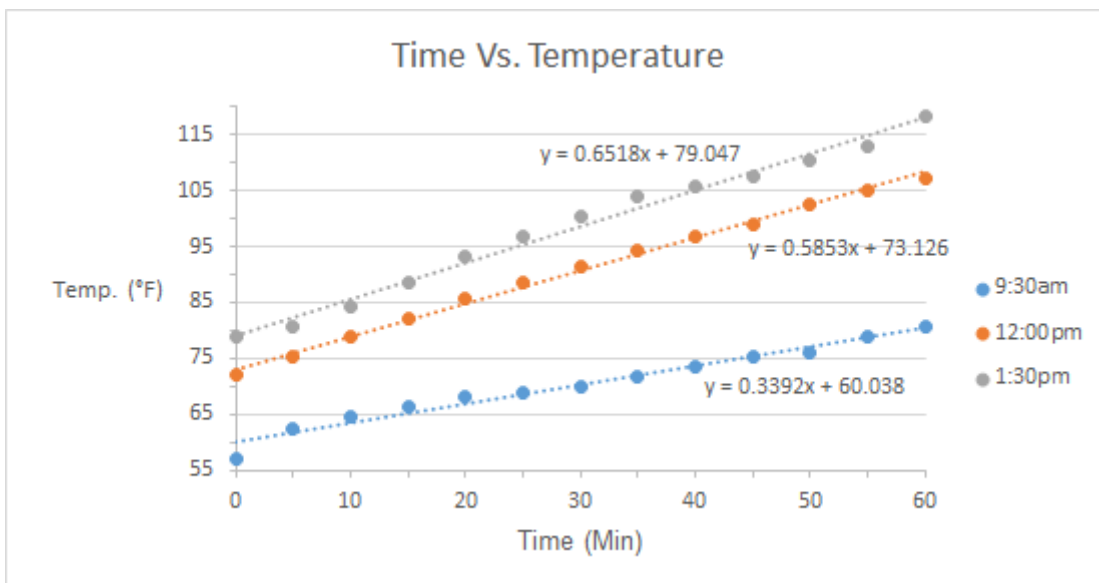
Figure 30- Time vs. Temperature

A plot of the temperature change at 750 Gallons per Hour flow rate at three different times of the day for 60 minutes is shown in Figure 30.

The plot indicates that at different times of the day, the water flowing through the pipe will have a different change of temperature for 60 minutes. At 9:30 am the initial temperature of the water was 57.2° Fahrenheit and the final temperature after 60 minutes was 80.6° F for a total change of temperature of 23.4° F. At 12:00pm the initial temperature of the water was 72.1° F and final temperature after 60 minutes was 107.2° F for a total change of temperature of 35.1° F. At 1:30pm the initial temperature of the water was 78.8° F and final temperature after 60 minutes was 118.4° F for a total change of temperature of 39.6° F. The results show that the temperature at which the water can be increased by varies throughout the day, but the system does increase the temperature at roughly the same rate for the times tested.

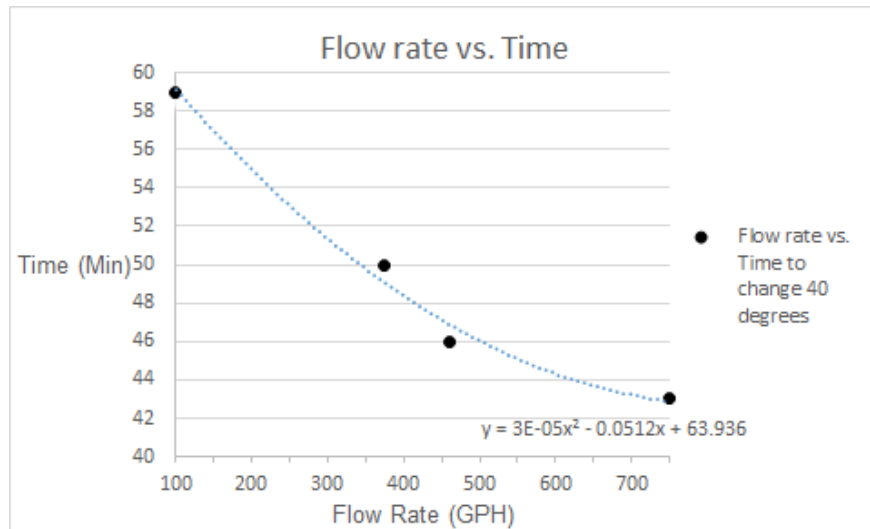
Figure 31: Flow rate vs. Time

A constant change of 40° Fahrenheit for different flow rates of water through the absorber is plotted in Figure 31 and the values for each flow rate with their respective times to achieve the desired change of temperature can be seen in Table 1.

As the flow rate decreases, the time to achieve a 40° Fahrenheit change in temperature increases. Since the water is recirculated in our system, the time to change the water temperature is lower in higher flow rates due to the water being heated through convection inside the pipe, but then being added back into the tank that contains water at a lower temperature. The faster the flow rate is able to recirculate the entire water in the tank through the system, the temperature of the water tank changes at a higher rate. The gallons per hour versus the time it takes to change the water temperature by 40° Fahrenheit is a decreasing 2nd degree polynomial function.
