Final Product Testing proof

Open-Source 3D Printed Foot Prosthesis

Team 18F04

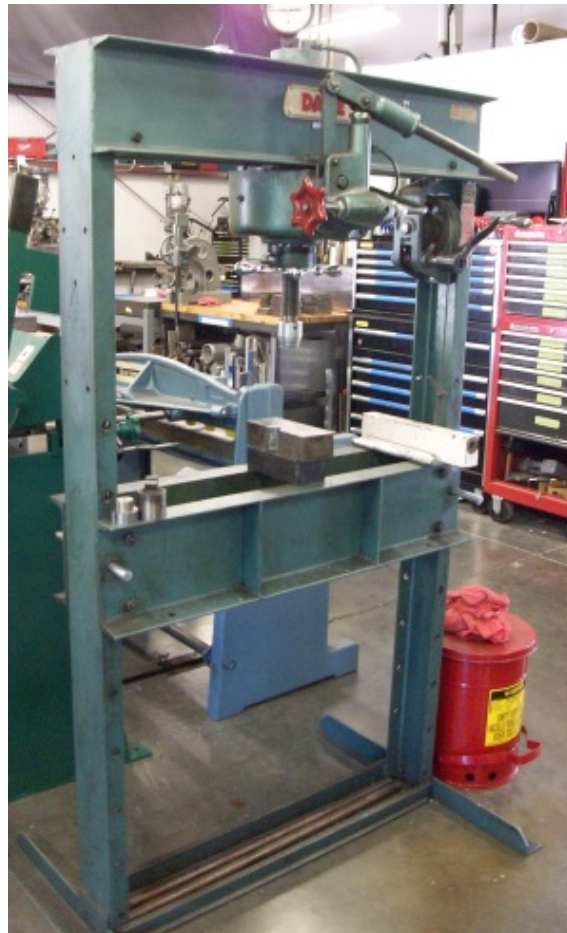
Figure1: Hand Press

The testing was taken in the machine shop at building (98C) using the machine called hand press. A hand press machine can be used for pressing and removing bearings (Figure 1.). There were three tests done in the machine shop. The first test was taken on the full design being positioned at an angle. The second test was on the full design standing up straight to see how much force it can withstand. The last test was on the PVC pipes by itself because the team wanted to see if anything would happen with the PVC pipes since they are fixed with a zinc metal screw.

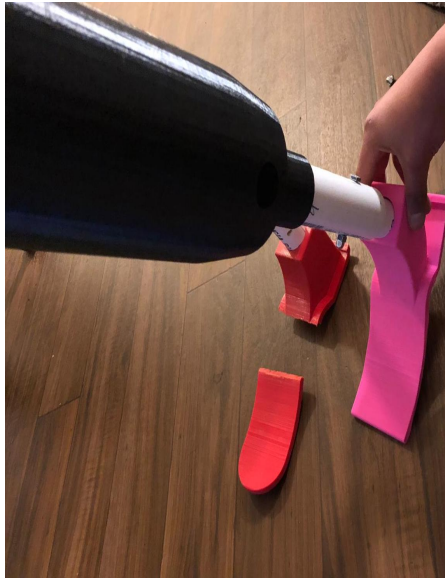
Figure 2: Position of the foot that was used

Test 1: The result of the first test was not done because as soon as we fixed it to the hand press it broke. Figure 2 shows how the design was added to the hand press before it broke with an old foot and Figure 3 shows the foot that was actually broken.

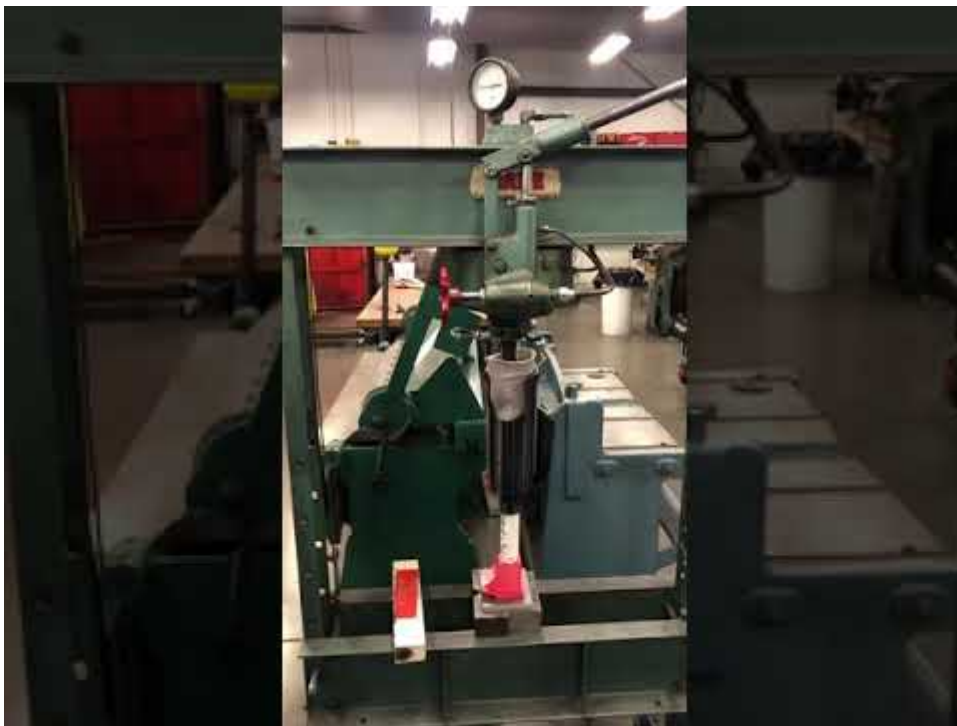
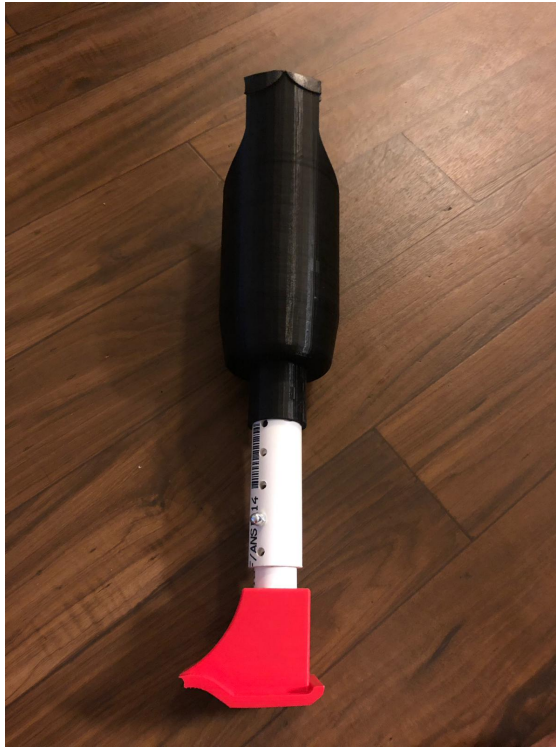
Figure 4: Design assembly

Test 2: The results of the second test was that the design was put up straight and three push of the hand press was added on a metal piece that weighs 7 pounds. The reason why the metal block was added in order to fix the hand press metal. There was not an exact amount of force calculated because the hand press didn't have a dial gauge. The gauge that is found on the hand press machine is used to measure the Psi, so the equation was used to come with the result:

The workers that operated on the machine shop said that one click is about 50 Psi and the video shows that there were three clicks which means that the design held more pressure than the amount that was required (219).

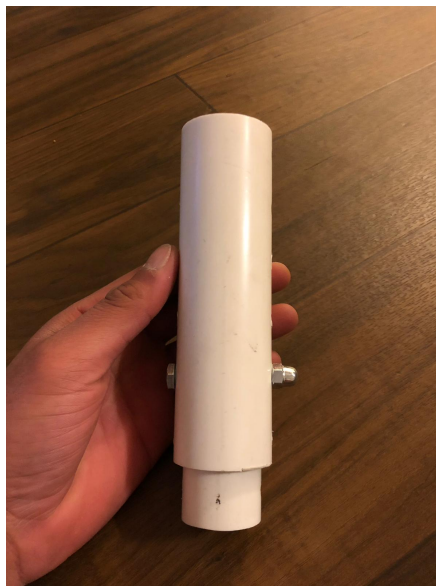
Figure 5: PVC pipes

Test 3: The third test was testing the PVC pipes alone with the same amount of pressure that we used to test the whole assembled design. The result was positive with no changes what so ever.
