Subject: Implementation Memo II

The Biomechatronic Hip Exoskeleton Team (BHET) is designing and manufacturing a robotic prosthetic for the NAU Biomechatronics lab. The goal of the device is to provide assistive torque to the wearer during a normal walking gait, assistance will aid with hip extension and flexion. The design has gone through many iterations, which is reflected in the revision number for each subsystem. The following memo outlines the team's final implementation plan for the last weeks of the project. This includes final design changes, applicable standards, codes and regulations, manufacturing status, and updates to the risk analysis.

Biomechatronic Hip Exoskeleton Team

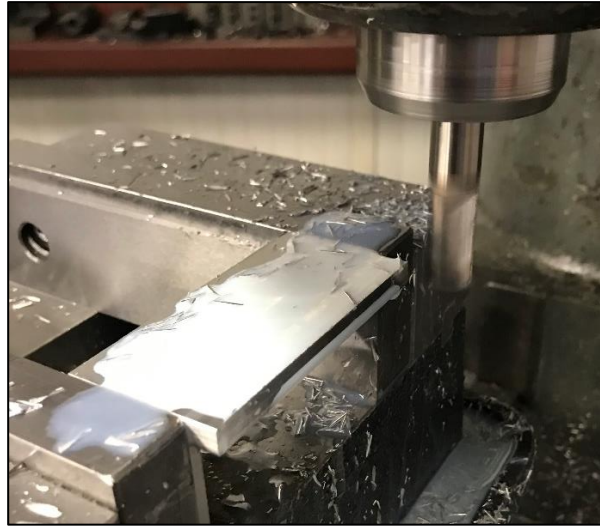
There are two main manufacturing process used for this project, these being machining and forming. 3D printing was also used for non-critical components. Machining applies to most of the components included in the motor mount assembly. Forming applies to the hip belt and knee brace components of the design. Machining was done with both a manual vertical mill (Bridgeport mills in 98c) and a CNC vertical mill (Tormachs in 98c). The manual vertical mill was used for roughing the outer dimensions of the parts, as setup time on these machines was significantly shorter than the CNC mill. The below figure demonstrates a part being roughed on the manual mill.

Figure 1.1: Roughing a Part on a Manual Mill

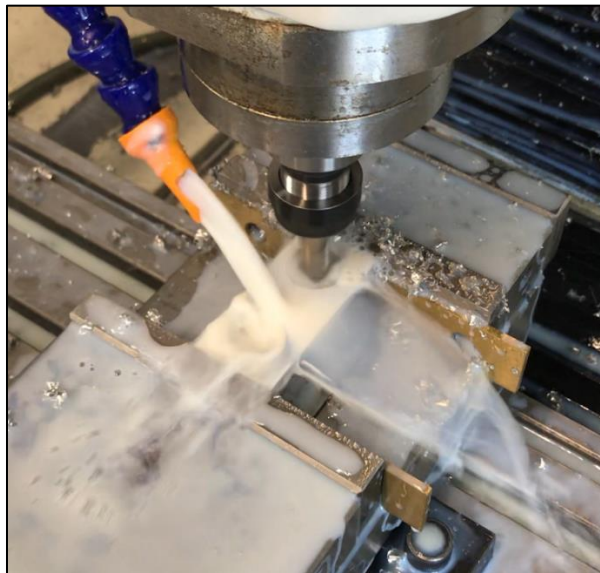
The CNC mill was used to finish parts and to cut the more complicated features that could not be cut on the manual mill. The below figure shows this process.

Figure 1.2: Finishing a Part on a CNC Mill

Both of these processes proved to be effective as a means of production for all of the aluminum parts required for this project.

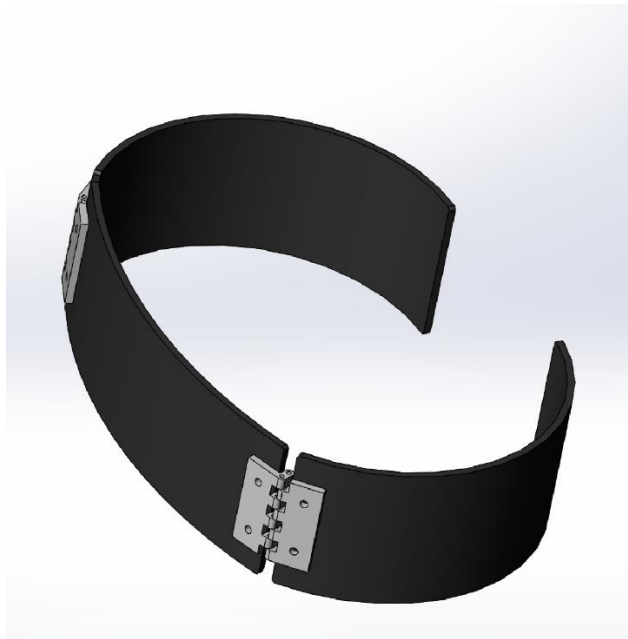
Figure 1.13: Current State of Hip Belt Design

The simplicity of the molded rectangular pieces of Kydex in this design has proven to be effective. However, manufacturing this design has identified some issues with mounting the hinges. Originally the hinges were mounted to the kydex with epoxy, but this proved to not be strong enough. To fix this issue, future iterations of the hip belt design will bolt the hinges to the hip belt, increasing the strength of this part of the design.

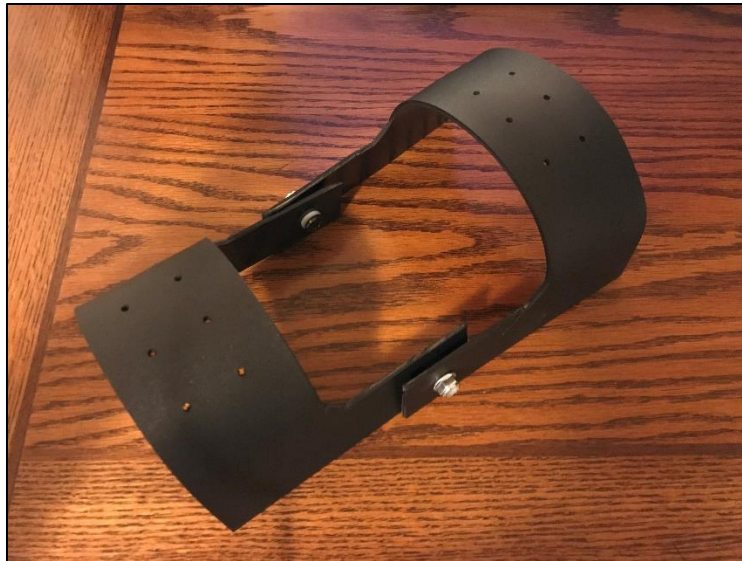
Figure 1.14: Current State of Knee Brace Design

This iteration of the knee brace design proved to be very easy to manufacture, however some possible improvements for the manufacturing process were identified. One issue with manufacturing this design was cutting the knee braces by hand. While this was easy to do, it left the part very rough around the edges. Ideally, finalized parts for this component will be cut on a CNC router prior to molding. This will allow for parts to have a better fit and finish. Additionally, the hinge is currently held together with a flush mounted bolt and a nylon lock-nut. While this proved to be effective and inexpensive, it could be improved with better hardware.
