SAE Baja '24 Capstone Team

Presentation 3

NAU SAE Baja 2020-2021

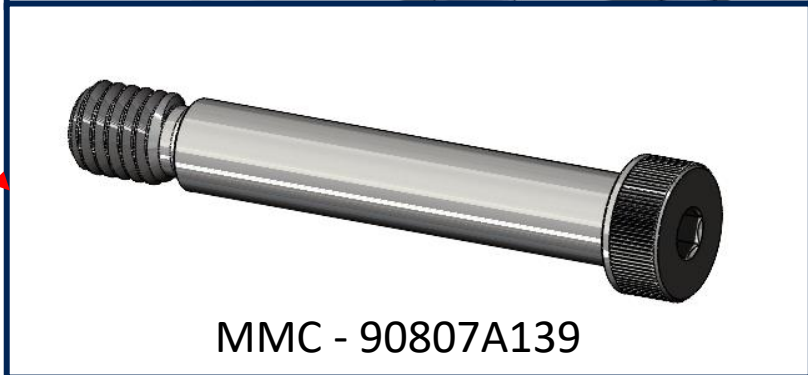
Control Arm Pivot Shoulder Bolt Sizing

- Grade 8 Tensile Strength: 150,000 psi [1]
- Ratio of Shear/Tensile Strength: ~0.6 [2]
- Dynamic Load Factor for Structural Bolts: 0.9 [3]
- Max Impact Load: 2160 lbf (max load from pres. 1, bolt will never see this, but better safe than sorry!)

Diameter	A_bolt (in ²)	F_shear of Bolt (lbf)	F_shear from Impact (lbf)	FoS
1/4"	0.10	7952	2160	3.68
3/8"	0.22	17892	2160	8.28

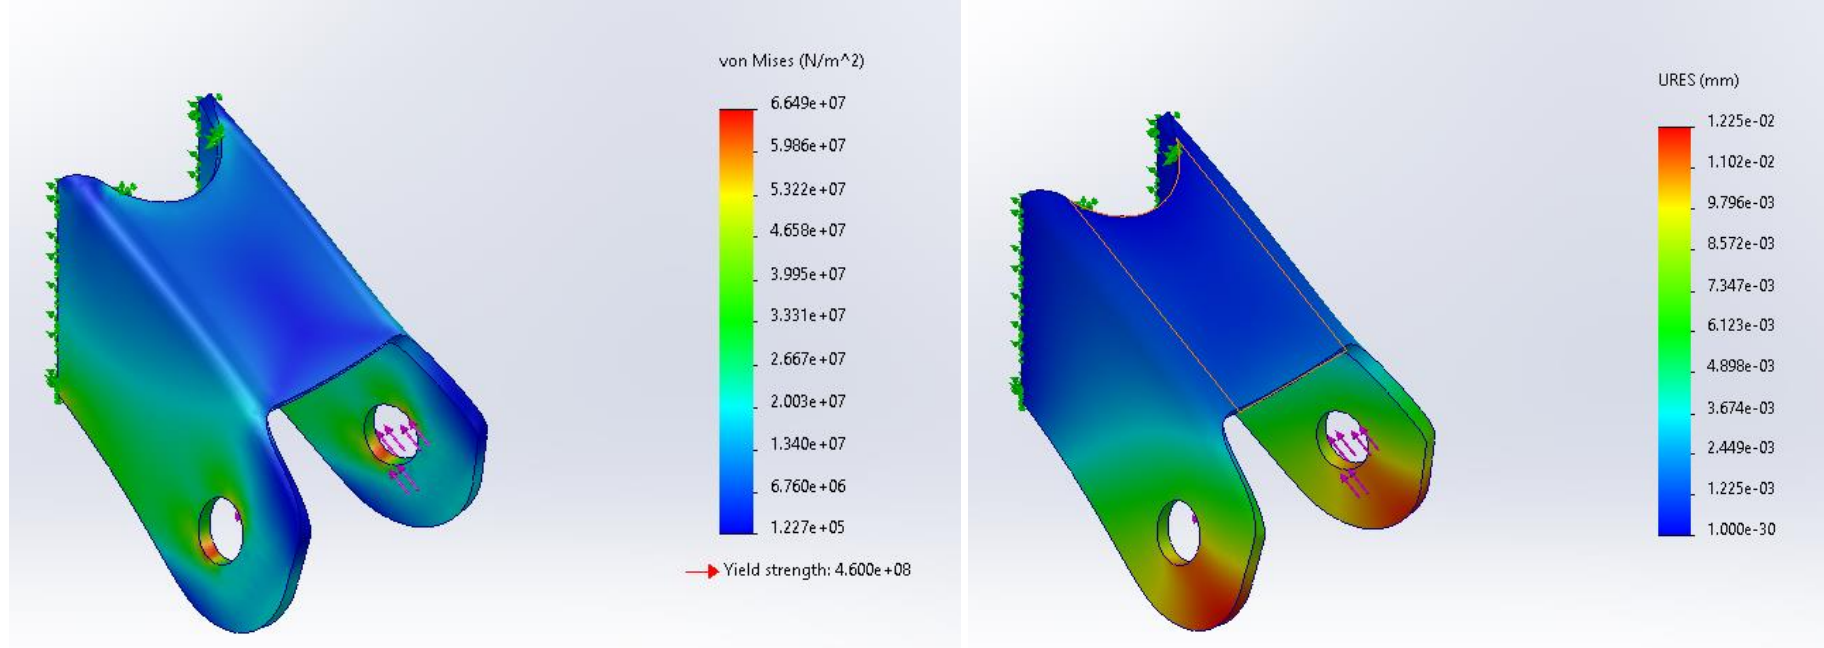
Rear Shock Mount Tab

Results:
Minimum factor of safety in part of 18 shows extreme safety in tab design.
Assuming proper manufacturing of tab, failure would likely occur due to incorrect assembly in the welding stage.
