Saginaw Hill Erosion Control

Design Report

Spring 2016 NORTHERN ARIZONA UNIVERSITY CENE 486 Capstone

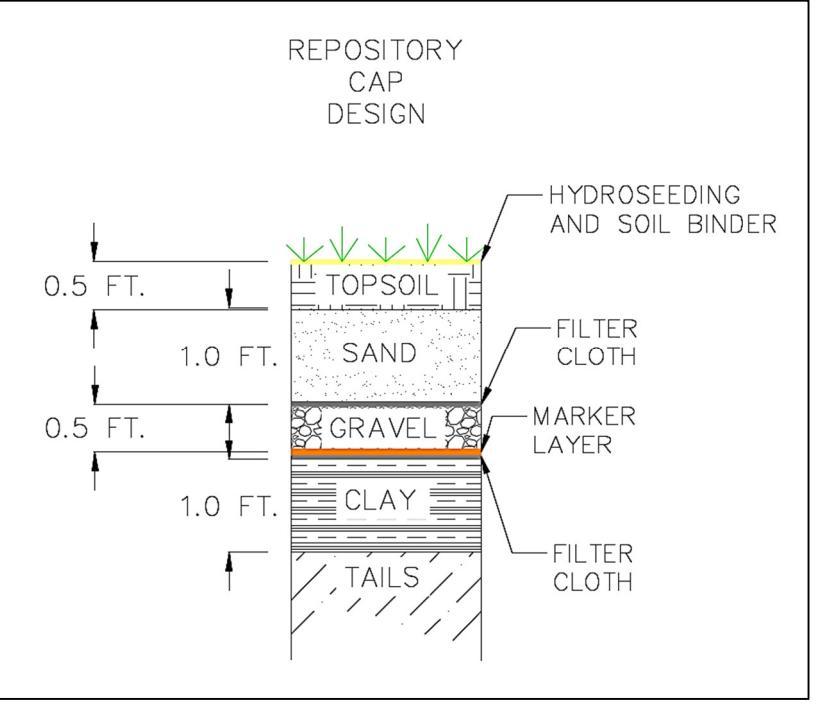
Figure 1.3 Repository Cap Design, as described in design report.

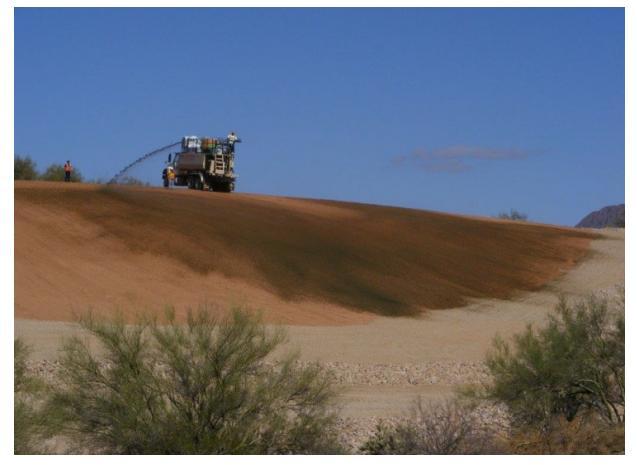
Figure 1.4: Revegetation efforts on top of repository cap [2].

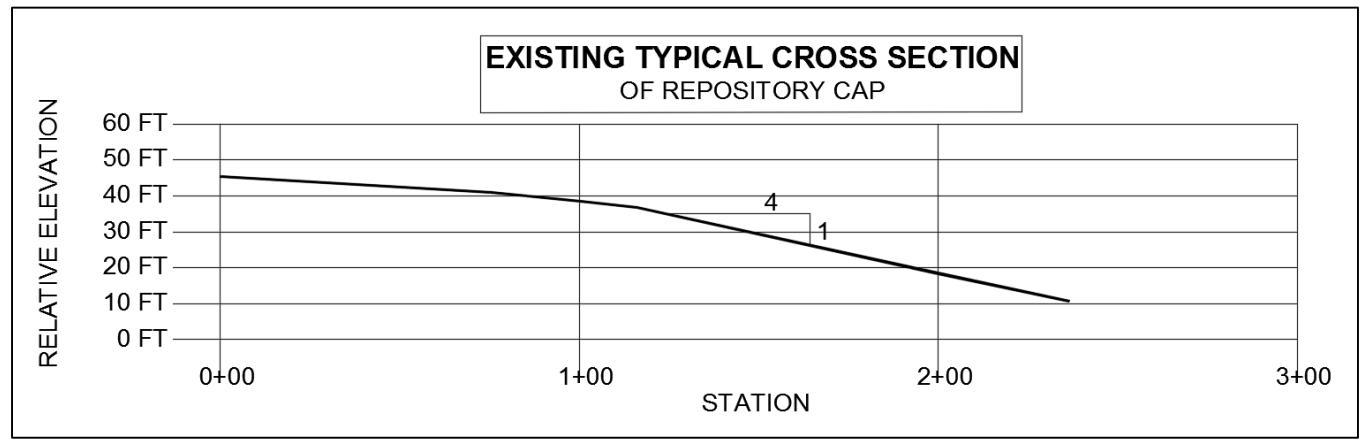
Figure 2.1: Typical cross section of cap.

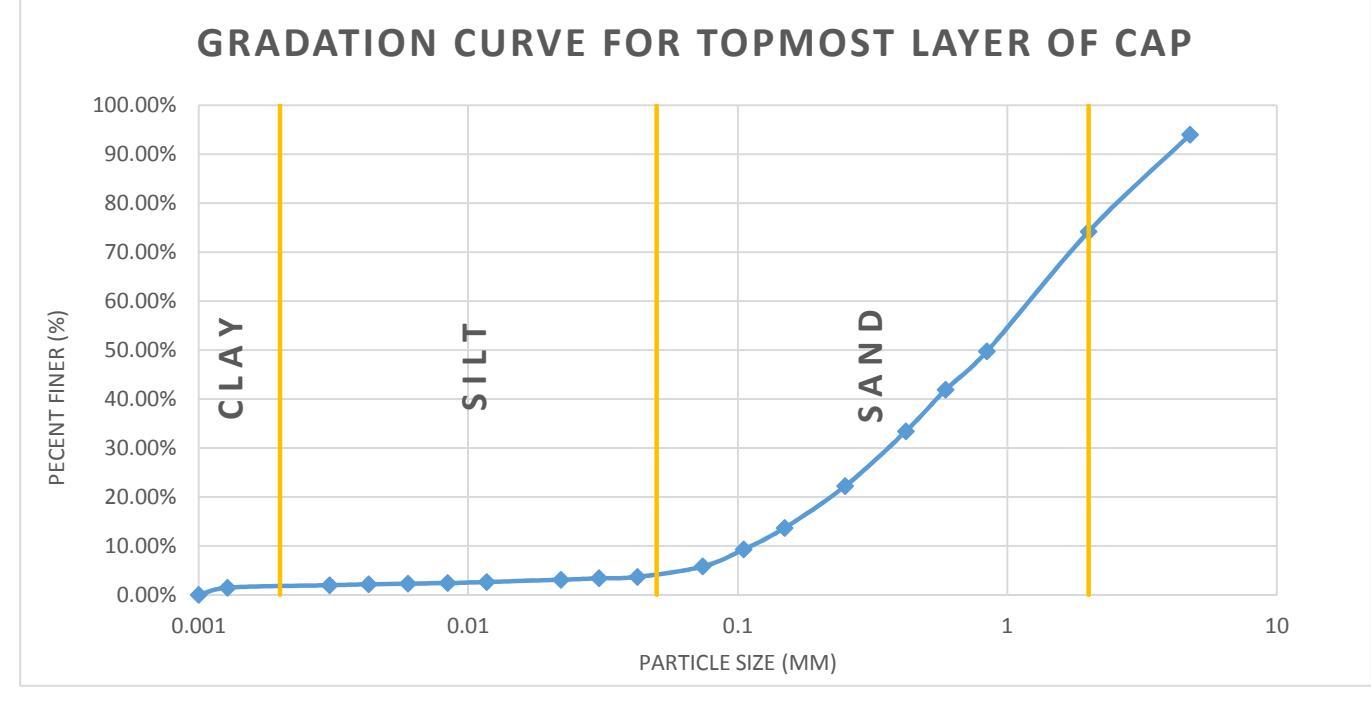
Figure 2.2: Gradation Curve of Upper Cap Layer

Based on the analysis discussed above, the source of erosion is most likely due to the composition of the top layer of the cap. MARS Consultants analysis found that the top two feet of the cap is composed primarily of sand, with no topsoil or drainage layers as specified in the original design. See Figure 2.7. The sand performs adequately as an infiltration layer, but without a gravel layer there is nothing to convey the infiltrated water off of the cap. Additionally, sandy soil is a poor growth medium, so the absence of a topsoil layer is likely why the initial hydroseeding failed.

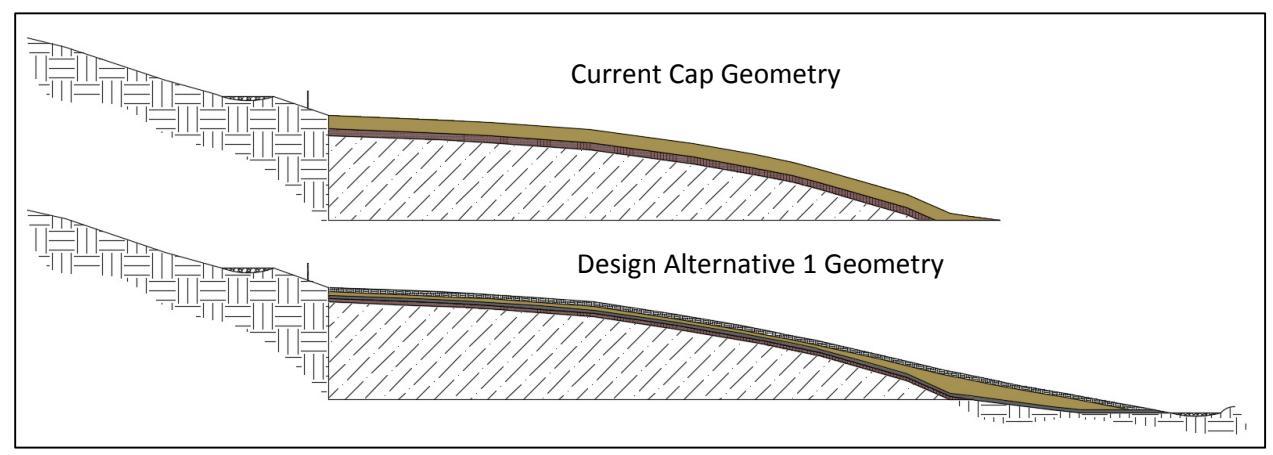
Figure 3.1: Cross section comparison of current cap and proposed geometry for Design Alternative 1.

Design Alternative 1 would include excavating the existing sand from above the marker layer. A drainage layer system that would include, starting from the lowest layer, a 6 in. gravel drainage layer, a minimum of 6 in. transition layer composed of the sand that is currently above marker layer, and an 8 in. layer of topsoil (see Figure 3.1) would be implemented directly above the marker layer. The geometry of the cap will be altered to decrease the slope as far as possible by using the transition layer of recycled sand, with maximum sloping of 4.5:1, to decrease the velocity of the

runoff. The length of the extension would vary based on the current caps geometry. Native grass hydroseeding would be spread across the entire cap to promote vegetation and reduce potential for erosion.

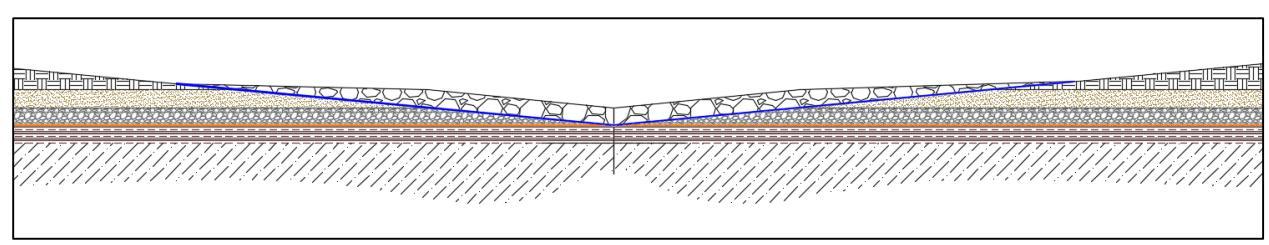
Figure 3.2: Design Alternative 2 Typical Channel Cross Section

Design Alternative 2 involves excavating the existing sand from above the marker layer and using excess material to reshape the geometry of the cap. The new cap geometry would direct runoff into three rip-rap channels on the cap to assist with drainage during large storm events. A 6 in. gravel layer would also be installed under the sand layer to further facilitate drainage and a 12 in. topsoil layer would be placed on top of the sand layer to provide a suitable growth medium for hydroseeding.

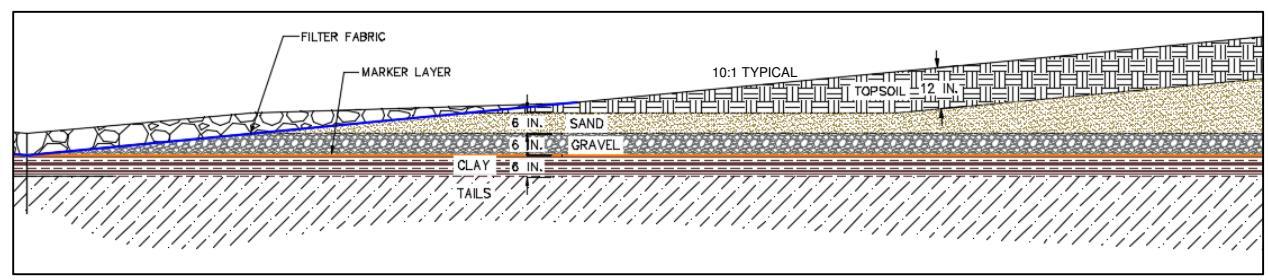
Figure 3.3 Design Alternative 2 Layer Details

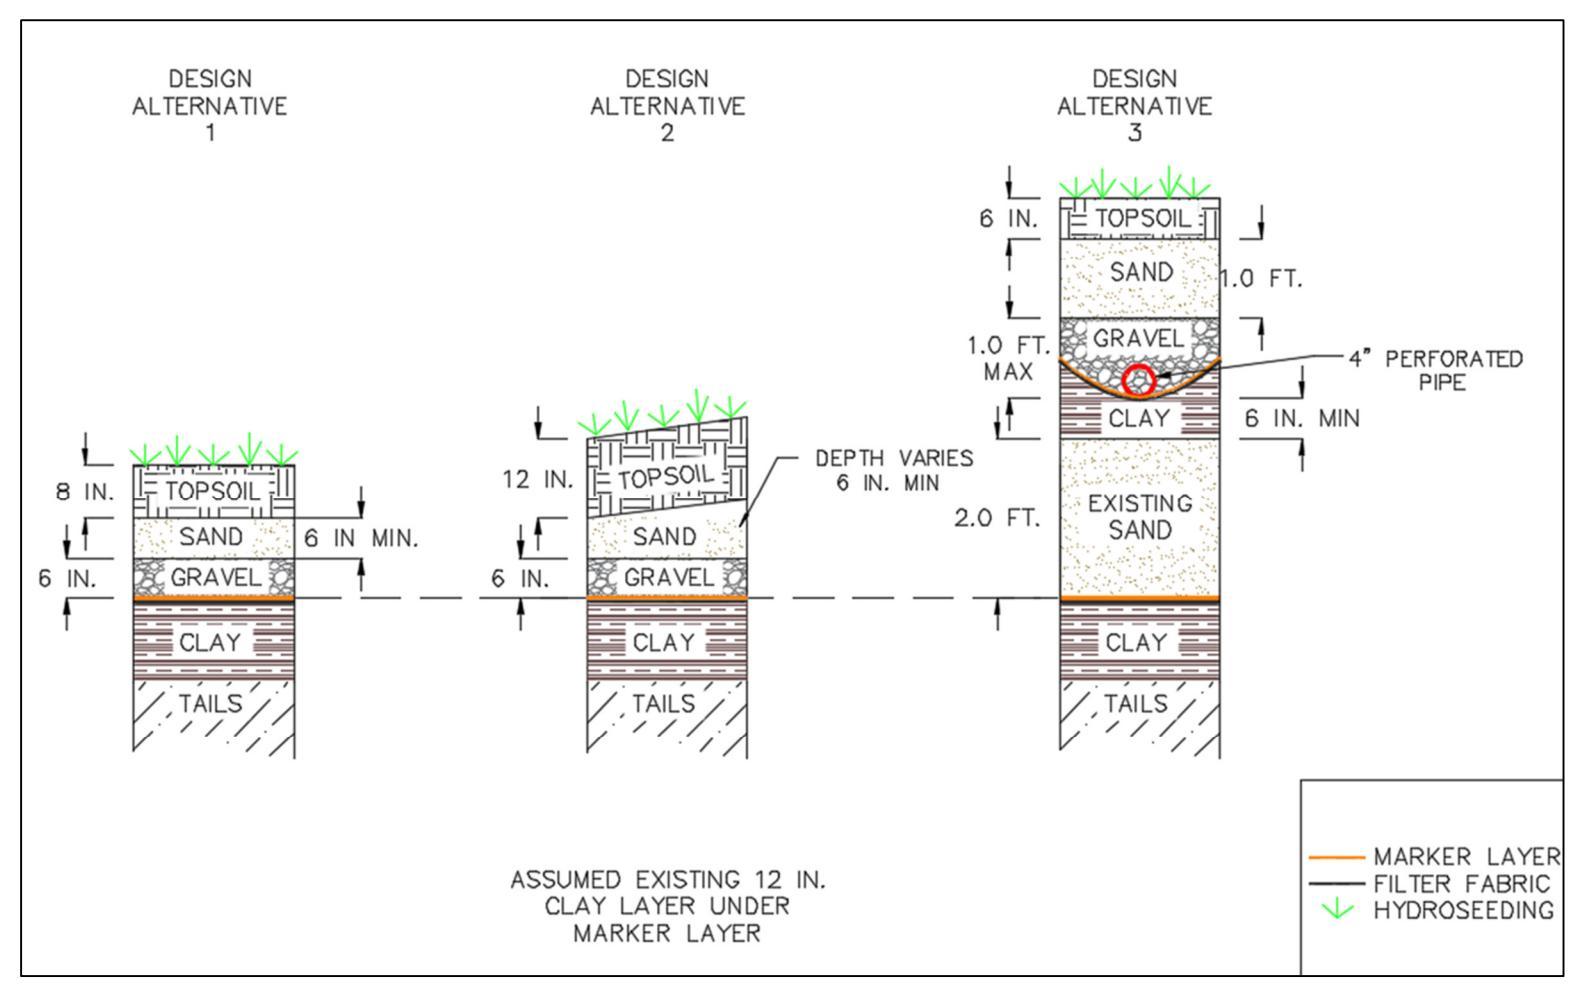
Figure 3.4: Cross section comparison design alternatives layering conventions

Design Alternative 3 involves leaving the cap as it is currently and adding additional layers on top of the existing sand. The sand would first be compacted and erosion rills filled in. The new layers would include, beginning with the layer directly above the existing sand, a 6 in. clay layer, a marker layer composed of orange construction fencing, a 1 ft. gravel layer with 4 in perforated pipe running down the slope of the cap to promote drainage at varying intervals, a 1.0 ft. sand infiltration layer, and a 6" topsoil layer. The new layer of clay would be vary in depth to create low points. The perforated pipe would be placed in these low points to direct drainage into the pipes. Native hydroseeding would be applied to the cap surface to promote vegetation and reduce erosion potential.
