Rio de Flag Drainage Study
Artemis Designs

December 7, 2021

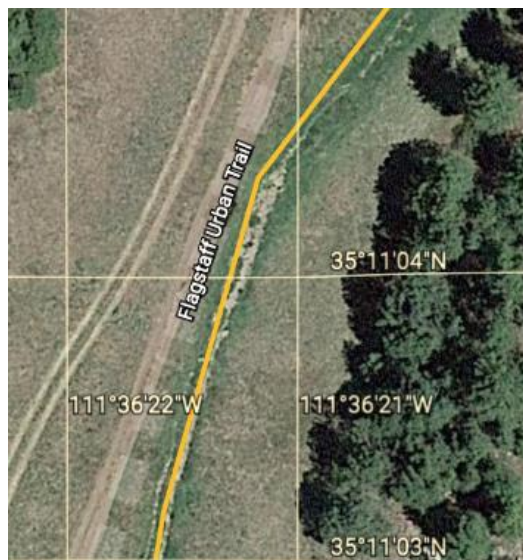
Figure 3: Example of Multi-use Section of Reach [1]

Much of the reach runs along a portion of the FUTS, an organization of mixed-use, recreational trails that weave through and around the City of Flagstaff, which are owned and maintained by the City of Flagstaff. Figure 3-3 below is a satellite image of the channel (right), the FUTS trail (center), and a rogue ATV trail (left), highlighting the issues related to the mixed-use nature of this section.

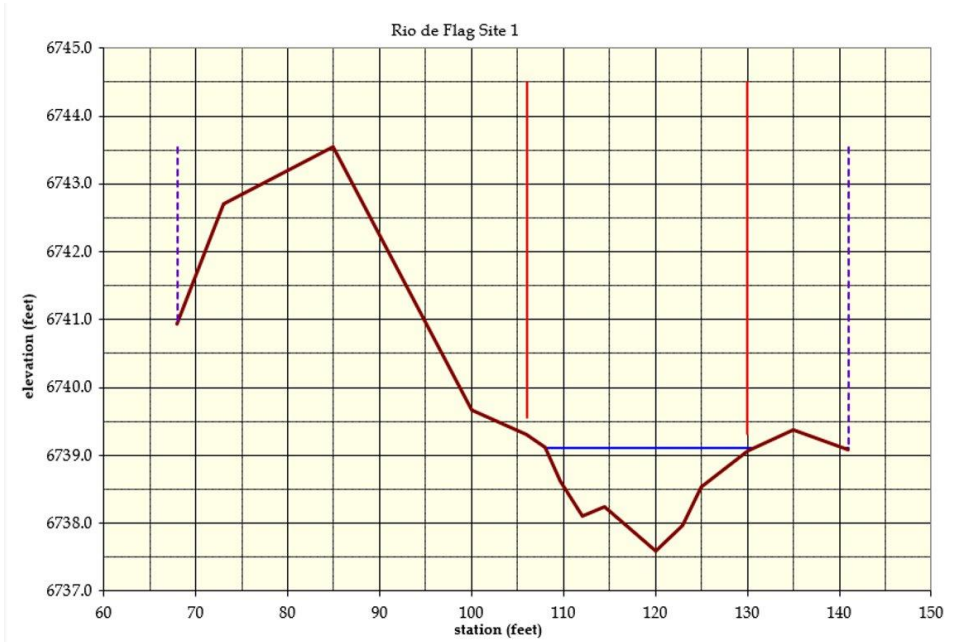
Appendix I.1: NRCS Results for Site 1

The cross-section analysis for Site 1 can be found in Appendix I, showing the cutting of the thalweg (circled in red to the right) and incision of the bank (circled red, left) due to excessive erosion.

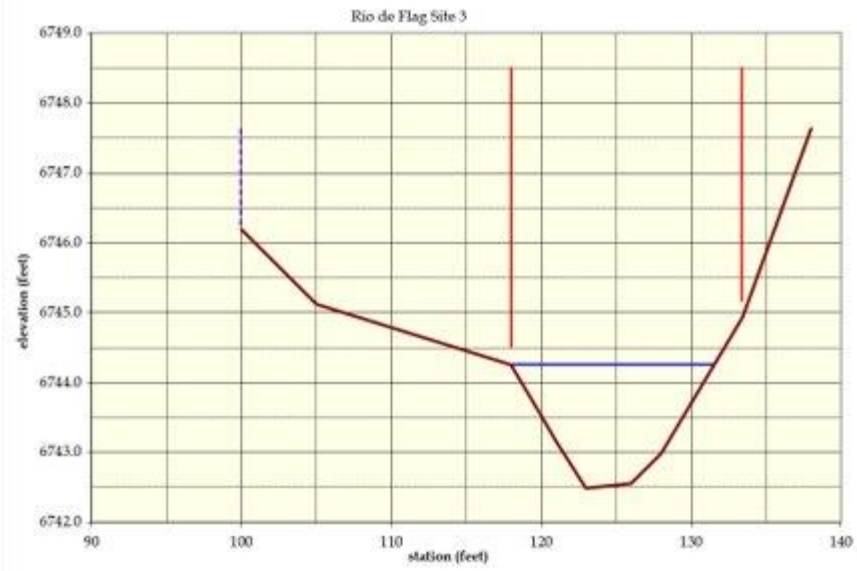
Appendix I.3: NRCS Results for Site 3

The cross section of site 3 can be found in Appendix I.

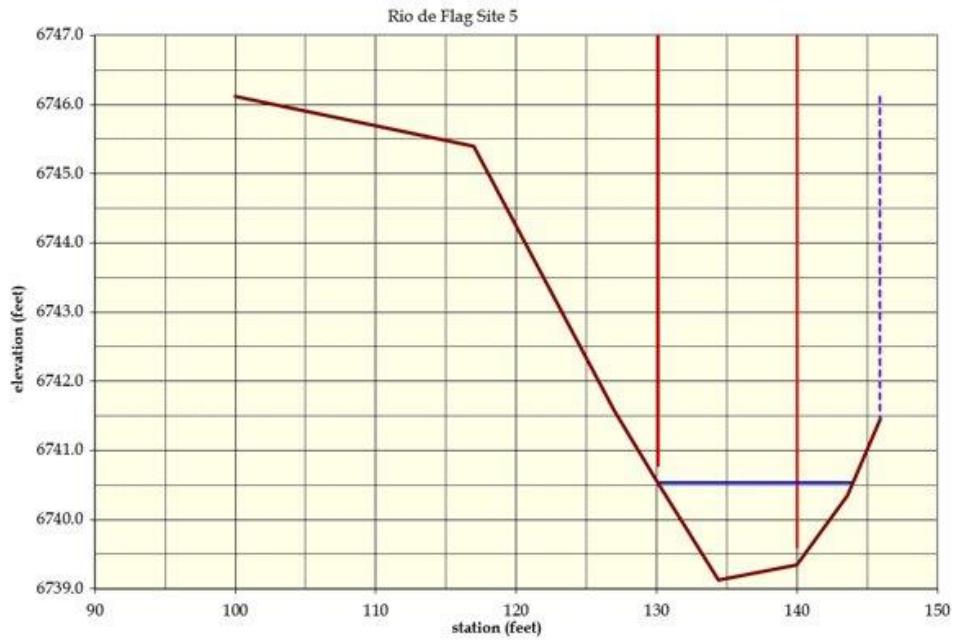
Appendix I.5: NRCS Results for Site 5

Site 5 showed evidence of high velocity discharge with a lack of vegetation in and around the channel, large boulders deposited, and no evidence of standing water. The results of the hydraulic analysis of this site can be found in Appendix I.

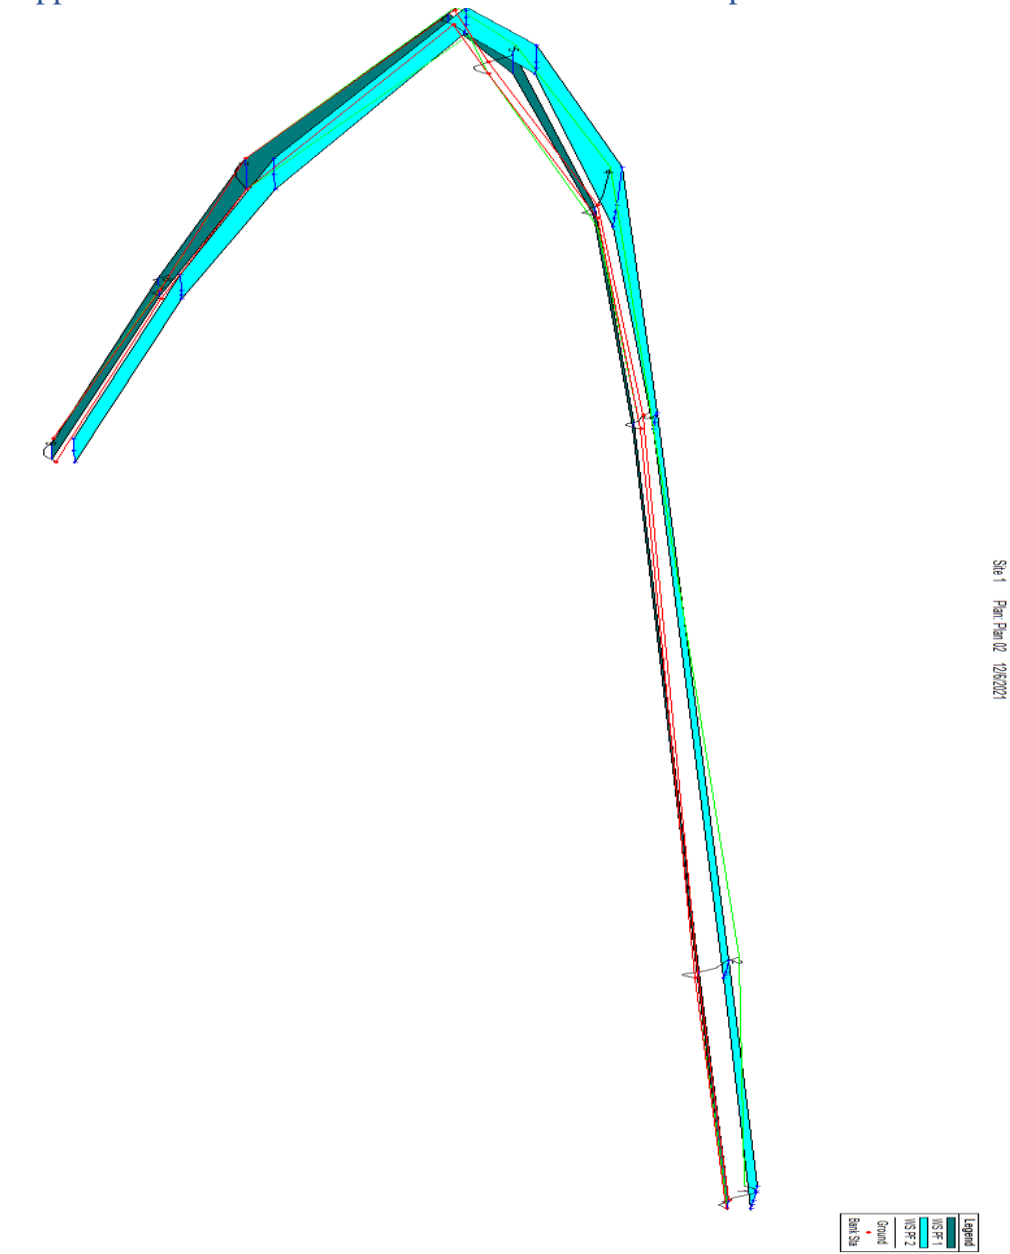
Appendix K: HEC-RAS Water Surface Profile Sample for Bankfull at Site 1

The prevailing flow regime for the reach as studied was sub critical, which is readily demonstrated by the excessive silting and water detention. Appendix K shows an example of the reach orthogonal view for flows under bankfull conditions at site 1 (extreme downstream). Appendix L contains allowable velocity values from the COF SWMDM to determine the standard values for erodible channels. Where velocities exceed 3.5 fps, these are areas of erosive concern.
