Parabolic Trough-Tracking System

Team 14

Project Proposal

Department of Mechanical Engineering
Northern Arizona University
Flagstaff, AZ 86011

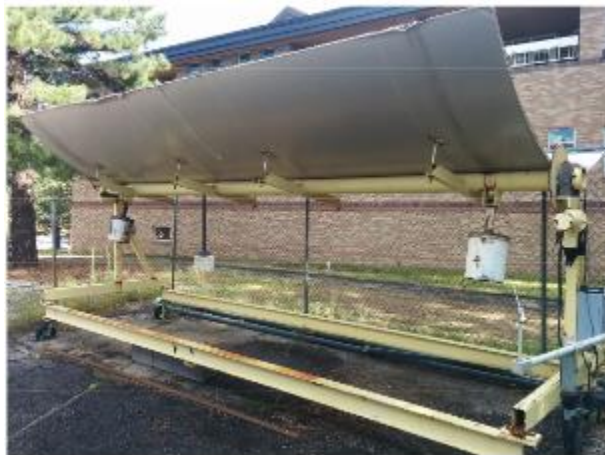
Figure 1- Overall system

In order to absorb the most solar energy from the parabolic trough, the tracking system must be repaired and damage done to the trough must also be repaired. An overall view of the system is displayed in Figure 1.

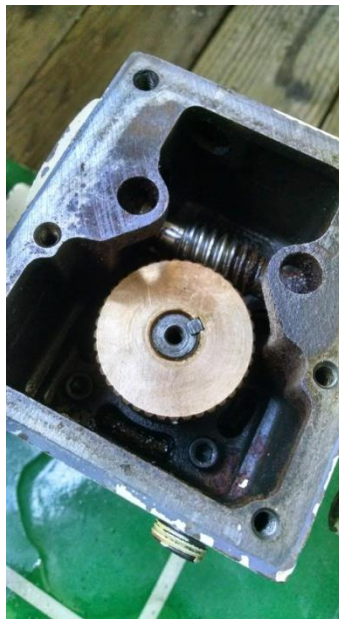
Figure 15- Post-cleaning upper gearbox

The rubber gasket has stretched and deteriorated from the weather of Flagstaff. The gasket will need to be replaced before the system is put back online. The defective gasket was the cause of the rusted parts in the upper level gearbox which are pictured in Figure 12. Moisture and condensation found its way through the gasket and the addition of minimal lubrication oil, the results was rust. There is a possibility that the cover plate will need to be replaced, but until it has been cleaned and tested, it will be unknown. The six bolts securing the cover plate will be replaced. The pink, once red in color, filler cap is made of plastic and will be decided at a later time if it needs to be replaced. The drain plug located on the upper level gearbox is in good working condition.

The gearbox was taken to Coconino Auto Suppliers to get it professionally cleaned. The total cost for the cleaning was \$35, and the material for a new gasket is also sold there for \$8 a sheet. The upper and lower gearbox cleaned up well with the exception of a small bit of rust on the worm gear located in the upper gearbox. Figures 14-17 show the gearbox after it was professionally cleaned. The gearbox will be used for the tracking system of the parabolic trough.

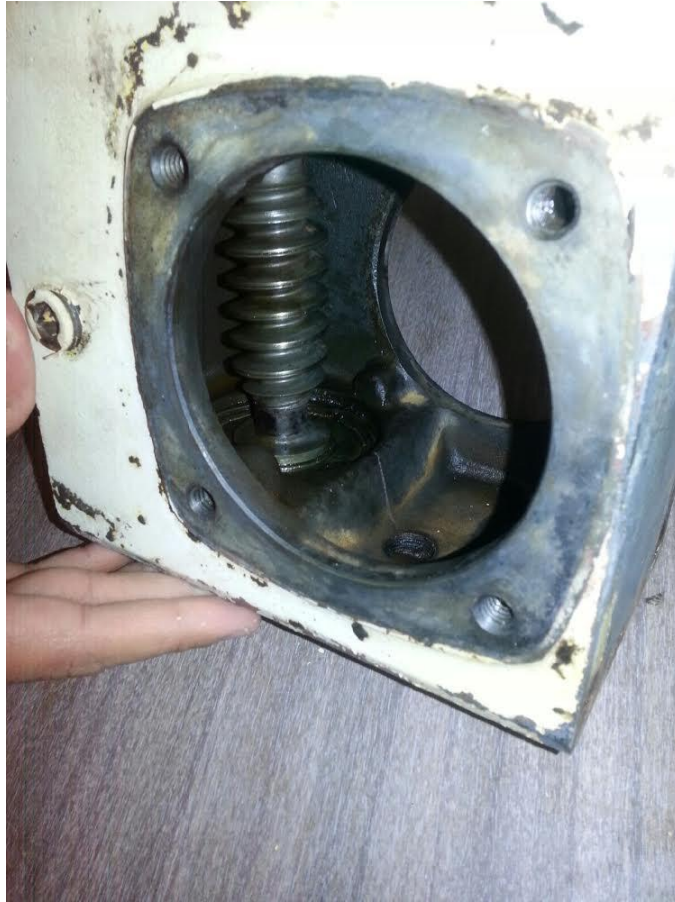
Figure 16-Post-cleaning lower gearbox

After disassembling the side cover mounted to the gearbox to observe the interior of it. It was found that it contains a vertical worm gear connected to the vertical shaft that rotates a helical gear in the same shaft located at the upper gearbox. The worm gear is connected perpendicularly to another helical gear located in the horizontal shaft that rotates the outer small sprocket. The vertical gear coming down has a roller ball bearing attached to it. As seen in Figure 13 the bearing sits between the upper level gearbox and the lower level gearbox to reduce friction and secure the vertical shaft. The roller ball bearing and the vertical shaft are in good condition. This is due to the lubricating oil protecting the parts from condensation and moisture.
