## 50% Design Report

**Team Flaming Bunnies (2016-2017)**

The Allan Lake Wetland Restoration project aims to restore the wetlands' historical ability to retain water and support wetland vegetation. The fine particle clay layer that had acted as an impermeable water-holding layer was disturbed during a habitat improvement effort, resulting in a loss of wetland function. The purpose of this project is to improve the distribution and retention of water in the wetland area. The Forest Service has a rough idea of how they would like to approach the restoration, they have previously used a bull dozer and half a dozen workers to carry out a test restoration in a single section. Figures C1 through C3 in the Appendix show the differences that are observable at the site between the unrestored area and the test restoration section. The Forest Service then put out a bid to contractors to see how much it would cost to have the entire lake restored like their test section, however they did not include a soil analysis of the site, which made the bids range from \$40,000 to \$250,000. The main objective for the students is to conduct the soil analysis, and then based on the soil analysis complet

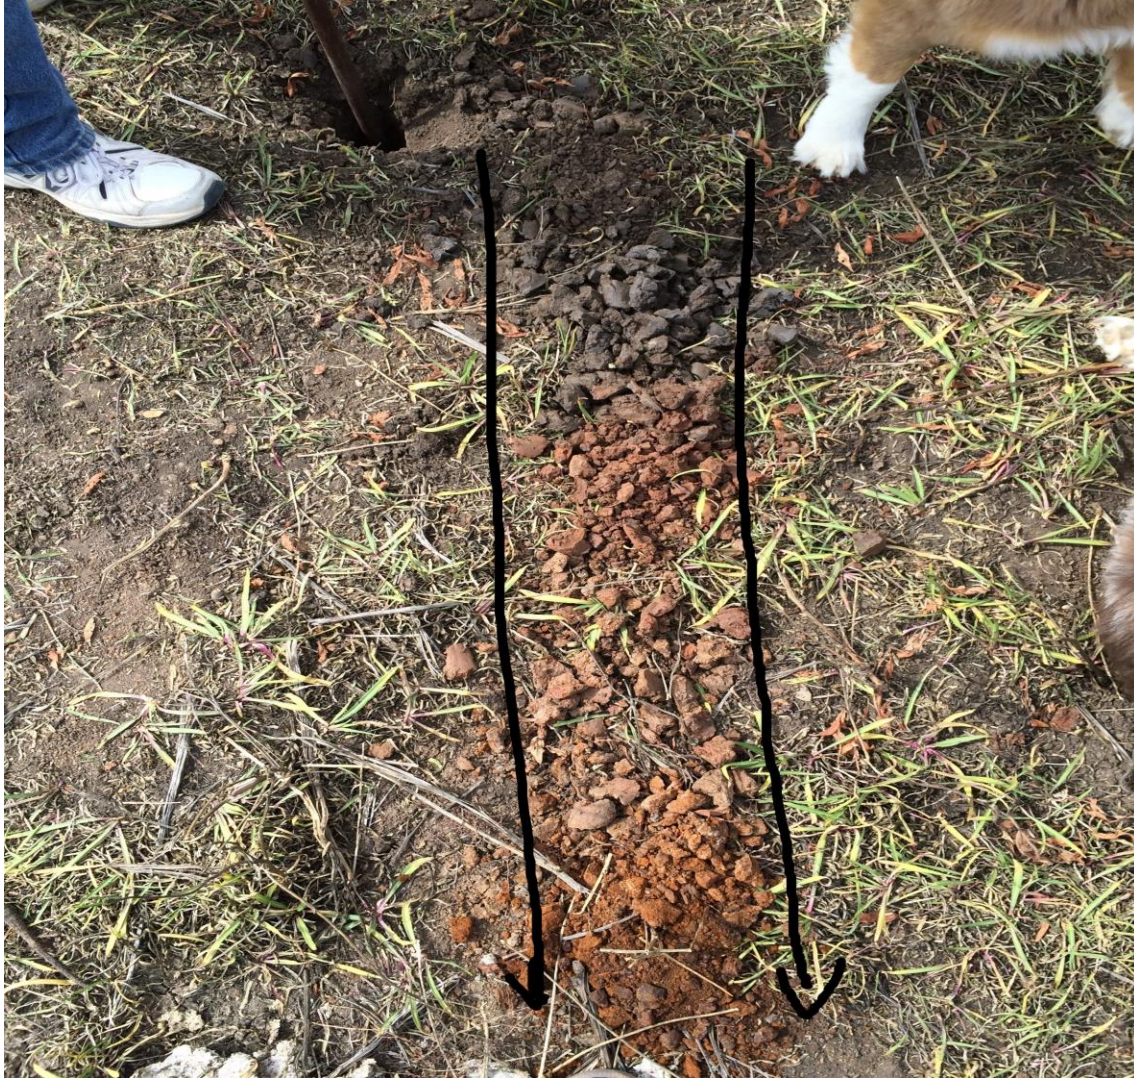
**Figure 3.11:** Soil profile of the undisturbed sections of Allan Lake.

Based on the soil samples collected, we found that parts of the wetland was undisturbed by Arizona Game and Fish. Thus, these soil profiles represent the soil layers for the undisturbed area (before the excavation of Arizona Game and Fish) and the disturbed soils, which are the side casted mixed piles and the trenches. The first layer of soil from the undisturbed area (shown below in Figure 3.14) is the hydric layer, which indicates heavy organic deposits, periodical moisture, and heavy clay. The second layer is the oxidation layer and iron deposits, but also heavy clay. The third layer is the sandy clay loam mixture. On the next page, a simplistic image of the layers is shown:

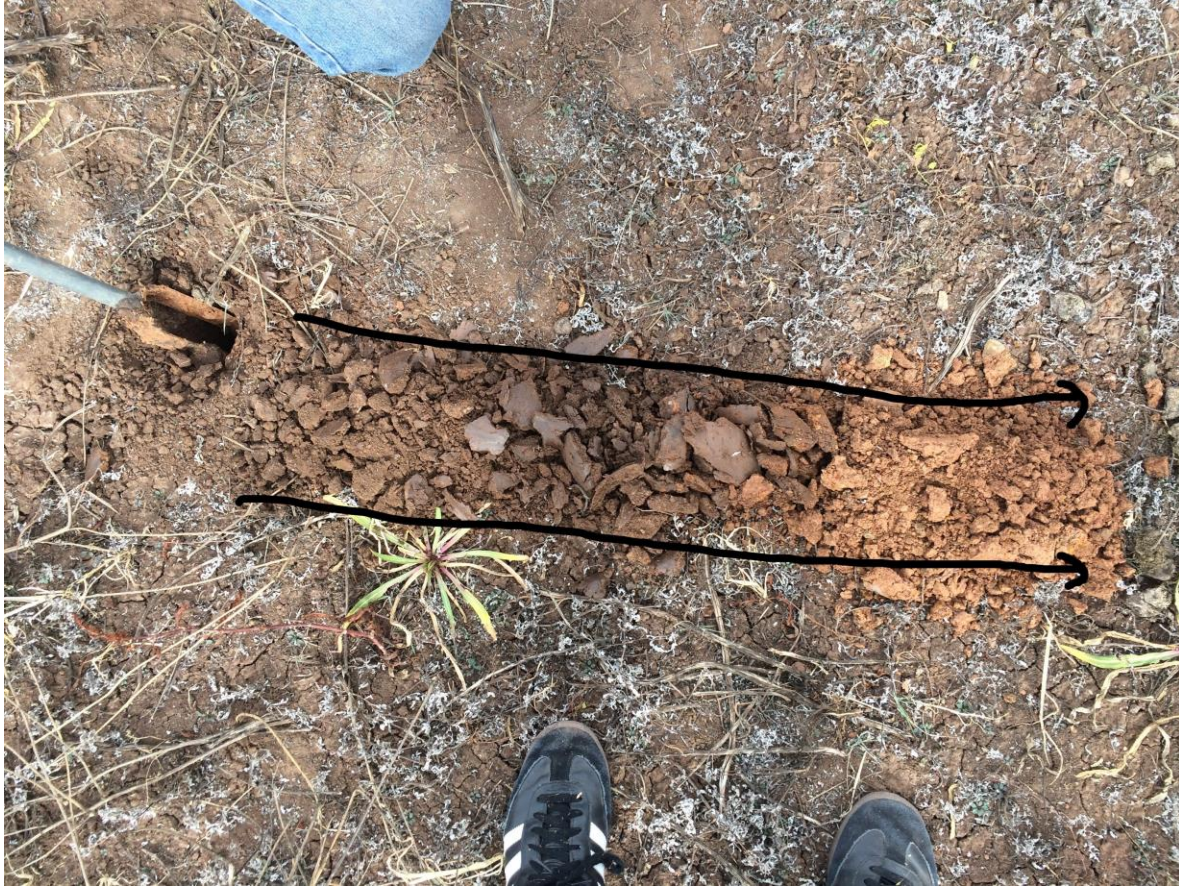
**Figure 3.13:** Soil Profile of the Trenches.

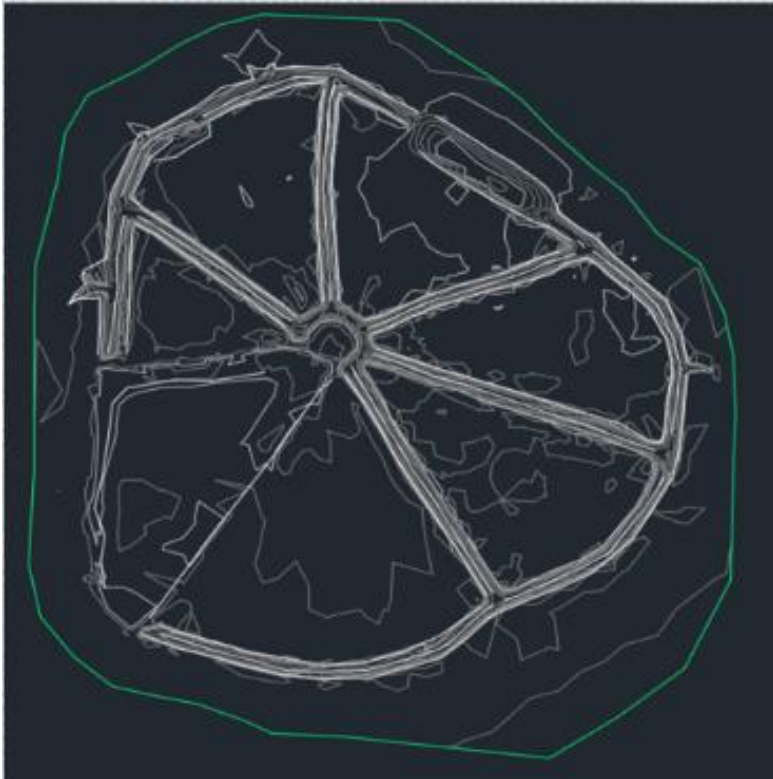
A topographical map was developed from the obtained points can be seen in the figure below. Breaklines are visible in this image that were inserted to help AutoCad construct an accurate topographic map.

**Figure 3.17:** The topographic map of Allan Lake.

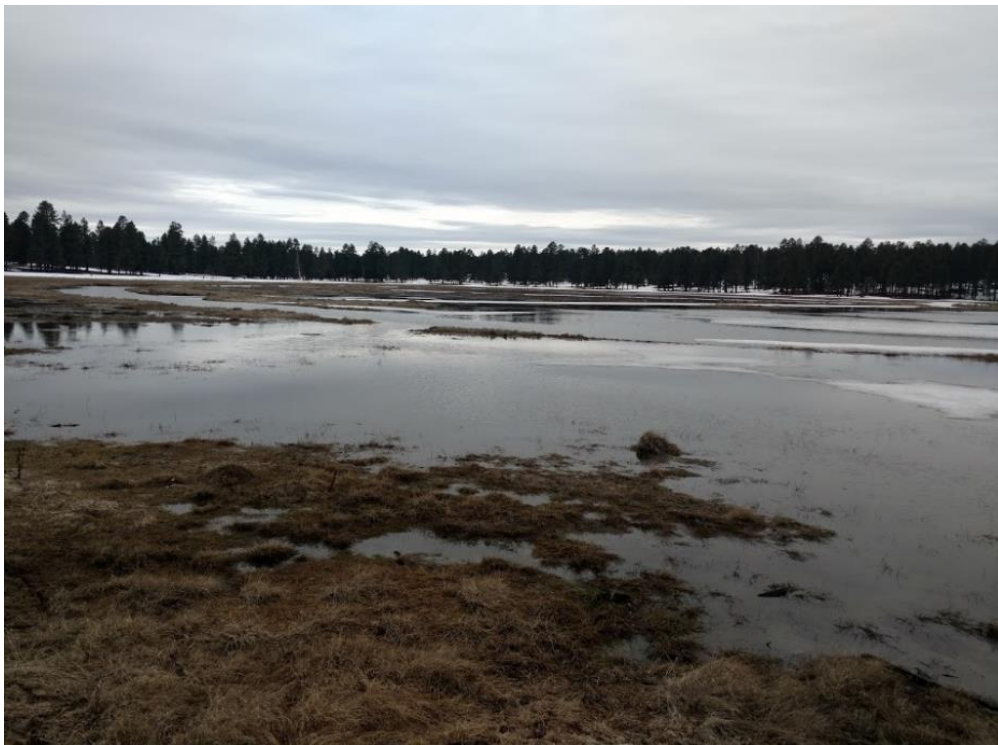
Appendix Figure C4: Overview of flooded wetland (February 17<sup>th</sup>, 2017)

on the ground, as shown in Figures C4 through C6 in the Appendix. This poses the problem of not being able to gather more soil samples until the area has dried some. Fortunately, the lake is currently at full capacity and overflowing through the natural spillway so flooding cannot worsen. Due to this, the main limitation of this project is what the site and weather conditions are like. This can limit the project by delaying the soil gathering as well as prevents the students from conducting additional survey work. The current conditions impose a delay in collecting more soil samples for the hydraulic conductivity tests and the proctor compaction tests.
