CENE 486C

Final Design Report

Team Flaming Bunnies (2016-2017)

The Allan Lake Wetland Restoration project aims to restore the wetlands' historical ability to retain water and support wetland vegetation. The fine particle clay layer that had acted as an impermeable water-holding layer was disturbed during a habitat improvement effort, resulting in a loss of wetland function. The purpose of this project is to improve the distribution and retention of water in the wetland area. The Forest Service has a rough idea of how they would like to approach the restoration, they have previously used a bull dozer and half a dozen workers to carry out a test restoration in a single section. Figures C1 through C3 in the Appendix show the differences that are observable at the site between the unrestored area and the test restoration section. The Forest Service then put out a bid to contractors to see how much it would cost to have the entire lake restored like their test section, however they did not include a soil analysis of the site, which made the bids range from \$40,000 to \$250,000. The main objective for the students is to conduct the soil analysis, and then based on the soil analysis c

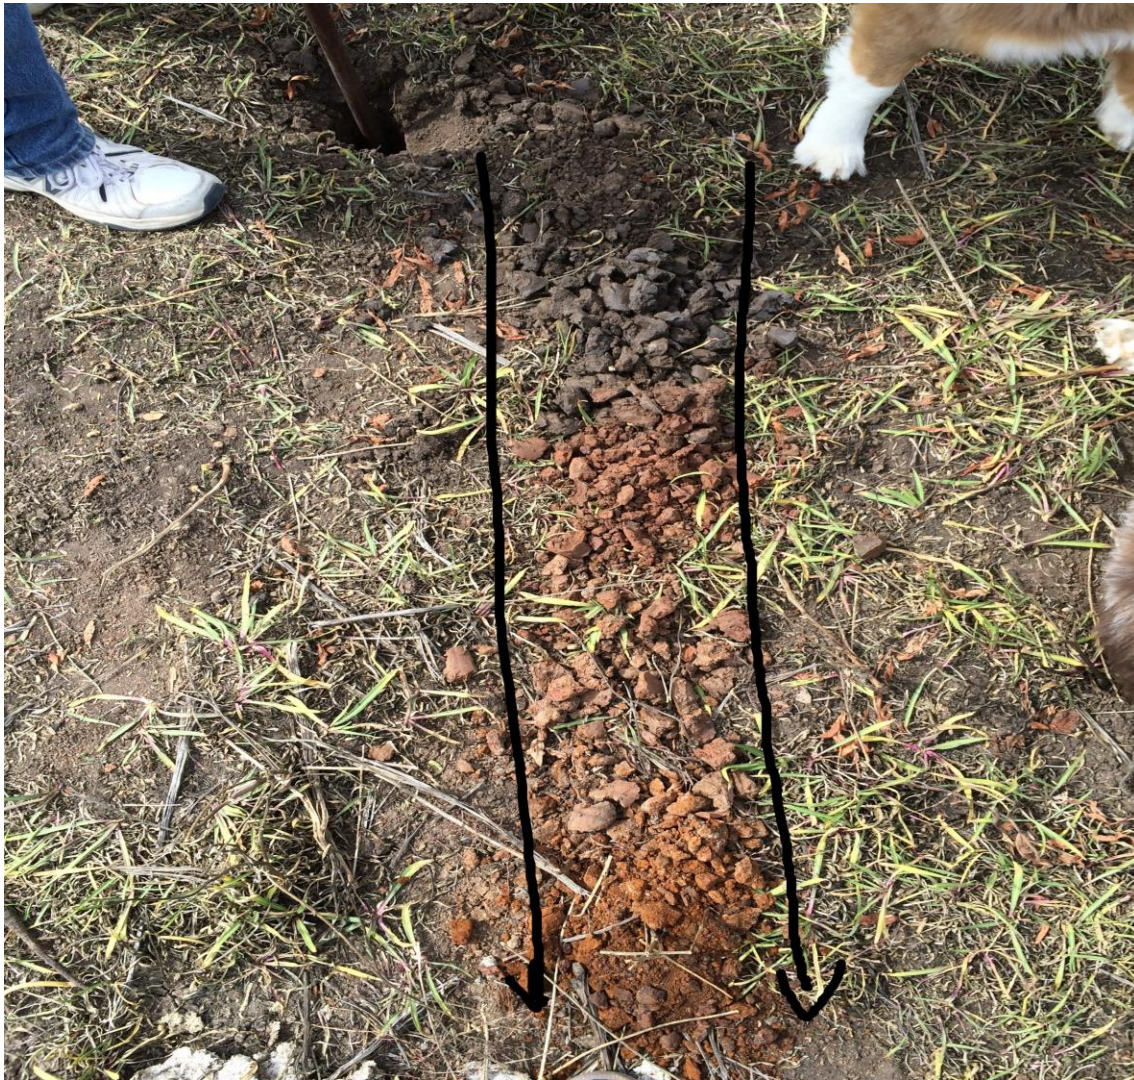
Figure 3.11: Soil profile of the undisturbed sections of Allan Lake.

Prior to conducting geotechnical lab analysis, soil sampling and surveying work were both completed as part of the fieldwork for the project. While collecting samples at the project site, we used a bore auger instrument to collect a soil profile. One of the bore logs used during the acquisition of samples can be seen in Appendix E. A total of 28 soil samples were initially collected from 13 sampling sites by the team, and shown below are some of the representative profiles:

Based on the soil samples collected, we found that parts of the wetland were undisturbed by Arizona Game and Fish. Thus, these soil profiles represent the soil layers for the undisturbed area (before the excavation of Arizona Game and Fish) and the disturbed soils, which are the side casted mixed piles and the trenches. The first layer of soil from the undisturbed area (shown below in Figure 3.14) is the top soil, which indicates organic content and plants. The second layer is the hydric soil, which indicates the top clay layer; periodically moisturized and dark. The third layer is the oxidation layer and iron deposits, but also heavy clay (shown as “the bottom clay layer”) which is indicated by the red color (as shown in figure 3.13). The fourth layer is the sandy lean clay mixture. On the next page, a simplistic image of the layers is shown:

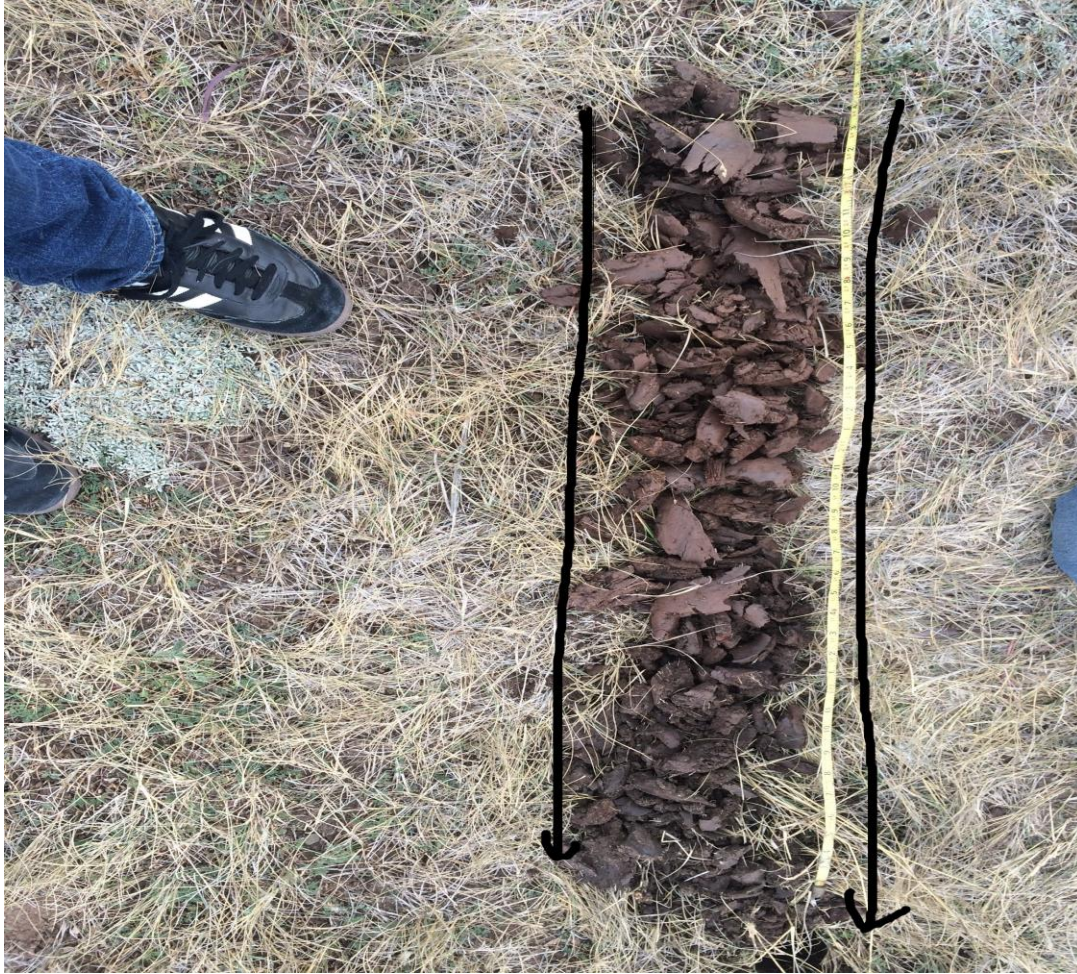
Figure 3.12: Soil profile of the side cast mix near the trenches.

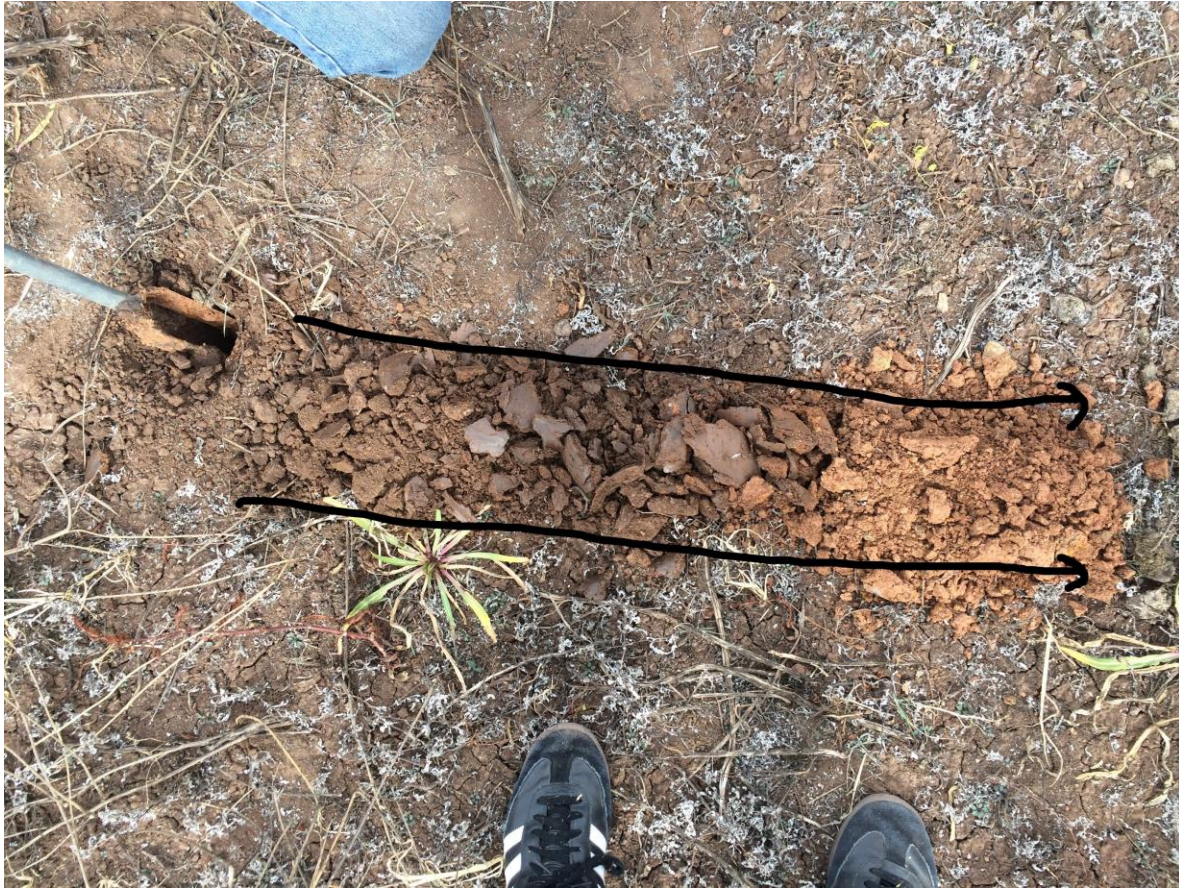
Figure 3.13: Soil profile of the trenches.

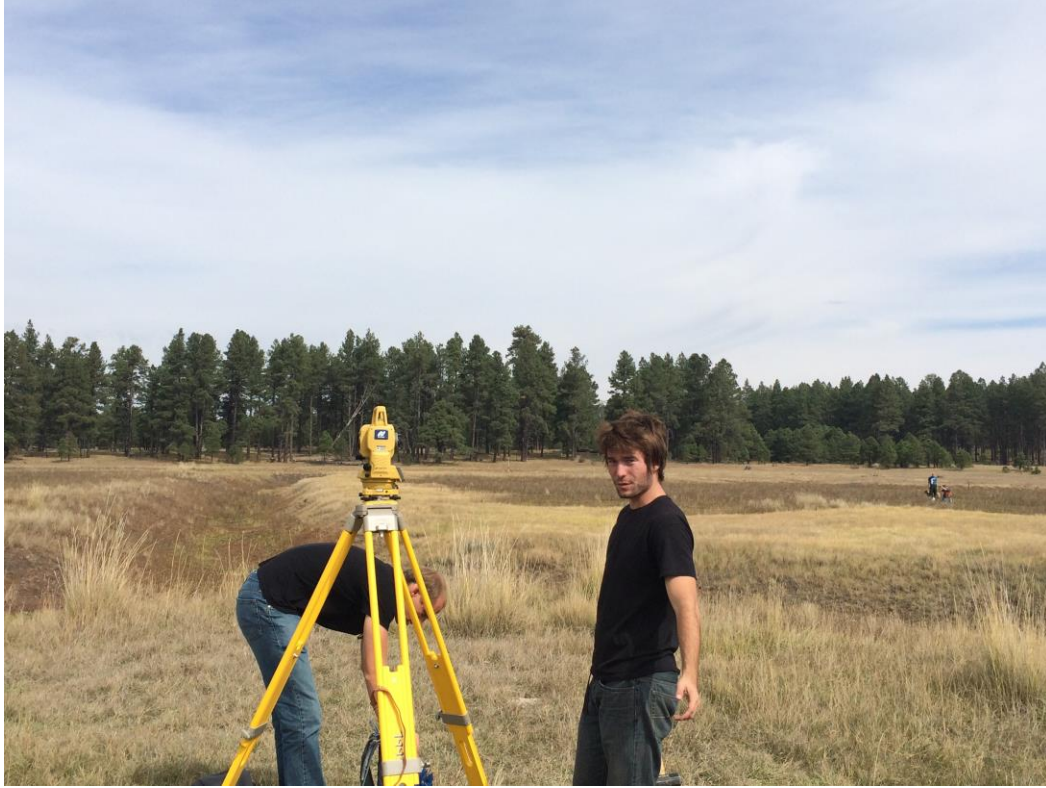
Figure 3.18: Surveying Allan Lake in the Fall of 2016.

After collecting soil samples and capturing each soil profile, we conducted surveying work. The Team conducted multiple site visits in order to collect data points. On our first day of surveying, we established 5 control points with a total station. However, due to the size of the area a GPS survey unit was utilized, as provided by the Forest Service. Kit MacDonald, a soil scientist for the Kaibab Forest Service, assisted with the setup and calibration of the GPS survey unit. Shown on the next page is the total station used for set the control points for the surveying work:

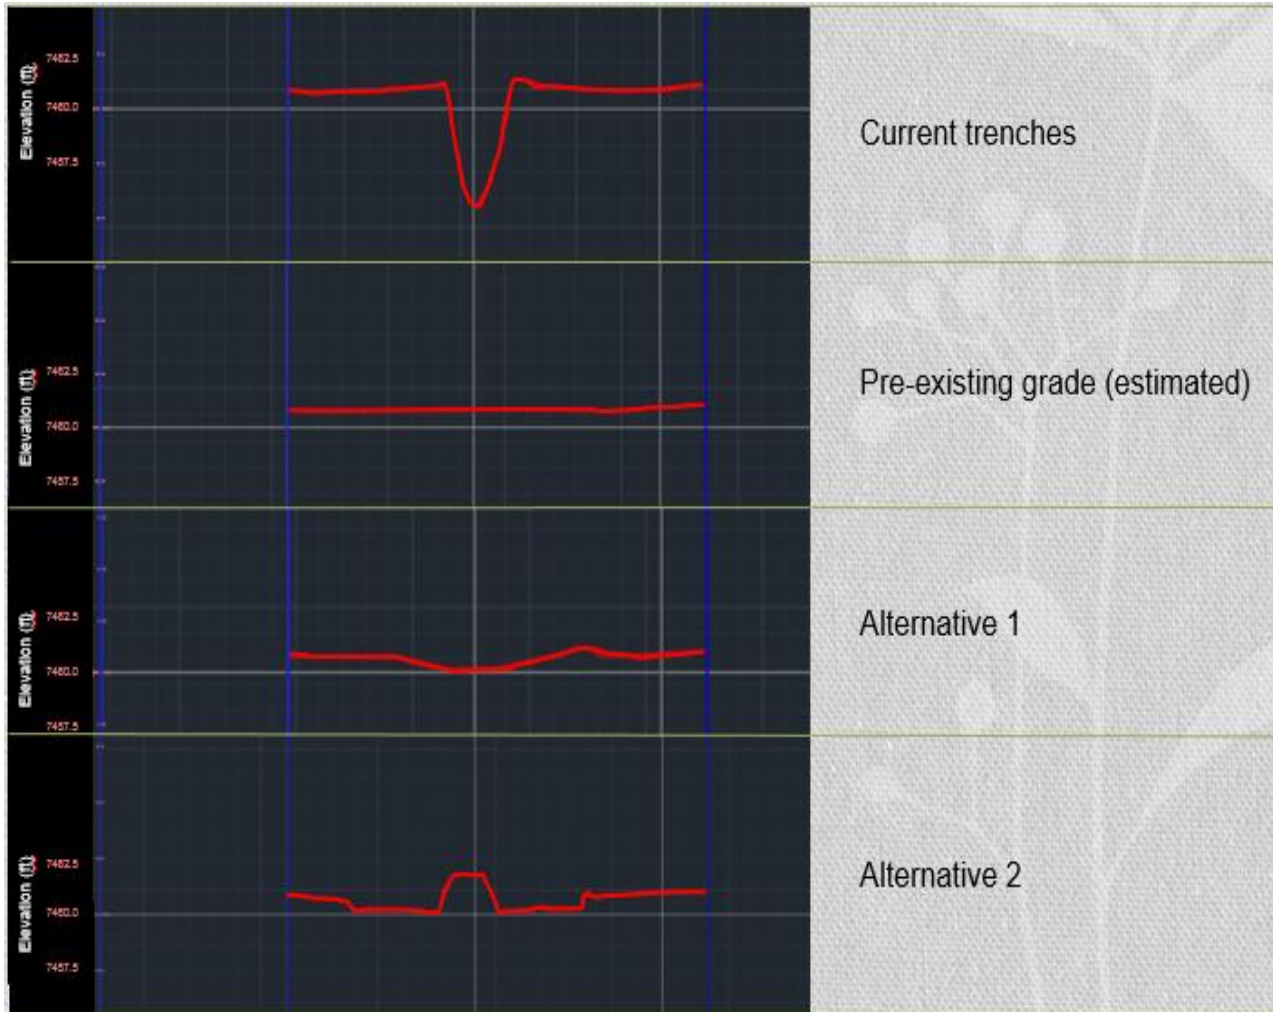
After conducting the soil analysis, AutoCAD was used to help derive alternatives for remodifying the wetland. In this figure below, it shows a comparison between alternative 1 and 2, but also gives a visual representation of the current site conditions:

Figure 3.21: Comparison of design cross sections.

For alternative 1, the plan is to raise the trenches to 1 foot below the pre-existing grade (as shown in figure 3.21). The benefits of this alternative are to lower the cost, lower the evaporation rate, and efficient construction time. The figure below shows alternative 1:

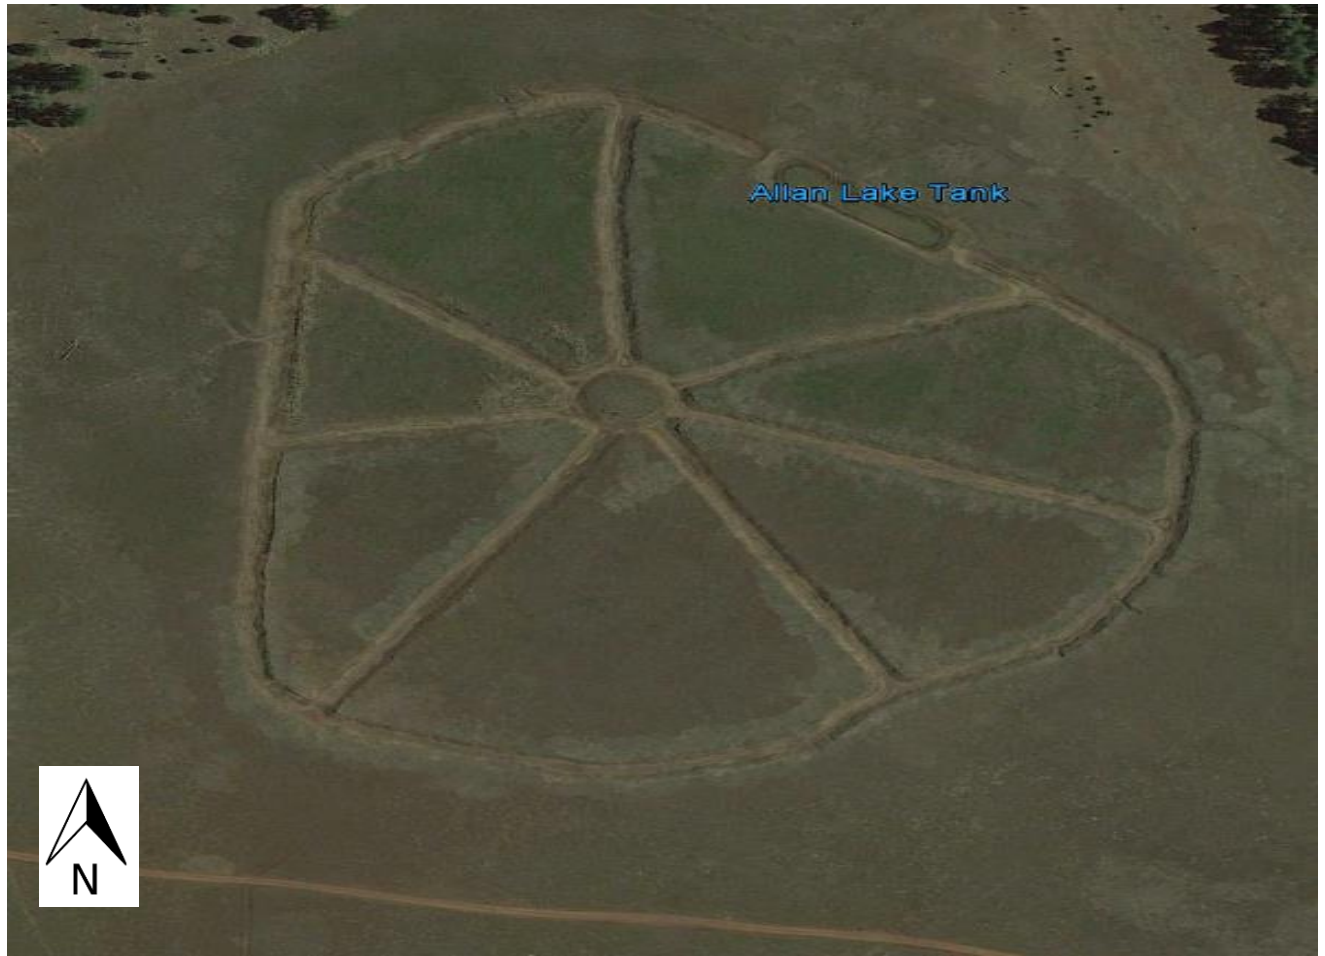
Appendix Figure B1: View of trenches of Allan Lake.

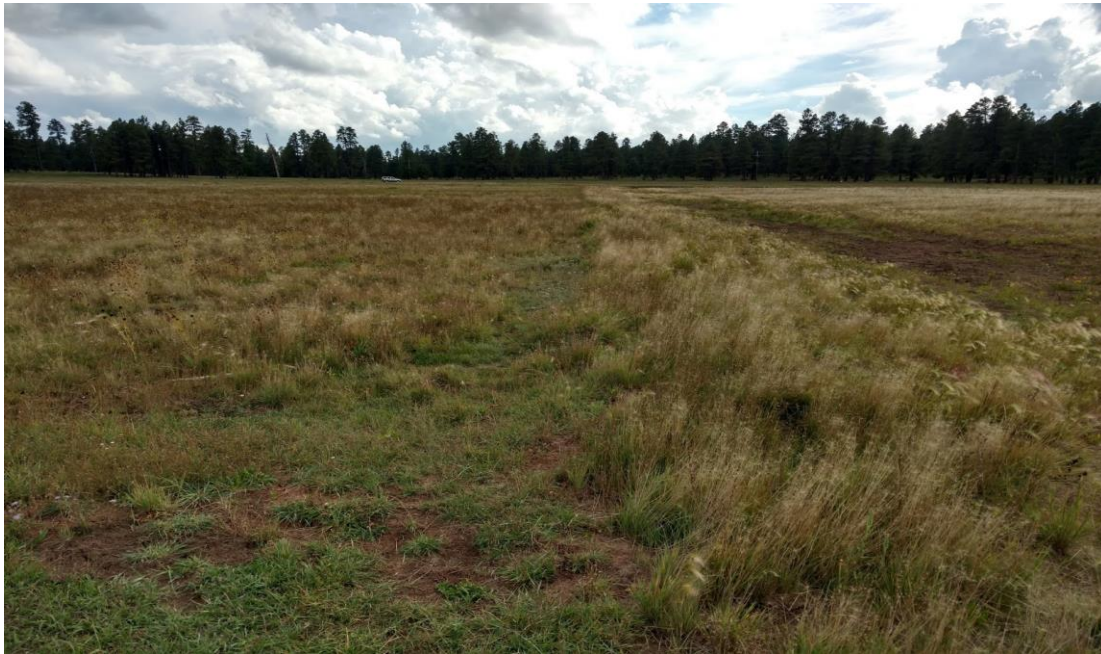
Appendix Figure C1: Differences in vegetation between the test restoration section on the right and the unrestored section on the left. (September 13th, 2016)

During the fall when the site was surveyed and the soil samples were gathered, the site was relatively dry and easy to traverse (this can be seen in Figure C1 in the Appendix). This contrasts with the conditions of the site during the months January and February. The site was heavily flooded with snow on the ground, as shown in Figures C4 through C6 in the Appendices. This posed the problem of not being able to gather more soil samples until Allan Lake had melted and dried up. However, during the month of March the team was able to go to a remote location to collect more samples in order to conduct more geotechnical lab analysis. The main limitation of this project was what the site and weather conditions were like during the time of site visits.

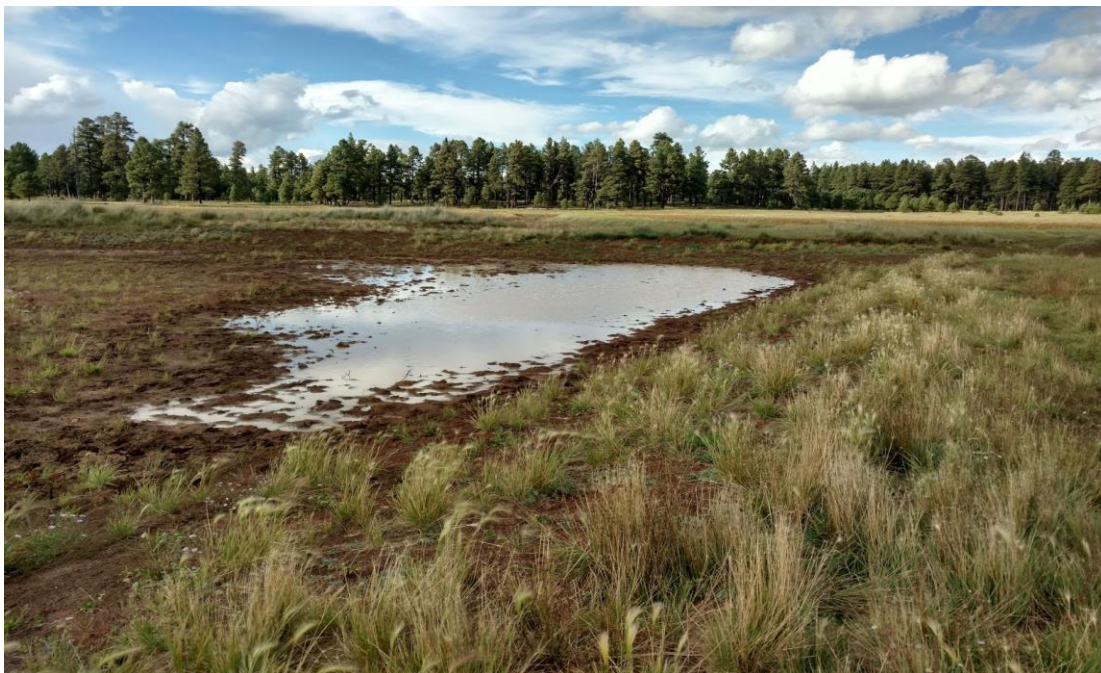
Appendix Figure C2: Small puddle of water in the deepest portion of the restored section. (September 13th, 2016)

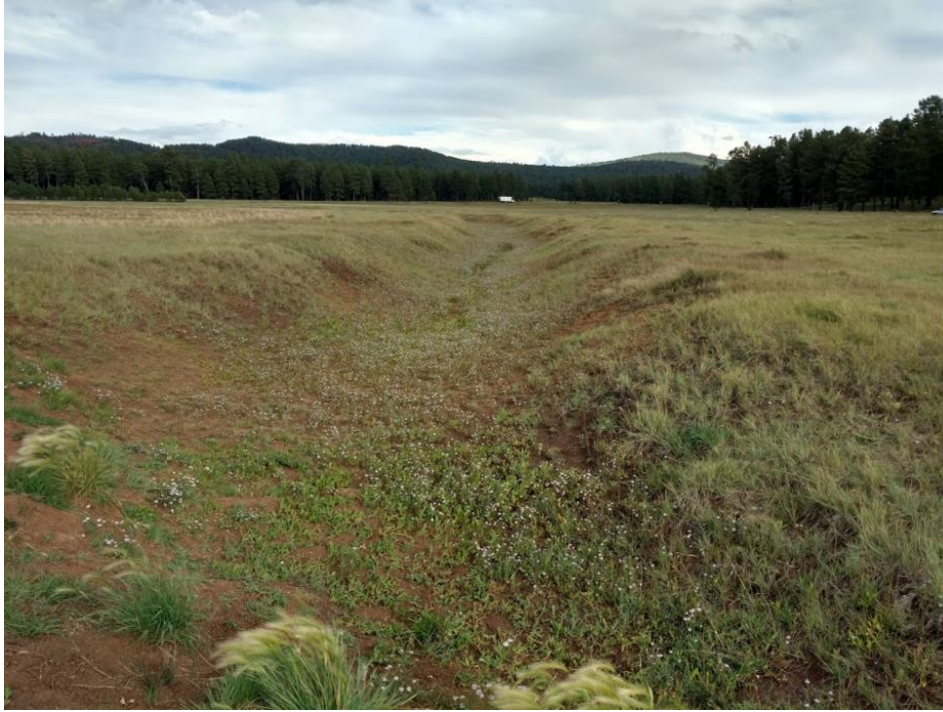
Appendix Figure C3: Unrestored trench in the southeast portion of the site. (September 13th, 2016)

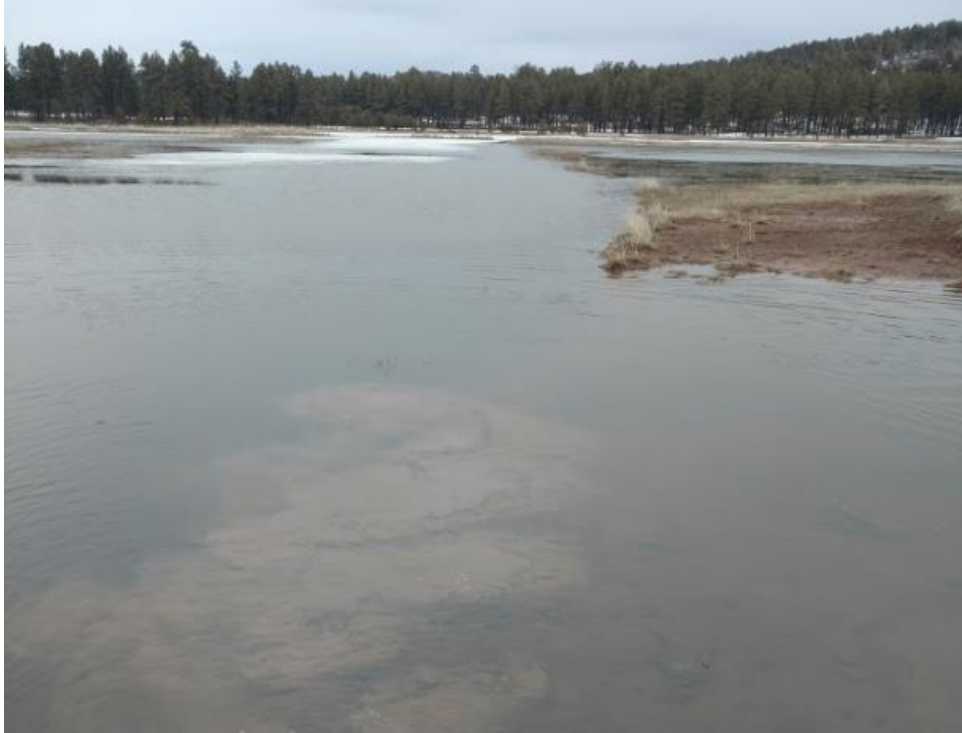
Appendix Figure C5: Looking at the test restoration section on the left and the unrestored section on the right, with the lake at full capacity. (February 17th, 2017)

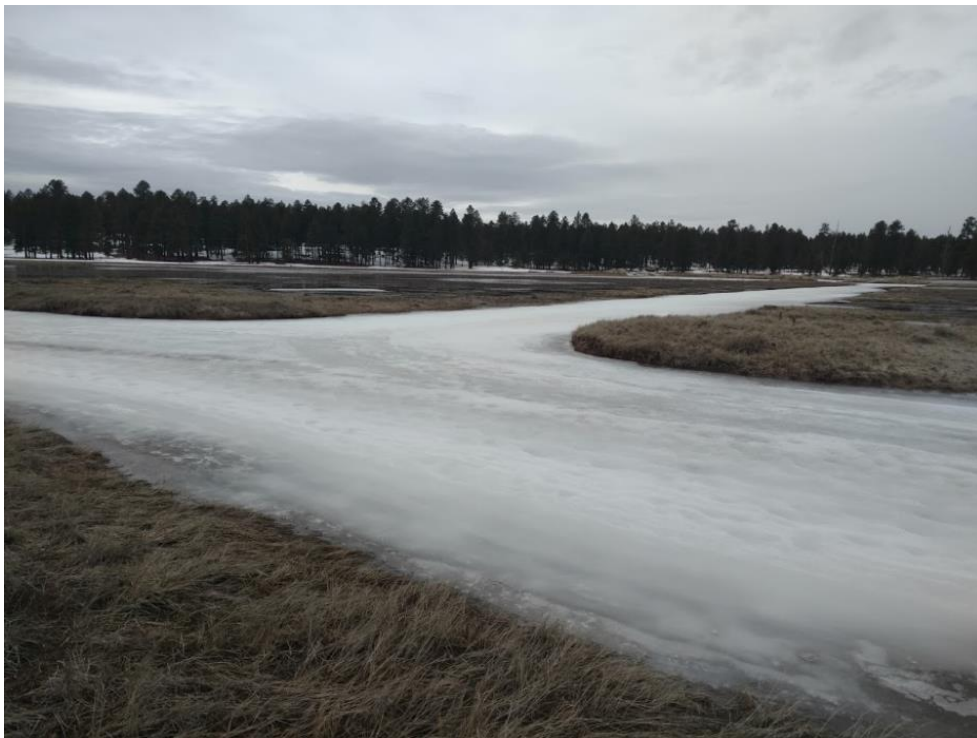
Appendix Figure C6: Trenches in the unrestored area covered by ice during the winter. (February 17th, 2017)
