# CENE 486C NAU Pottery Ramada

Luis Corral, Madison Kaltschnee, Samantha Ray, and Kayla Cross

November 13th, 2020

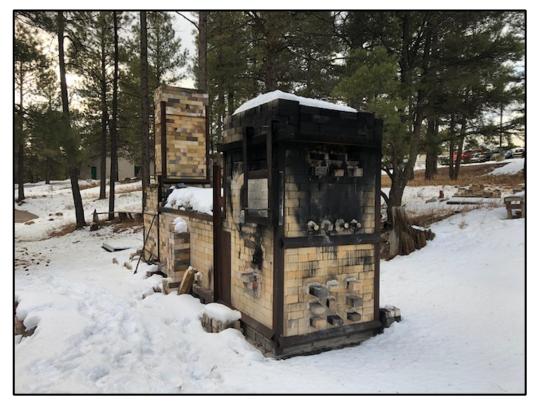
A kiln located at Northern Arizona University's Pottery Complex needs a ramada to protect students from inclement weather conditions.
