TO: Rich Goepfrich, Jr. National Park Service Manager
FROM: Desmin Fontaine, Dylan Edens, Julia Trivers
DATE: Wednesday, November 18, 2020
SUBJECT: Final Report – Saguaro National Park Parking Lot Assessment/Design

Saguaro National Park Parking Lot Assessment and Design: Final Report

Fall 2020 – CENE 486C- Section 1
To Richard Goepfrich, Saguaro National Park
Facility Manager

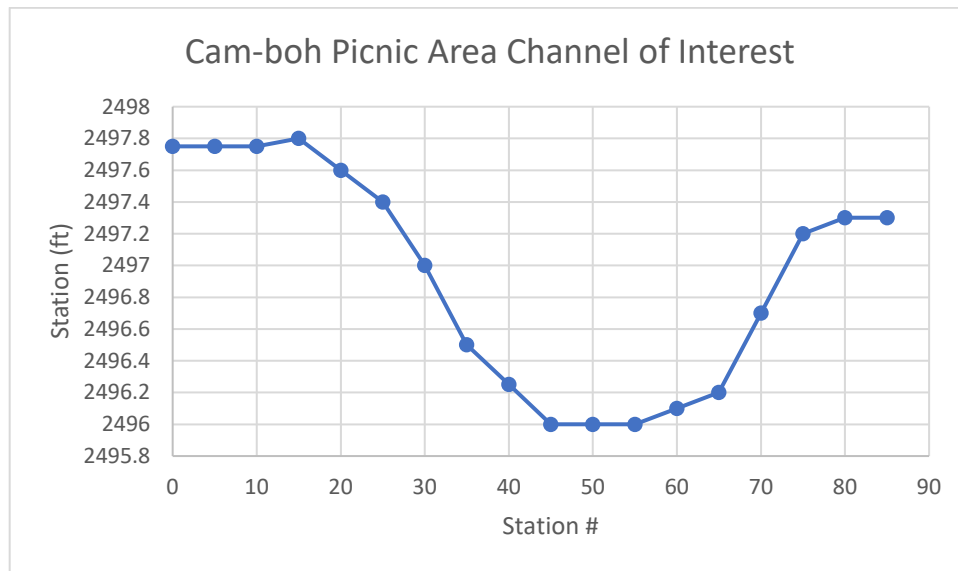
Figure 6- 2: Cam-boh Picnic Area Channel of Interest Cross-Section

To examine the existing volume of the basin, the project team began with conducting a cross-section analysis on the provided topographic map of one cross-section because the client informed the team that the channel is uniform throughout the site. A thalweg, a line that connects the lowest points along the length of the channel, was drawn along the channel’s length. Next, important data points of left overbank (LOB), right overbank (ROB), and thalweg were noted. In order to gather the cross-section data, the project team used the stationing interval method that consisted of establishing a 5-foot interval for each station and then noting the elevation of each of the 5-foot stations. Below in *Figure 6-2* is a cross-section view of the channel of interest in the hydrology analysis and the inputted cross-section data can be found in *Appendix I*.

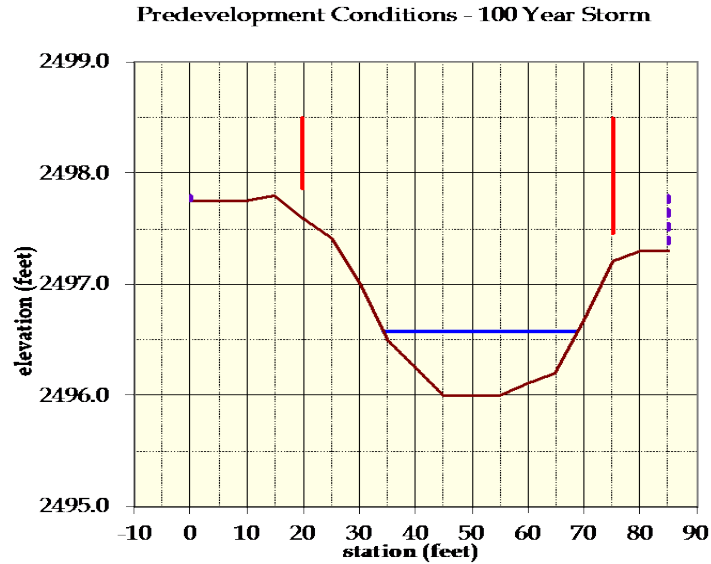
Figure 6-3: Pre-Existing Cross-Section Conditions of Channel

Once the cross-section data was established and recorded, the project team utilized NRCS Cross Section Analyzer to determine if the flow produced from the change in impervious surfaces will be able to be transported in the existing channel. This utilized spreadsheet allows the user to describe a cross-section of a channel by entering ground elevations and stations. The cross-section data was inputted along with the corresponding n-value for the LOB, thalweg, and ROB. Because the project team was not able to take a visual site survey of the existing channel, the project team was able to estimate from the topographic DWG file and Google Maps that the profile slope and n values of the LOB, thalweg, and ROB was 0.04, 0.08, 0.04 from the Table of Manning’s n for Channel produced in *Appendix J*. This spreadsheet employs macros of programmed commands that are activated when the user selects one of the two buttons in the spreadsheet. After the channel information was inputted into the sheet, a ratings table was produced with hydraulic parameters. The project team selected analyze single condition and inputted the flow calculated from the PC-HYDRO for the existing site conditions of a 2, 10, and 100-year storm event. Below in *Figure 6-3* is the pre-development existing cross-section of the channel for the 100-year storm.
