Subject: Implementation II

The SAE Mini Baja project is an international collegiate competition that requires a team of students to design and build a single-seat, all-terrain vehicle. The team will then compete with other collegiate design teams in a series of static and dynamic challenges. Northern Arizona University (NAU) possesses a team of 12 students to compete in the prestigious competition. The team is divided into four sub teams: Front End, Rear End, Frame, and Drivetrain. In the last month, the NAU competition team, Lumberjack Motorsports, has made major progress towards completing the manufacture of their vehicle. Milestones include the completion of suspension components, frame mounting configurations, and critical drivetrain components.

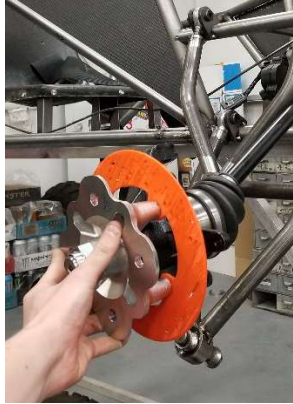
Figure 3: Front Hub Assembly on CV Axle

In addition, the front brake rotors and calipers were required be mounted to the aftermarket hubs and steering knuckles without interfering with other components as the front axles rotated. As mentioned previously, the rotor mounting studs on the front hub were cut 0.5” shorter using an angle grinder to provide sufficient space between the brake rotor and steering knuckle. The existing mounting points for the brake caliper on the steering knuckle were cut 1” shorter to provide clearance for the brake caliper mounting bracket. Figures 2 and 3 display the knuckle and hub modifications, respectively. Figure 4 represents the front brake caliper mounting bracket design.

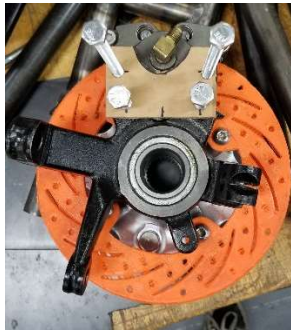
Figure 4: Front Brake Caliper Mounting Bracket (Prototype)

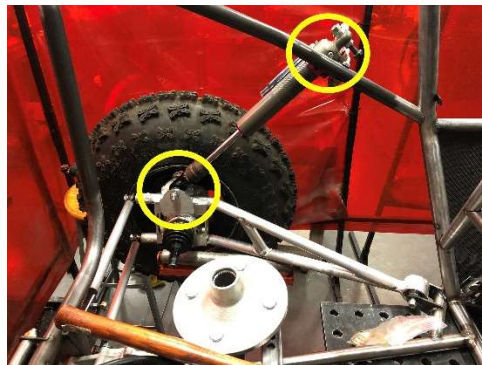
Figure 5: Rear end shock mount locations

At the end of week before spring break the team assembled the parts of the trailing arm they had in place. At this point the team was able to visualize where the shocks would best align to not bind during use. The original plan of mounting was not able to be used as the shocks were too long, thus we moved it to more align. The plan for creating shock mounts can be seen in Figure 5, where the mounting points are circled. The original design was to have the mounts further up the trailing arm. The shocks were too short as well as the tire was rubbing on the shock mount. The old trailing arm can be seen attached to a previous year's frame in Figure 6.

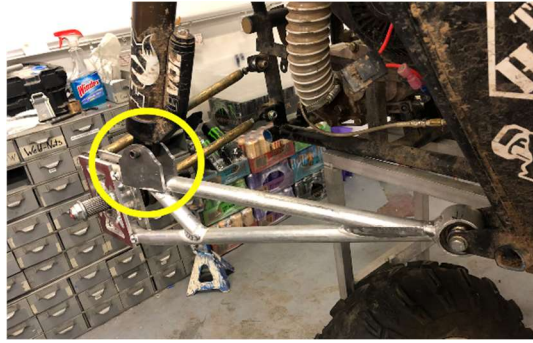
Figure 6: Old rear end shock mount

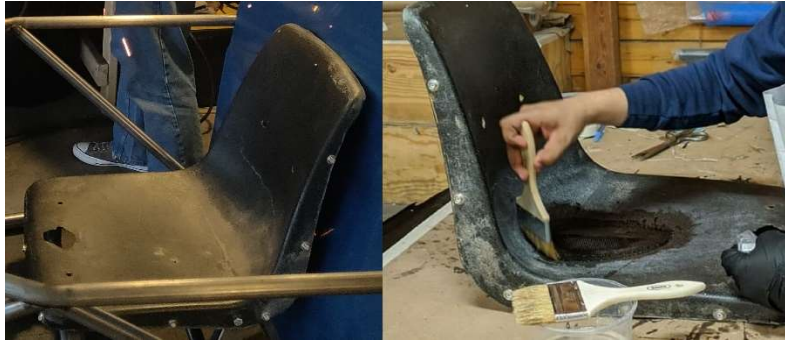
Figure 8: Seat Differences

Once we started getting the cockpit area dialed in, we realized that the drive shaft under the seat was in fact hitting the seat. We checked the rule book on the height requirements with a driver in the seat. It in fact could not move up any further due to this restriction. Since the seat was molded off a school chair, the bottom was a simple shallow bowl shape. To make the small clearance we needed we cut out an oval shape along the drive shaft length. A thin sheet of aluminum was then bent to match the oval cut out and curved around the drive shaft. The seat was then taken to Nova Kinetics where we patched the hole with carbon fiber in the form of the bent plate. The logic behind this was that it would be just enough to clear the driveshaft and the seat might conform to a butt shape a little better. This ended up working perfectly for our needs. The before and during patching photos can be seen in Figure 8.

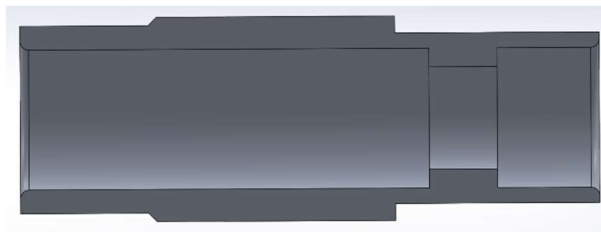
Figure 9: Old Complex Shaft Design

The redesigned shaft was designed for ease of manufacturing. This included a shorter shaft that allowed for bearings to be pressed in right next to each other. This still allowed the shaft to keep the contact points required for proper support but also allows for in house manufacturing. Figure 9 is the old shaft, which required complex manufacturing. Figure 10 is the new simple shaft, which still allows for support through bearings next to each other, while allowing for simple manufacturing.
